# SURFACE INVESTIGATION ON PROTOTYPE CAVITIES FOR THE EUROPEAN XFEL

X. Singer<sup>#</sup>, S. Aderhold, A. Ermakov, W. Singer, K. Twarowski, (DESY, Germany)  
M. Hoss, F. Schölz, B. Spaniol (W.C. Heraeus, Germany).

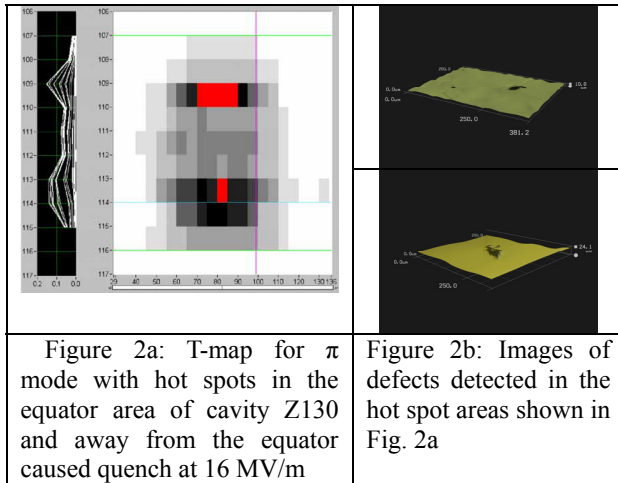
Some examples of the foreign material inclusions can be seen below. Many surface inclusions with sizes from a few  $\mu\text{m}$  to hundreds of  $\mu\text{m}$  were detected by SEM on two samples separated from the cell 1 of the cavity Z130 (Fig. 2a,b). One inclusion indicates increased content of iron (Fig. 3a,b)

Similar black spots of different shapes have been observed in the cavity Z111 too (see for example figure 5a). At first glance it seems that the black spots lie on the surface (Fig. 2b upper image for example) and do not stick in, but more precise analysis shows that the material of the black spots adheres to the surface (Fig. 2b beneath).

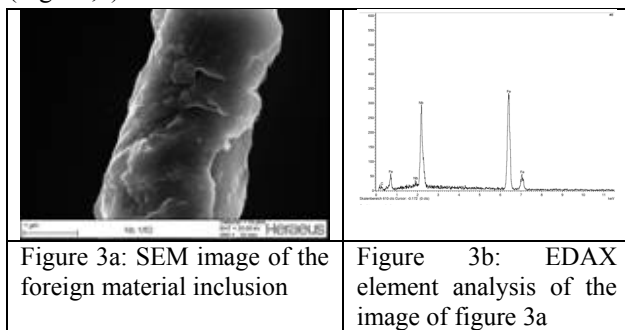
For example, it could be highly probably supposed that imbedding of iron particles happened during deep drawing or handling of subassembly parts at the factory. Particles were already present during EP treatment; the surface of the particles is smooth as usual after EP. On the other hand they were not present in the niobium sheet. The sheets were provided to the vendor after eddy current scanning [2]. Iron, as a magnetic material, contributed significantly to eddy current signal and definitely would be detected.

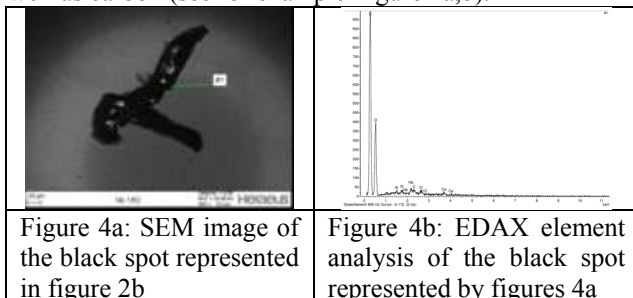
Most inclusions indicate increased content of carbon. Some inclusions indicate increased content of oxygen as well as carbon (see for example Figure 4a,b).

More difficult to explain is the cause of the black spots as shown in Fig. 2 and Fig. 4-6. The Auger spectrums indicate attendants of hydrocarbons. On one hand a lot of hydrocarbons surround the electron beam welding EBW procedure (not sufficient part degreasing, oil fractions from the diffusion pump, rest of oils on the wall of the EBW chamber etc.). At the same time it is difficult to imagine, even if the surface were contaminated, how the contaminants could survive the subsequent treatment including removal of the surface layer of ca. 150  $\mu\text{m}$  thick. On the other hand a lot of hydrocarbon-based material is used into treatment procedure too (polymers, alcohols etc.) which (if remains on surface) can adhere during 800°C annealing. Final EP removes these remainders possibly less efficiently compared to BCP Flash. Suspicion of this could perhaps explain why the bad cavities were mainly EP treated in the end. From this point of view the corrosion holes in Z111 can be considered as the residues remaining after etching away of the black spots by BCP.

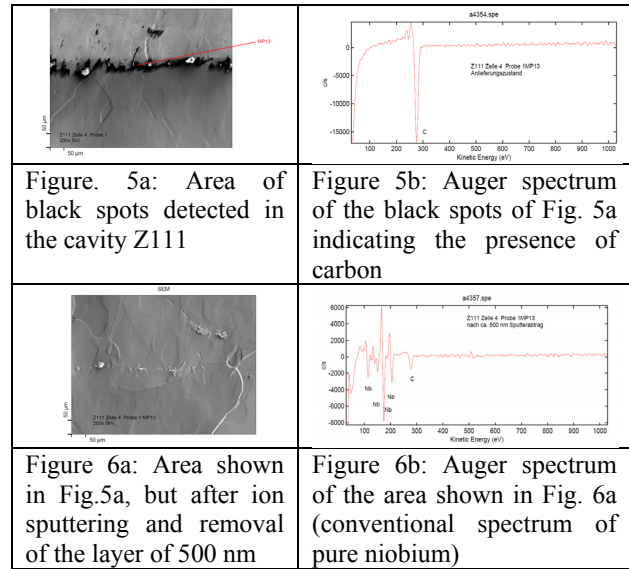
One of the black areas (see image in the Fig. 5a) with pronounced carbon signal in the Auger spectrum (Fig. 5b) was removed by ion sputtering. The black spot and the carbon signal disappeared only after many cycles of sputtering and removal of a layer of 500 nm.

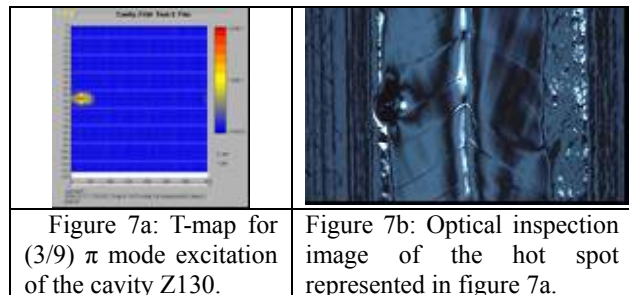
Fig. 7a shows the T-map for (3/9)  $\pi$  mode excitation. Quench at 23,3 MV/m was found in cell 5 of the cavity Z130. Optical inspection done on the cavity by high resolution camera discovered a topographical defect of ca. 1mm size on the interface between the welding seam and heat affected zone (Fig. 7b). The defect area was studied more carefully on the separated sample. No foreign material was monitored. The topography of the defect with a big distance between the peak and the valley (more

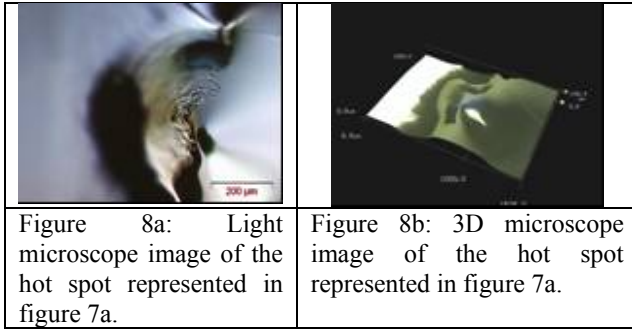
than 150  $\mu\text{m}$ ) can be seen on images of light- and 3D microscopes (Fig. 8a,b).

The topological defect presented in Fig. 7-8 seemingly could be caused at the factory presumably as a result of not sufficiently getting rid of the flake after machining; or imprecise clamping, or possibly a welding error in this location.

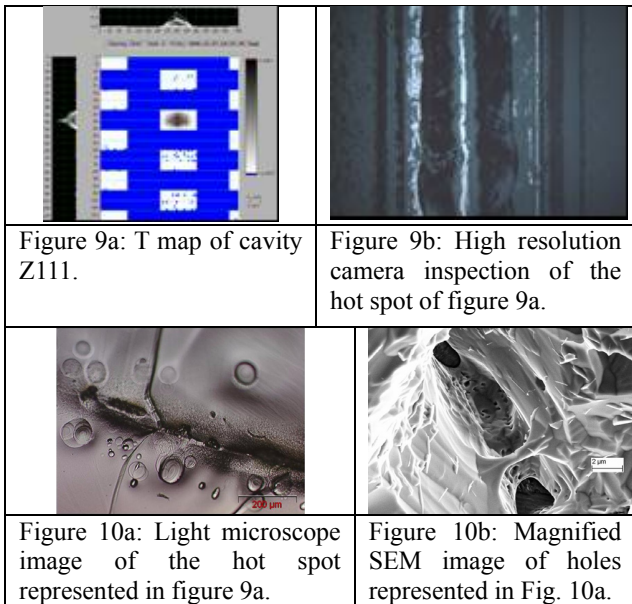
Another topographical defect that limited the accelerating gradient by thermal breakdown at 16 MV/m were detected in cell 6 of cavity Z111 on the equator weld. A group of beads 1.5mm wide were observed in the heating location (Fig. 9a) by optical inspection (Fig. 9b).

More details have been observed on the sample: several holes positioned mainly along a grain boundary were clearly visible in the light microscope image (Fig. 10a). Smaller holes inside of the bigger hole were detected by high SEM resolution. The impression gained was that of local corrosion taking place in this area. Several etching pits were positioned around corrosion holes.
