SURFACE INSPECTION ON MHI-01~09 CAVITIES

Ken Watanabe, Hitoshi Hayano, Eiji Kako, Shuichi Noguchi, Toshio Shishido, Yasuchika Yamamoto (KEK, Ibaraki), Yoshihisa Iwashita (Kyoto ICR, Uji, Kyoto), Y. Kikuchi (Tohoku Gakuin University, Miyagi).

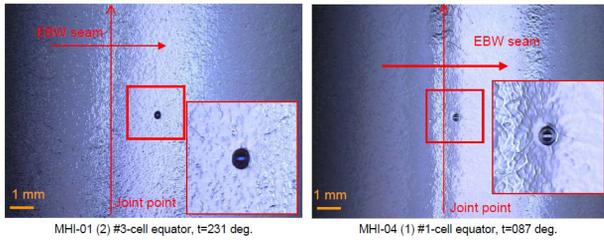
The optical inspection after finished STF Phase 1.0 was done at Sep 2009. Surface condition and typical defect of 1st series cavity are shown in Figure 2. The surface condition looks like the satin finish surface due to CBP. The pit type defects were found around equators. Locations of these pits were (a) on the EBW seam and (b) on the boundary between EBW seam and heat affected zone. In the outside weld area around equators, there was no defect. All 1st series cavities had few pit type defects at the similar location shown by Figure 2. The defects existed around equator though the surface was grinded by CBP at initial treatment.

Figure 2: Typical defects of 1st series cavities.

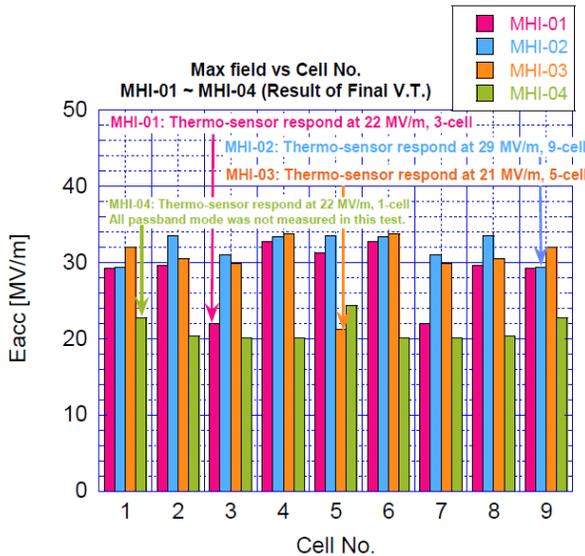
Figure 3: Summary of passband mode measurement in vertical test with old T-mapping.

Table 1 is the summary of the amount of removed material and number of the defect for 1st series cavities. Figure 3 shows the summary of the result of passband measurement at final vertical tests. The thermo-sensors responded at quench in pi-mode and passband measurement in all tests. In the MHI-01, MHI-03 and MHI-04, the geometrical defects found at equator of quenched cell, however, the number of thermo-sensor of old T-mapping was small. The position resolution is not enough. The vertical test with full-scale T-mapping system for 1st series cavity must make to check that “found defects are really reason of cause of quench”.

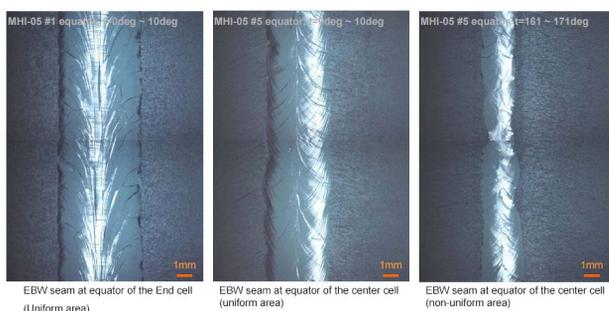
2nd series cavity were fabricated at 2008. The surface treatment to remove material was EP only. The optical inspection of mock-up was done before welding all equators to check a good parameter of EBW. The optical inspection at “as built” was started from this series. The 2nd series cavity had both of the uniform area and the non-uniform area at around the EBW seam of the equators (see Figure 4). The non-uniform area of EBW seam has a possibility for a reason of the limitation to achieve a high accelerating gradient [3],[4],[5]. Possible reason of the non-uniform EBW seam is seemed as the material thickness error of the joint point of the equator. The two types suspicious spots were found at outside of weld area after Bulk EP. The diameter and depth of the pit type spots were 200 ~ 500 μm diameter and 10 ~ 30 μm depth. The diameter and height of the bump type spot was 800 μm diameter and 50 μm height. These spots were observed on the surface even in the dumbbells stage. These spots don't occur in neither the surface treatment nor EBW process. The location of these spots was within 15 mm from a joint point of the equator. To understand “Are these suspicious spots become heating source?”, the thermo-sensor attached on the suspicious spots at vertical test. The heating of these suspicious spots of both cavities were not detected by T-map at ~ 39.9 MV/m in the pass-band measurement. The observed suspicious spots in 2nd series cavity are not reason of limitation of cavity performance at this moment.

Figure 4: Typical EBW seam of MHI-05 “as built” at equators.

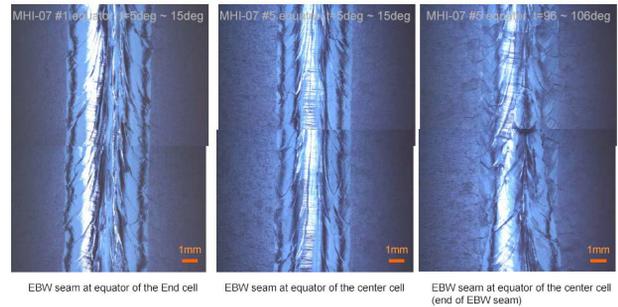
A parameter of EBW of equators was studied for 3rd series cavity to obtain the smooth and uniform EBW seam [3]. The 3rd series cavity was fabricated at 2009. As a result, the EBW seams of 3rd series cavity were improved (see Figure 5) by the new EBW parameter. The qualities of EBW seam for three cavities were similar.

Figure 5: Typical EBW seam of MHI-07 “as built” at equators.
