RADIATION DAMAGE OF UNDULATORS AT PETRA III

P. Vagin*, O. Bilani, A. Schöps, S. Tripathi, T. Vielitz, M. Tischer, DESY, Hamburg, Germany

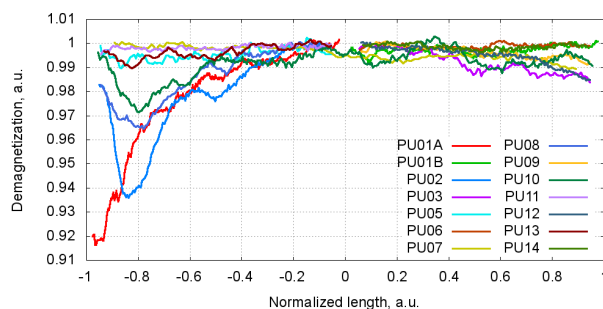
Figure 1: Demagnetization of PETRAIII undulators, horizontal axis is normalized to the length of a straight section.

There are 9 straight sections in the rededicated PETRAIII octant with 14 undulators installed. Some devices are paired in a straight section. The first ones of these show a stronger demagnetization, mainly from upstream part. The second devices show less demagnetization, mainly on the downstream end (Fig. 1).

For the undulators installed in pairs in straight sections the first IDs show demagnetization from the upstream side, while the second ones are damaged from downstream side. This indicates demagnetization by particle losses. At these positions the vertical beam size is largest in each undulator cell, since the vertical beta function has its minimum in the center of straight section, between two paired undulators. Losses are higher at the upstream end of the first undulators, where aperture is decreasing for the straight section.

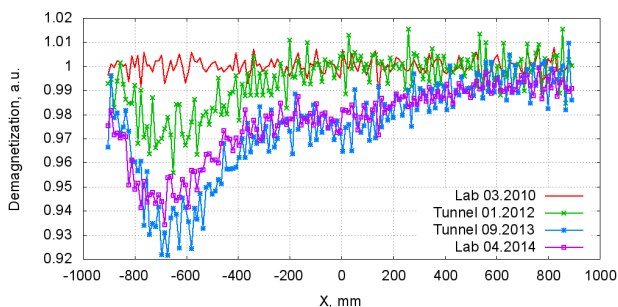
The sensors were mounted on a carriage that used the bottom magnet module as a reference for the vertical position. The assembly was manually moved along the undulator and the Hall probe voltage was continuously digitized in time. The data had no longitudinal coordinate reference, however only the peak amplitude was required to be measured. The position information could be extracted from the measured data by finding positive and negative extremum positions. Although this setup did not allow to measure the absolute field amplitudes and field integrals, in order to compare directly to the results of measurements in the lab performed before installation into the tunnel, still it was well suited to determine relative field changes along the magnet structure. The reproducibility of the measured data over several repetitions is 0.1%. However because of measuring both girders separately, and because absolute fields level could not be determined due to poor vertical and transverse positioning, the total accuracy is only 1% (Fig. 2). Which is significantly worse than in the lab.

Figure 2: PU02 undulator demagnetization progress.

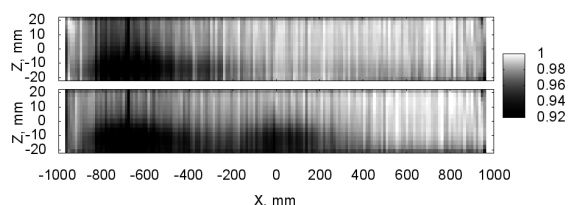
Figure 4: PU02 undulator demagnetization fieldmap measured for top and bottom modules separately at open gap.

During the current shutdown a few devices were removed from tunnel and properly remeasured in the lab. Measurements show a transverse non-uniformity of the demagnetization (higher field decrease at "ring-outside", negative Z), which is also different for top and bottom magnet modules (Fig. 3, 4). The demagnetization is highly localized longitudinally around X=-700mm and does not have its maximum

in the beginning. That would indicate a localized source of radiation, close to the undulator entrance, for example where the decreasing aperture of the vacuum chamber could cause additional beam losses.

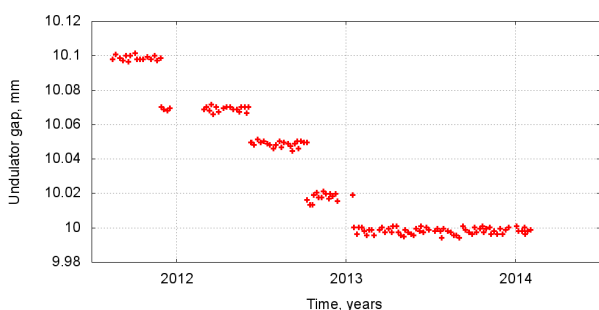
Figure 5: PU02 gap setting to reach 60keV on 7th harmonic is decreasing over time to compensate demagnetization, till it reaches minimum gap defined by vacuum chamber size.

For this particular device it was decided to refurbish the magnets. The magnets will be remagnetized, the coercivity will be enhanced by a rare earth diffusion process to strengthen the grain boundaries and after all an additional coating will be applied to prevent them from corrosion by exposure to synchrotron radiation.

In order to compensate for the demagnetization of the PU02 undulator, gap settings to reach the same wavelength were decreasing over time until reaching the minimum value defined by vacuum chamber. Therefore it was decided to refurbish the magnets during current one-year shutdown for building PETRA III Extension. After that, further improvements in beam lifetime and more careful machine operation should reduce beam losses and therefore radiation damage to the insertion devices.

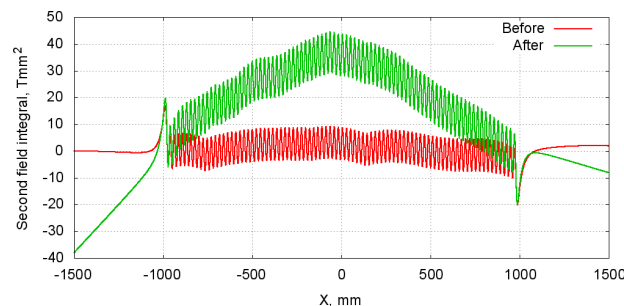
Despite the strong field losses of ~6%, the trajectory straightness was not really affected, as a significant number of poles were demagnetized. Thus field changes on neighbouring poles with opposite signs were similar, having only minor impact on field integrals (Fig. 6).

Figure 6: PU02 trajectory before and after demagnetization.

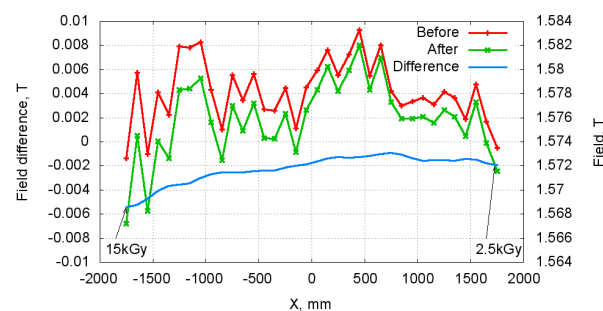
Figure 7: DW05 peakfields after 5 years of operation.

A review of one of the damping wigglers in the lab showed only slight demagnetization mainly on the upstream end. Since this is the first wiggler in a long straight damping

wiggler section, the full dose measured by TLDs can be attributed to the particle losses, and not to synchrotron radiation. The total accumulated dose measured is 15kGy at the upstream side, and 2.5kGy downstream. This is more or less consistent with the magnetic measurements, showing a demagnetization of 5mT (0.3%) at the upstream and only 1mT at the downstream end, which however is only slightly above accuracy level of these magnetic measurements.

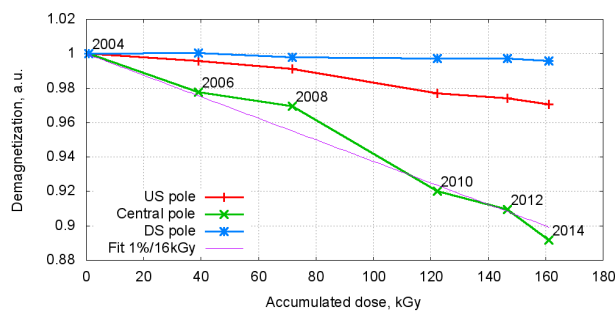
To study radiation damage effects at FLASH, a special 3-pole undulator (with +0.5;-1;+0.5 poles) is installed right before the SASE undulator section. Correlating the periodically remeasured magnetic field of this device with the TLD data for the accumulated dose shows that the magnetic field degradation is 1% per 16kGy of accumulated dose.

Figure 8: Sacrificial undulator demagnetization.

The up- and downstream poles show less demagnetization as they have smaller magnets. Therefore demagnetization fields are lower than for the normal magnets in the center. In addition to that the downstream magnets are shielded by preceding poles.
