RADIATION DAMAGE OF MAGNET COILS DUE TO SYNCHROTRON RADIATION

K. Tsumaki, S. Matsui, M. Ohishi, T. Yorita, JASRI/SPRING-8, Hyogo, Japan
T. Shibata, T. Tateishi, KOBELCO RESEARCH INSTITUTE, INC., Hyogo, Japan

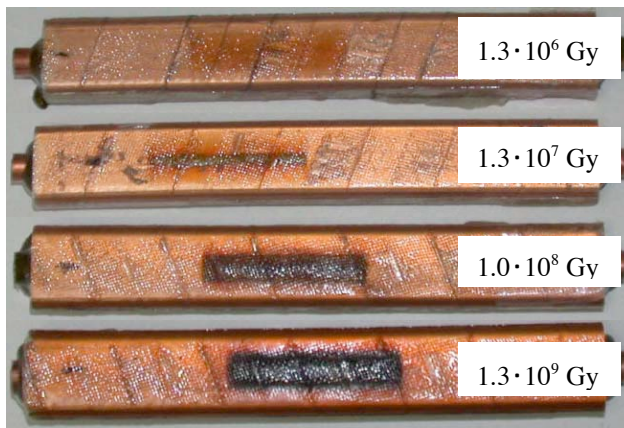
Figure 3: Test pieces after irradiation.

The test pieces after irradiation are shown in Fig. 3. The irradiated part of the test piece was slightly colored in the case of 10^6 Gy irradiation. When the irradiation increased to 10^7 Gy, the center of the irradiated part became white. It became black when the irradiation was greater than 10^8 Gy. The temperature rise in the test pieces during the irradiation was 2°C , so the effect of temperature was negligible. Photographs magnified by a microscope are shown in Fig. 4. We can see the glass cloth vaguely under the milky-white epoxy resin in the non-irradiated test piece. The glass cloth could be seen more clearly under the epoxy resin when the irradiation was 10^7 Gy. With more irradiation, the epoxy resin was carbonized and became black. The irradiated part expanded in volume.

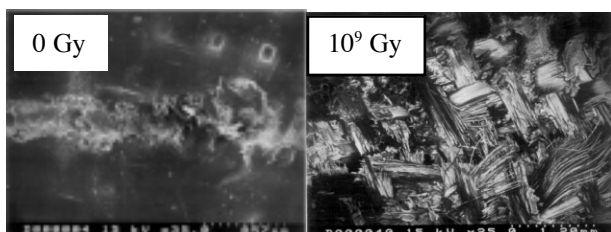
Figure 6: Scratch test results for non-irradiated and irradiated test pieces.

Test results showed almost no difference between the non-irradiated and the 10^7 Gy irradiated test pieces. Above irradiation of 10^8 Gy, the scratch width became wider and the area of damage spread as the radiation dose increased. Photographs of the non-irradiated and irradiated test pieces are shown in Fig. 6. Although the glass cloth of the non-irradiated test piece was not damaged, that of the 10^9 Gy irradiated piece was seriously damaged. That is, the glass prepreg was weakened as the radiation dose increased.

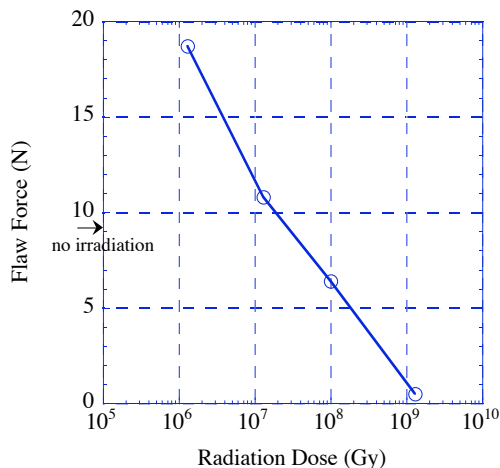
Figure 7: Relation between radiation dose and the flaw force.

When the force was applied, we saw that flaws appeared in the test pieces at certain levels of applied force. We refer to this force as the flaw force. The relation between the radiation dose and the flaw force is shown in Fig. 7. With 10^6 Gy irradiation, the glass prepreg hardened and the flaw force became higher than that for no irradiation. However, the flaw force decreased with increasing irradiation and reached 3 % of the flaw force for 10^6 Gy irradiation at 10^9 Gy. This shows the epoxy resin becomes increasingly fragile with greater radiation exposure.

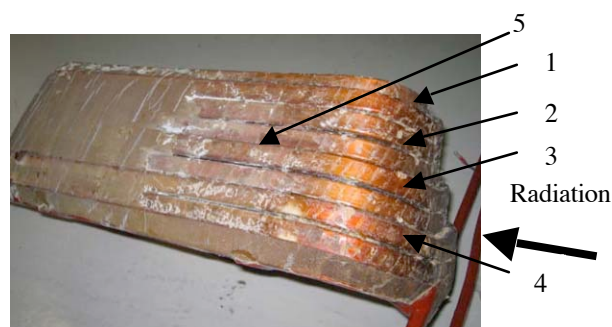
Figure 8: External view of the removed magnet coil.

The measured magnet had been located near the absorber. The greatest part of the radiation dose was in the lower left side of the coil and the estimated accumulated radiation dose was 6×10^6 Gy. After removal of this coil, we investigated the coil damage.

An external view of the removed magnet coil is shown in Fig. 8. The side of the coil was milky-white in color, but the color of the part that had faced the absorber had

changed to brown. We applied the scratch test to five test pieces taken from the coil. (The test pieces were numbered as shown in Fig. 8.) The five flaws arising from the scratch test were similar in appearance to each other and to that of the acceleration test piece exposed to 10^6 Gy irradiation. The measured flaw forces for pieces one to five were 8.5, 13.1, 5.1, 7.5, and 7.1 N, respectively. These values correspond to irradiation of 10^6 to 10^8 Gy (Fig. 7). The resistivity was more than $1 \text{ G}\Omega$. From the above results, we can see that the coil was still able to perform properly. The degree of damage suggested by the external view and scratch test results corresponded to the damage caused by irradiation of 10^6 to 10^7 Gy in the acceleration test. This agrees roughly with the estimated radiation dose of this magnet and shows the validity of the acceleration test results.
