EXPERIENCE WITH LONG TERM OPERATION WITH DEMINERALIZED WATER SYSTEMS AT DAANE

L. Pellegrino, LNF – INFN, Frascati (Roma) - Italia

During eight years operation of the DAANE water cooling system some critical situations have been successfully managed by upgrading the demineralized water system. The collected data and the experience gained in the field of copper corrosion and related water treatment are critically revised.

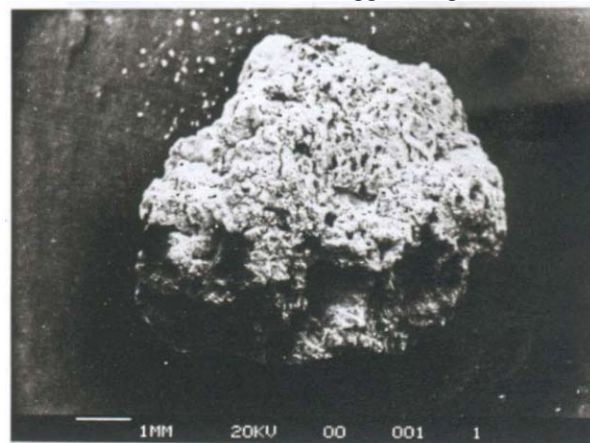
The rubber hose between the manifold spigot and the coil end forms a flow section enlargement, with internal diameter going from 4 to 6 and again to 4 mm, as a little "chamber". Solid pebbles (D>5 mm) formed in some of these "chambers" inside the hoses and, there, moved back and forth, obstructing sometime the flow in one or more coils. Therefore the coils, no more cooled, heated until safety thermal device switched down the whole chain of four wiggler magnets.

Figure 3: copper oxide pebbles.

the only component, as well as the water at inlet and outlet of the polishing system, as in table 2. In figure 3 is the micrographic picture of a pebble.

The conclusion was that the relatively high conductivity, the relevant dissolved oxygen contents of cooling water and the high electric potential of some coils with respect to the grounded piping yield the production of copper oxides and their migration according to the potential difference. Probably, sulphide-reducing bacteria catalysed the agglomeration process of the oxide, starting on the lips of the inlet copper spigots, in a slower flow region.

The deposits grew until detached and continued growing, probably without leaving the "chamber".

We modified the polishing circuit and its location in the plant, to assure a continuous treatment of the whole water mass with the proper flow in the mixed bed bottles, and added new instruments and a data logger; the N₂ cushion system was reviewed and frequently checked; the whole plant pressurization scheme was reviewed, to ensure a positive pressure everywhere, avoiding unwanted air intakes.

As soon as a stable operating condition was reached, the failure did not present anymore.

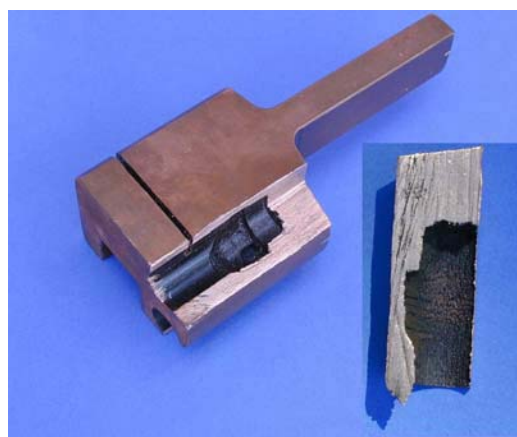
Nevertheless, after some year of operation, a tiny crack opened a way to the water. The alarm was early on, so the damage was limited, but the probability of other occurrences of a similar failure was high, due to the large number of absorbers installed.

A visual endoscopic inspection revealed a pitted area downstream of the hole between the inlet and the outlet channels (figure 4). Moreover, the water flow was measured as more than twice the design one.

Because of the local narrowing of the water passage, a very high velocity was reached in the water flow, leading to cavitation that damaged the internal surface of the outlet channel. This phenomenon was surely enhanced by corrosion, until the opening of the crack. Some similar cases are reported in literature.

Figure 4: the tip of an absorber and a section showing the internal of the crack area.

Following this analysis, a proper flow velocity was restored, with no further consequences.
