# AUTOPSY ON AN RF-PROCESSED X-BAND TRAVELLING WAVE STRUCTURE

F. Le Pimpec, S. Harvey, R.E. Kirby, F. Marcelja  
SLAC, 2575 Sand Hill Road, Menlo Park CA 94025, USA

## Abstract

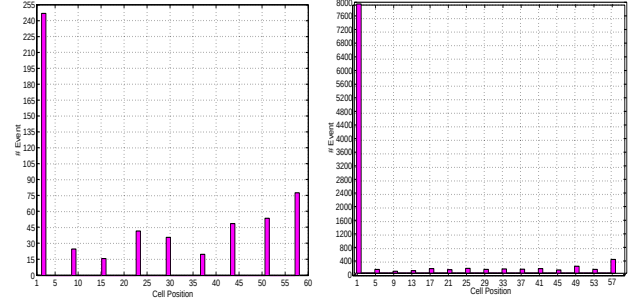
Figure 2: Example of damage localization in T53Vg3R (left) - T53Vg3RA (right) during operation

The breakdown pattern localization Fig.2 reveals that most of the breakdown are occurring in the input coupler (IC) of the TW. In Fig.3 we can see that the input coupler is divided into two parts the waveguide section, left side of the picture and the cell side in the center. The feature separating the waveguide side and the cell side is denominated "horns". The gap between the top and bottom horn is  $\sim 9$ mm.

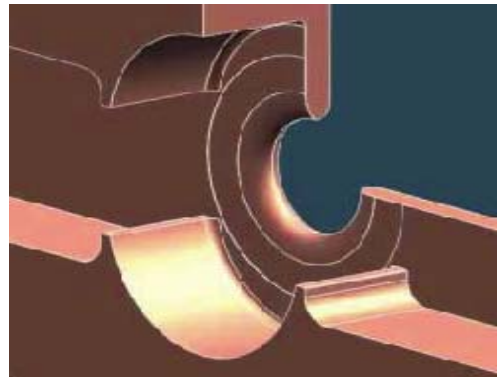
Figure 3: Input coupler design. The center is the cavity side with the first iris

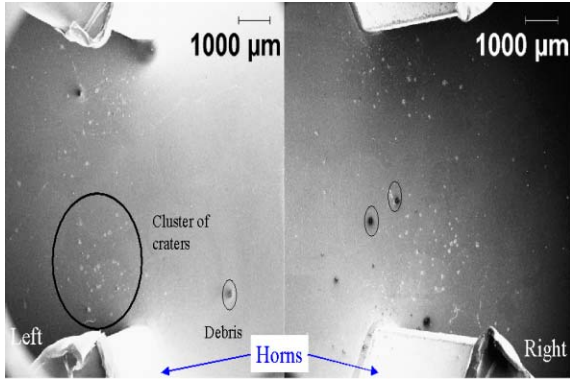
Fig.4, 5 and 6 reveal a very interesting pattern of damage. The craters on the floor of the IC, Fig.4, are mainly located along the imaginary circles connecting the two faces of the horns. Closing up to the horns and focusing on the details, one can observe droplets of copper [3]. Craters ap-

Figure 4: Pitting due to RF breakdown on the floor of the Input coupler. The iris is in between the horns.

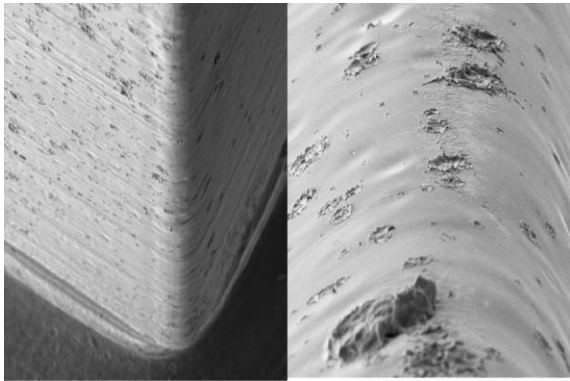
pears on all the sides of the horns, with a density higher in the face side than the waveguide or cavity side. Looking more closely of the edges of the four horns has revealed that the edge on the waveguide side, Fig.5, shows little damage. In the contrary the edge on the cell side shows a chaos of features, Fig. 6, with sharp and melted objects. The dimension bar in the right picture of Fig.6 is  $\sim 10\mu\text{m}$ .

Figure 5: Typical damage on the waveguide side of a horn of the IC

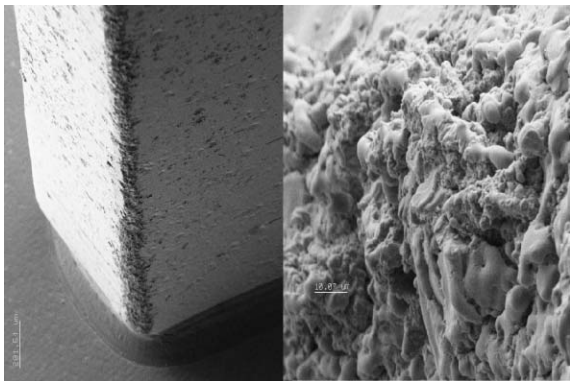
Figure 6: Typical damage on the Cell side of a horn of the IC

The observation of the damages on the horns is coherent with the acoustic sensors analysis. Also pictures taken during breakdown show clearly after averaging over 100 of breakdowns 4 spots in the approximative location of the horns [4]. At first Ion bombardement and sputtering might be invoked to explain the damages. However, the horns

lies in a very low electric field area, and the vacuum is of the order of  $3.10^{-9}$  Torr. It is then not possible to explain how such a low gas density and kinetic energy might start a breakdown leading to the so seen damages. It is also not possible to explain the very localization on the edge of the cavity side of the horns Fig.6. During processing, the RF pulse went from 50 ns to 400 ns carrying up to 100 MW of power. Part of this energy is dumped in the Cu in form of heat or directly or by the induced current due to the high magnetic field 0.7 MA/m at 400 ns pulse length [5]. Along the edge (76  $\mu\text{m}$  radius) this RF pulse heating leads to an increase of temperature up to 130 °C. It is clear that this temperature do not cause the observed damage. However, it might induce thermal fatigue in the Cu, inducing formations of cracks, as observed in [6], and leading in roughening of the edge. As the surface becomes rougher, the local resistivity of the Cu increases leading to a higher temperature maybe up to the melting point (1083 °C). At this temperature, the vapor pressure of the Cu is  $\sim 3.10^{-4}$  Torr [7]. This gas can now be ionized by the electrons coming from the surface and back bombard the horns. As a result, raising up the temperature and sputtering the surface. We might, in addition, explain the droplet of Cu seen at the surface of the floor. The patterns of craters on the floor, Fig.4, seems to follow the high magnetic field line. As we move toward the center the density of craters diminish and increase again as the electric field start to be consequent Fig. 7.

Following our autopsy many studies and simulation led to the decision of rounding the edge to 3mm instead of  $76\ \mu\text{m}$  radius in order to avoid the thermal fatigue rough-

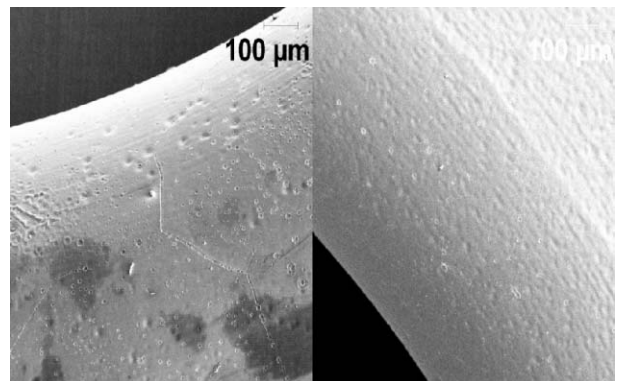
SEM (secondary electron microscopy) Fig. 7 shows the damage on the upstream side and the downstream side of the iris, respectif to the displacement of the NLCTA electron beam. On both sides etch pits can be seen as well as craters. However, the density of craters is much higher in the upstream side. Many craters are also located in the grain boundary. A particle search in and out of the craters shows MnS located in and out of them. Most of this inclusions are located in the grain boundary. The analysis of the contents of the craters shows mainly pure Cu. The black spots on the upstream side is carbon. An Auger analysis of the surface, not including those spots, shows heavy contamination by carbon of this iris [3]. Carbon contamination due to electron bombardement is a well known problem, [8]. There is no such contamination in iris 28 further down the structure [3].

Figure 7: Activity on the 1<sup>st</sup> iris, Upstream side left picture and downstream side right picture

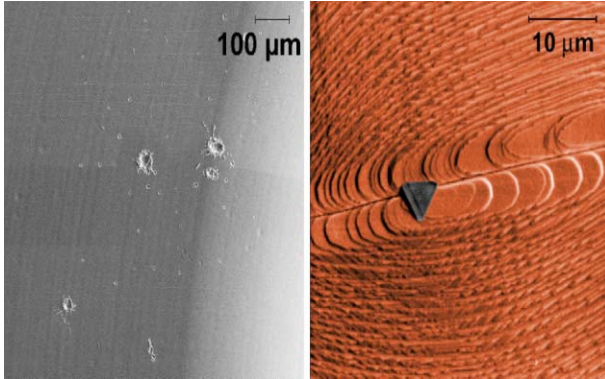
As we move toward the output coupler (OC), the activity on the irises decreases, endoscope (boroscope) monitoring. Fig.8 shows the sparse activity on the 28th iris of the structure. As we looked for particles/inclusions on the surface and at the grain boundary, we did not find MnS. However, some other sulfur compound were found [3], as the atypical one shown in Fig.8.

Figure 8: Activity on the 28<sup>th</sup> iris, Upstream side. CrS inclusion at a twin boundary, right picture

The cells used to make the structure are bonded and then brazed in a stainless steel (SS) H<sub>2</sub> furnace at  $\sim 1020^\circ\text{C}$ . The Sulfur (S) composition is 0.03 weight % in stainless steel. Other material like Mn, Cr, Ni are also used in the making of SS. The solubility of sulfur in copper is very high at this temperature and significant at a few hundred  $^\circ\text{C}$ . Hence, a significant amount of S can get into the copper. After its fabrication, the structure is vacuum baked in a SS pot at  $650^\circ\text{C}$  for few days, in order to desorb the H<sub>2</sub>. Metals might be present in the atmosphere of the H<sub>2</sub> furnaces and bakeout pot at this given temperature, with vapor pressures of  $10^{-5}$  Torr for Mn,  $10^{-11}$  Torr for Cr,  $10^{-1}$  Torr for Ca and below  $10^{-11}$  Torr for Ni [7]. At  $300^\circ\text{C}$  and above the S concentrates at the grain boundaries of the Cu. The S also start migrating to the surface at low temperature  $75^\circ\text{C}$  [9]. The Model for sulfur compound formation is that the sulfur getters the metal vapor out of the furnace atmosphere to form crystals/inclusions at/near the grain boundaries. A particle search on the IC reveals that  $\sim 80\%$  of the particles are Mn-S. On the very next iris the proportion falls to  $\sim 50\%$ . The search in the 28<sup>th</sup> cell shows no Mn-S but S-compounds are present at  $\sim 50\%$ . Finally the search on the last cell in front of the OC shows Mn-S and other S-compounds. Finally in all the cases, other particles are compounds based on C, Al and Si not excluding the presence of Mn or S or other elements. This model might explain the sulfur compound formation, but the understanding of the distribution along the structure of those elements is under investigation.

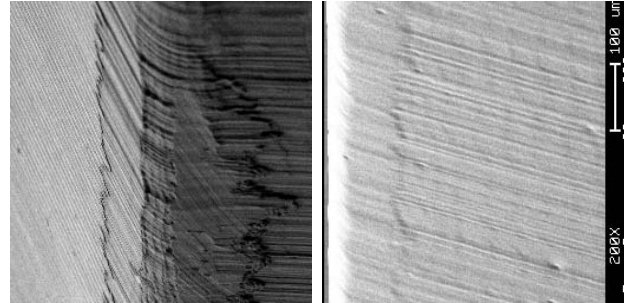
ening mechanism. It is believed that the new design of the IC and OC implementing this rounding will cure our breakdown problem in those couplers. Also, machining a 3mm edge radius should leave the surface extremely smooth. We have shown on an identical input coupler of T53Vg3R, Fig.9, that the 4 edges of the cavity side of the horns present a roughness after machining. Following the etching and thermal processing, that sees the structure, do not removed this roughness. In a contrary, the edge on the waveguide side of the horns are well finished.

Figure 9: Surface of the edge, cell side, of a horn after machining (left) and after 60" etch and thermal processing
