MAGNET-RELATED FAILURE EXPERIENCES AT THE SPring-8 STORAGE RING

K. Tsumaki, N. Kumagai, S. Matsui, M. Ohishi, H. Yonehara, SPring-8/JASRI, Hyogo, Japan
 T. Tateishi, Y. Torii, KOBELCO RESEARCH INSTITUTE, INC., Hyogo, Japan

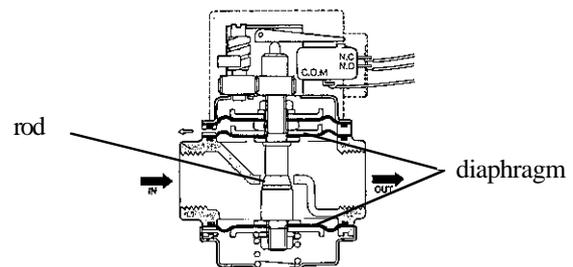
The number of flow switches and the parameters of cooling water are shown in Table 1 and the structure of a flow switch is shown in Fig. 1. When the water flows in a flow switch, the pressure difference between before and after orifice is generated and due to this pressure difference, a rod moves downward. If the flow rate reduces, the rod moves upward and a micro-switch becomes off state. There were two capabilities as the cause of failures. One was the hardening of rubber diaphragm and the other is the erosion of rod. The maker thought it was due to the hardening of a rubber diaphragm. We measured the hardness of the diaphragm. Results are shown in Table 2. There is only a small difference between used and unused diaphragms.

Figure 1: Structure of flow switch.

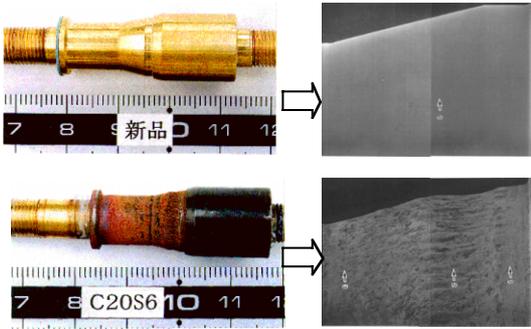
Next we observed the rod. The rods for used and unused flow switches are shown in Fig. 2. The rod is seriously damaged by erosion. If the rod becomes thin by erosion, pressure loss becomes small. We measured the pressure loss for used and unused flow switches. Pressure losses for used and unused flow switches are 0.024 MPa and 0.054 MPa, respectively. We concluded the cause of failure is due to the erosion of rod and resultant reduction of pressure loss of water flow. We stopped the use of this

Figure 2: Rods of unused and used flow switch.

type of flow switch and employed float type flow switches.

Magnet flow switches began to give a false signal. The rods of flow switches were eroded and pressure loss of water in the flow switch became small even if the sufficient water flowed, which caused a false operation. We changed them for float type flow switch.

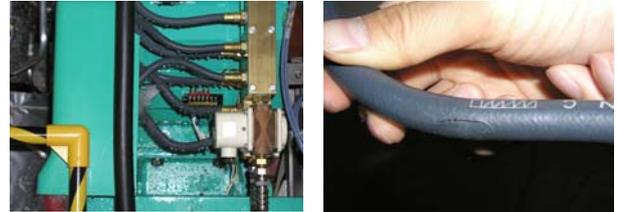
In September 2001, cooling water leaked from the rubber hose for quadrupole magnet at injection cell. Usually magnet hoses face to the inside of the storage ring but at injection cell, the hoses face to the outside of the ring to avoid interference with a transport line from a synchrotron. For that reason the rubber hoses face the

absorber directly. We measured the radiation strength and the radiation level at the leaked hose is one or two order higher than the other cells. So we considered the injection cell was special. Rubber hose at injection cell was shielded by the lead. However in January 2003, water leaked from the other normal cell hose and during one month and a half since that time, water leakage occurred three times at normal cells. All leaked hoses were at Q7 and Q10 magnets, where they faced to the absorbers named AB3 and AB4. We exchanged the rubber hoses for all Q7 and Q10 magnets where radiation dose is higher than the other magnets.

Figure 3: Water leakage from a rubber hose for a quadrupole magnet.

Radiation dose for the rubber hoses, from which the water leaked, was measured together with the rubber hoses for both ends of the girders. Radiation doses for Q7 and Q10 magnets are one or two orders higher than the other magnet. Maximum integrated dose is 4×10^5 Gy. There are eight rubber hoses for a magnet. Leakage occurred for the rubber hose at the same position. Rubber of leakage point was hardened by radiation.

Water also leaked from the rubber hoses. Radiation scattered from the absorbers hit the rubber hoses of quadrupole magnet. Integrated radiation dose at the rubber hose was 4×10^5 Gy. We exchanged all the rubber hoses near the absorbers. We are planning to shield around the absorbers. Problems of the radiation damage become serious with the increment of integrated current and it is one of the important subjects for the operation of the storage ring.

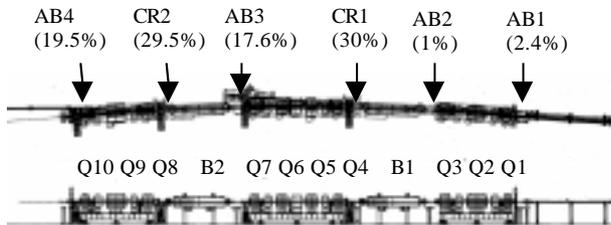
Radiation sources are the absorbers (AB1~AB4) and crotch absorbers (CR1, CR2) as shown in Fig. 6. Radiations from bending magnets are scattered by these absorbers and damage the surrounding equipments.

Figure 6: Magnet and absorber arrangement and radiation power distribution from the bending magnets. Total radiation power per cell is 21 kW.

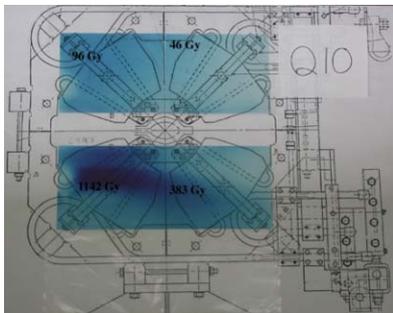
Measurements were done for the quadrupole magnets of both ends of girders. One of the measurement results is shown in Fig. 7. Integrated current during irradiation was 0.1179 A*h. Integrated current at April 2003 is 1678 A. Therefore maximum integrated dose is 1.6×10^7 Gy. No radiation effect is observed for magnet coils until now, however, if there is any effect, it becomes serious. So we are planning to study the radiation effects for magnet coils.

Figure 7: Measured results of radiation around the magnet coils.

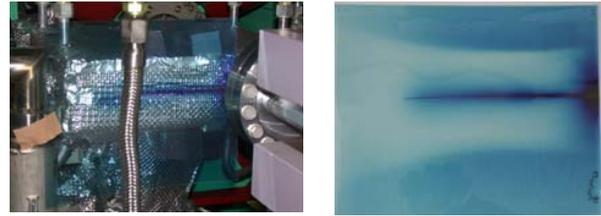
Radiation dose behind the absorber was measured as shown in Fig. 8. High energy x ray was transmitted through the chamber even though the lead plate was

placed for shielding the radiation. Maximum integrated dose is 2×10^9 Gy. It is clear that the thickness of the plate should be increased.

Figure 8: Radiation distribution behind absorber 3.
