RESOLUTIONS OF PROBLEMS THAT OCCURRED IN SPEAR3 MAGNET PRODUCTION

Nanyang Li, SLAC, U.S.A. Huamin Qu, Fuhe Huang, IHEP, China

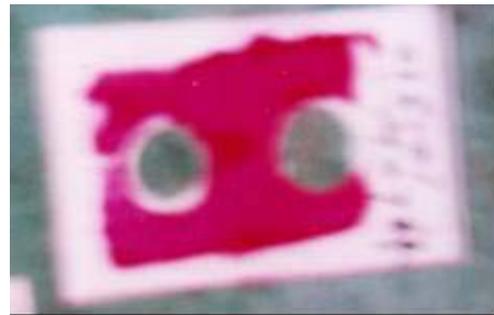
Good connections between buss and coil lead lugs are vital to prevent overheating and degradation of the contacting surfaces. To verify this connection SLAC suggested using pressure film to test the contact area between the buss and the flag. The film is made of polyester and can be cut. Accuracy is $\pm 10\%$ and temperature range is 41° to 95° F. SLAC selected the film with pressure range 350-1400psi for this purpose. The film was placed between the two connecting surfaces and bolted tightly, under the pressure applied by the bolts the film will turn red if there is contact between the surfaces. The mating surface that achieved 80% contact area was considered acceptable (refer to fig.1); otherwise, the surface should be trimmed. The films that were used for testing had been kept in the travellers of each magnet.

Figure 1: An Acceptable Connection

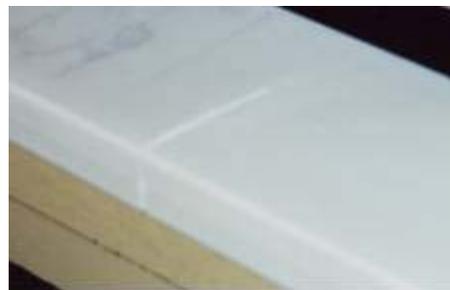
In the early stage of coil fabrication at IHEP, about 80% of potted coils sustained severe epoxy cracks either right after the potting or few days later. Eventually 100% of those potted coils cracked (refer to figure 3). Theoretically, a thin epoxy layer, <0.5mm is desirable to avoid cracking. But in practice, in order to cope with coil winding tolerances and necessary taper of the potting mould, the epoxy thickness is larger in some segments of the coil. Therefore, using G10 filler or reinforced epoxy filler is necessary to avoid epoxy cracking at these places (refer to fig. 4 and fig. 5). The following engineering data shows thermal expansions of four materials:

One can see that non reinforced epoxy, which has high shrinkage coefficient (about 3.18 times higher than copper), should never be used as a filling material as the differential expansion rates between it and copper are great and will eventually cause epoxy cracking in potted coils .

Figure 3: Epoxy Crack

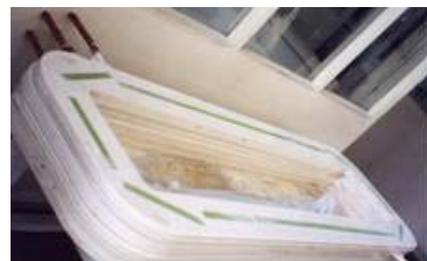
Figure 4: G10 Straps

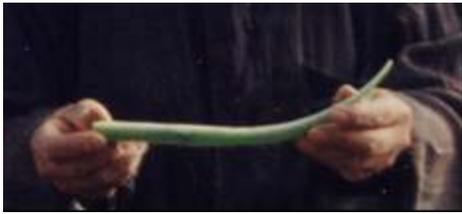
Figure 5: G10 Filler

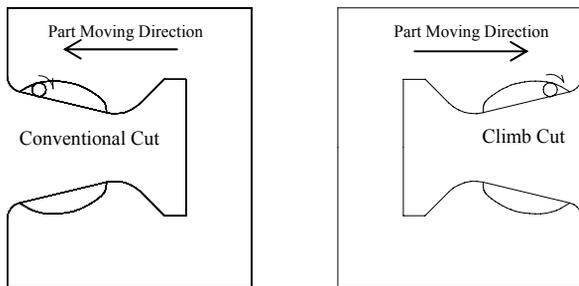
The first dipole end pack chamfering was done in a configuration that used a milling machine programmed for a conventional cut on one pole and a climb cut on opposite pole (refer to fig.6). The glued laminations peeled off under the conventional cut method. The technician modified the program making both poles cut under climb cut method which solved the peeling problem (refer to fig. 7).

Figure 6: Both Poles Start Chamfering at Open End

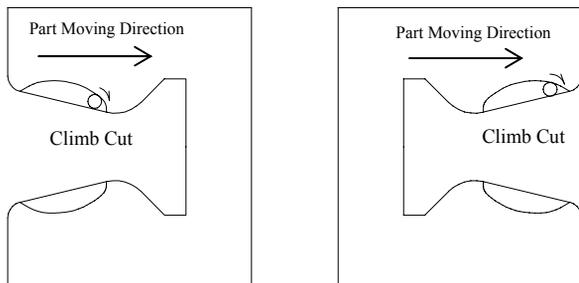
Figure 7: Start Chamfering at Different Pole End
