# LONG-TERM STABILITY OF THE BEAM POSITION MONITORS AT SPRING-8

T. Fujita<sup>#</sup>, H. Dewa, M. Masaki, S. Matsubara, S. Sasaki, S. Takano,  
Japan Synchrotron Radiation Research Institute (JASRI/SPRING-8), Hyogo, Japan  
H. Maesaka, Y. Otake,  
RIKEN SPRING-8 Center, Hyogo, Japan

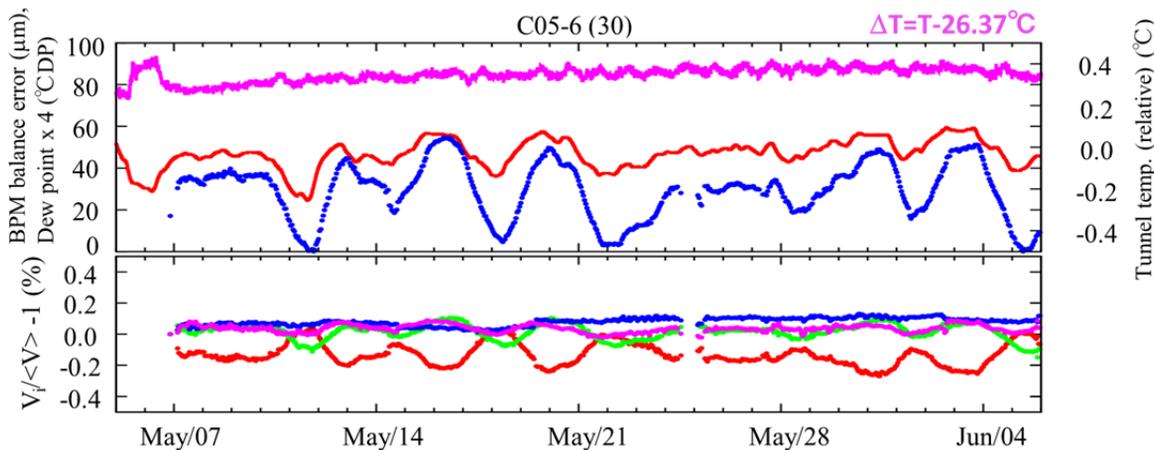
several features of variations of balance error of the BPM. Figure 3 shows an example of BPM with balance error correlated with the DP. Drift of balance error is 48  $\mu\text{m}$ . Voltages of some channels are also correlated with the DP.

Figure 3: An example of BPM with balance error correlated with the DP. See Fig. 2 for legends.

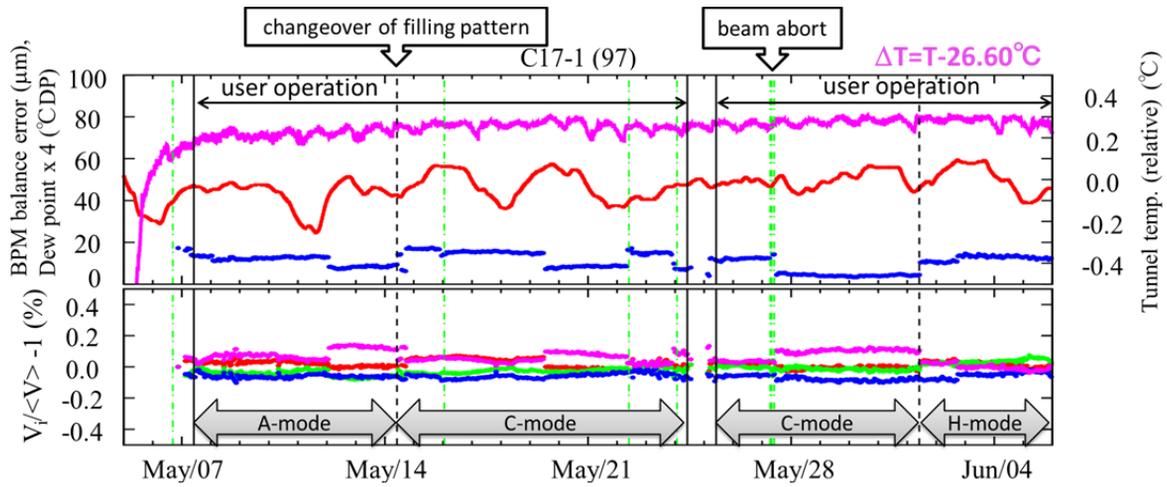
Figure 4 shows an example of BPM of which balance error varies like step functions. Some of discontinuous jumps of balance error are identified to occur at occasions after beam abort and changeover of beam filling-pattern. Jump of balance error is 10  $\mu\text{m}$ . Voltages of some channels jumped simultaneously with the balance error. Sources of the jumps could be failed behaviors of RF switches in the BPM circuits which select one of 4 BPM electrodes. Inspections of the switch modules and exchanges of the faulty ones are planned.

Figure 4: An example of BPM with step function like variations of balance error. See Fig. 2 for legends. In operation modes given in the figure, bunches are stored as follows [4]; A-mode : 203 bunches with each bunch current of 0.5 mA are equally spaced, C-mode : 29 bunch trains are equally spaced. Each train consists of 11 bunches with the bunch current of 0.3 mA, H-mode : one bunch train which consists of 924 bunches with the bunch current of 0.1 mA and one isolated bunch with the bunch current of 5mA. In every operation-modes, the total beam current stored in the ring is 100 mA.

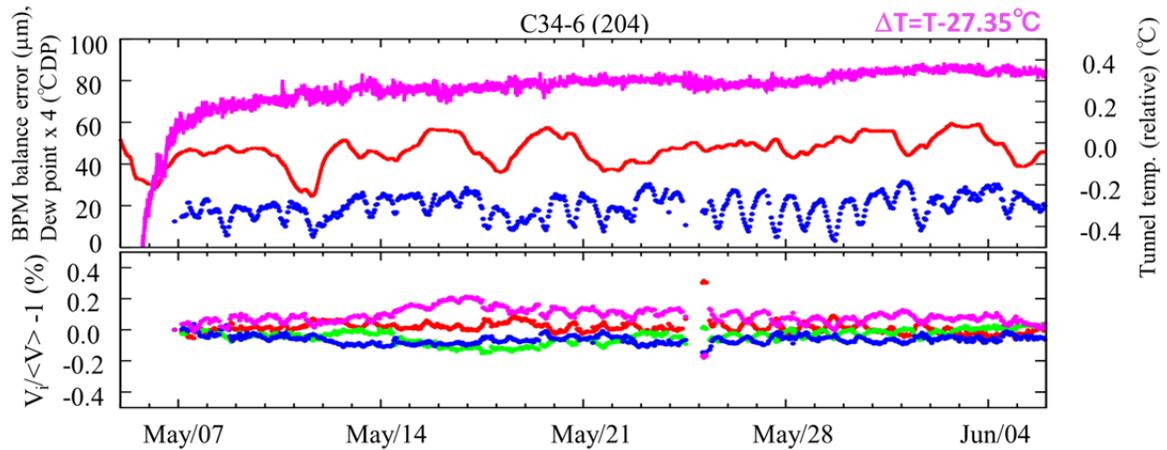
Figure 5 shows an example of BPM balance error varying with a period of approximate one day. Voltages of some channels also varied with the same period. Variation of balance error is 25  $\mu\text{m}$ . The period of approximate one day suspected the environment temperature as suspected cause of variations. However, no significant correlation has been found so far. Further investigations are necessary to find the cause.

Figure 5: An example of BPM with balance error varying with a period of approximate one day. See Fig. 2 for legends.

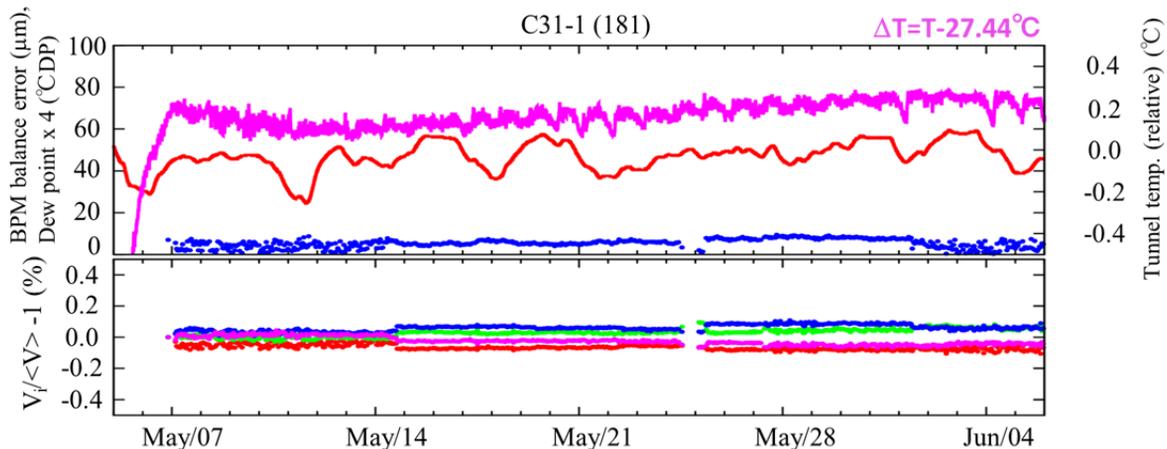
Figure 6 shows an example of BPM with fast variations of balance error. Voltages of some channels also varied. Variation of balance error is about 7  $\mu\text{m}$ . No significant correlation has been found so far with other parameters. The behavior of variations seems to change at the changeover of beam filling patterns, suggesting that the source of the variations could be the beam, for example higher-order modes of electro-magnetic waves excited in the vacuum chamber.

Figure 6: An example of BPM with fast variation of the BPM with balance error. See Fig. 2 for legends.

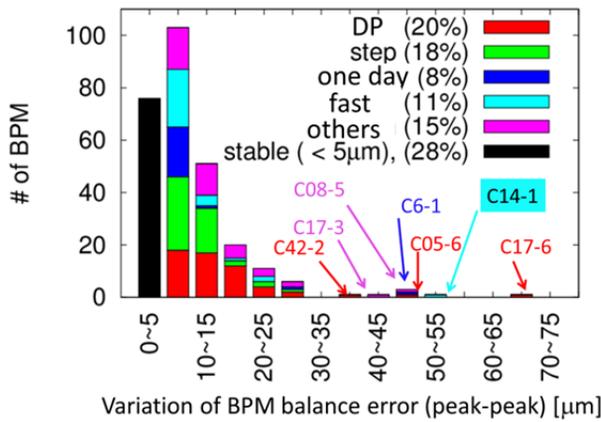
The features of variations of the balance errors of the SPring-8 BPM are summarized in Fig. 7. The BPMs with variation smaller than 5  $\mu\text{m}$  are counted as stable BPMs. When the balance error of a BPM has both the correlation with the DP and the step behavior, both “DP” and “step” are counted up. The variations correlated with the DP and the step variations are the majority, accounting for 20% and 18%, respectively. For BPMs with step variations, of balance error, inspections of the switch modules of the readout circuit and exchanges of the faulty ones are planned. We will discuss possible causes of variations correlated with the DP in the next section.

Figure 7: Histogram of the peak-peak variations of the BPM balance error. BPMs with variations smaller than 5  $\mu\text{m}$  are counted as stable.

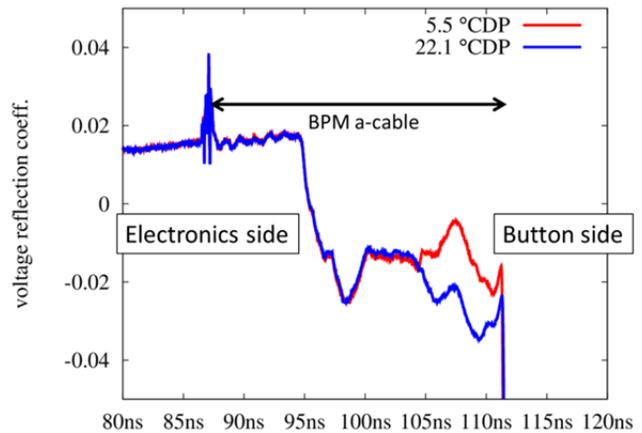
We also removed the cables from the BPM C29-6 which showed variations with the DP. TDR waveform of the cables also indicated unusual reflection similar to that of the BPM C05-6 caused by the radiation from the photon absorber. We measured TDR waveforms of the removed cables in a humidity controlled chamber to investigate the effect of the DP to reflections. Fig. 10 shows TDR waveforms measured by changing humidity at a fixed temperature (28 °C). Significant changes of voltage reflection coefficient were revealed near the end of the damaged cables on the button side. A new cable

was measured for comparison, which had small reflection coefficient independent of the DP.

We have found that the reflection coefficient of a radiation damaged cable is affected by the DP. Therefore, we consider that a possible cause of the BPM balance error correlated with the DP is the variations of standing waves in the BPM cables damaged by radiation which is dependent on the DP. To confirm this idea, we will carefully observe the imbalance variations for the BPMs C05-6 and C07-1 after the machine operation is restarted in September.

Figure 10: TDR waveforms of the damaged BPM cable ( C29-6-2 ) measured by changing the DP at a fixed temperature (28°C) .

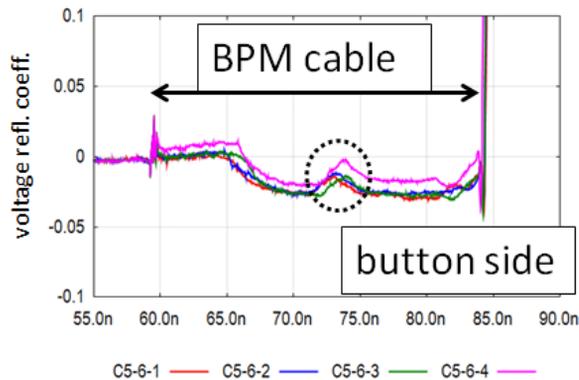
Among the BPMs showing variations of balance errors correlated with the DP, we have found that the BPMs with cables damaged by radiation have large variations (C05-6, C17-6 and C42-2 in Fig. 7). Figure 8 shows TDR waveforms of the cables of the BPM C05-6. Reflections in portions of the cables irradiated by radiation scattered by a photon absorber is evident (Fig. 9). To investigate the cause of the imbalance variation, we replaced the damaged cables with new ones and covered them with Pb tube with 3 mm thickness for shielding radiation. The cables removed from the BPM C05-6 were installed in the BPM C07-1 which did not show variations correlated with the DP.

Figure 8: TDR waveforms for the cables of BPM C05-6. Humps around 73 ns correspond to shade of a steering magnet girder placed between the cables and a photon absorber (Fig.9).
