# QUICK RECOVERY OF THE KEK $e^-/e^+$ INJECTOR LINAC FROM THE GREAT EAST JAPAN EARTHQUAKE

Atsushi Enomoto, KEK, Tsukuba, Japan

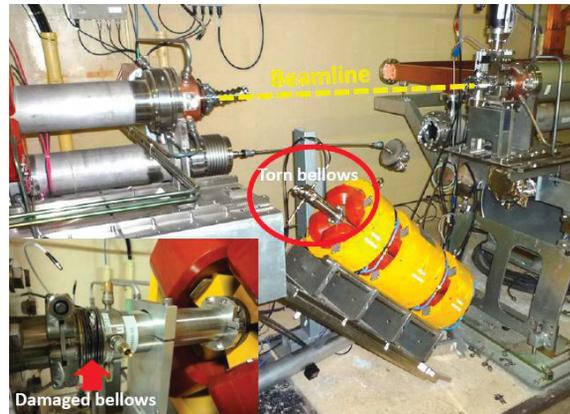
The peak earthquake strength was 6-lower in the Japanese scale which has been never experienced so far, and strong oscillation lasted nearly five minutes. The acceleration of the ground motion was recorded 0.3 – 0.4g in Tsukuba. Just after the quake went away a visual investigation was initiated in the darkness without electricity. And it was immediately turned out the linac was caused heavy damages: In the accelerator tunnel there were many vacuum bellows torn hardily, broken girders, a quadrupole magnet dropped down to the floor

(Fig.1), inflow water coming from the tunnel joints and spilled over the floor, etc.

Figure 1: The linac damage in accelerator tunnel.

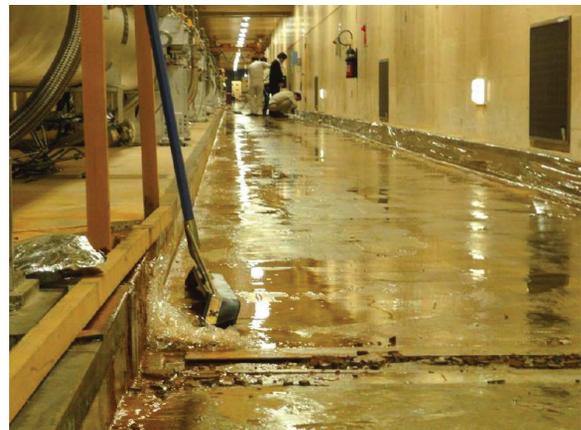
Figure 2: Inflow water into the tunnel.

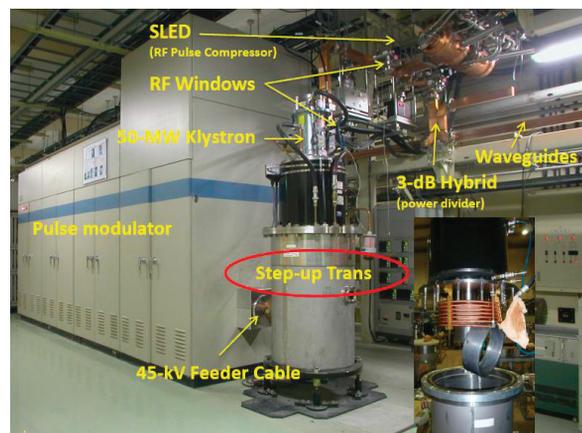
Figure 3: The linac damage in klystron gallery.

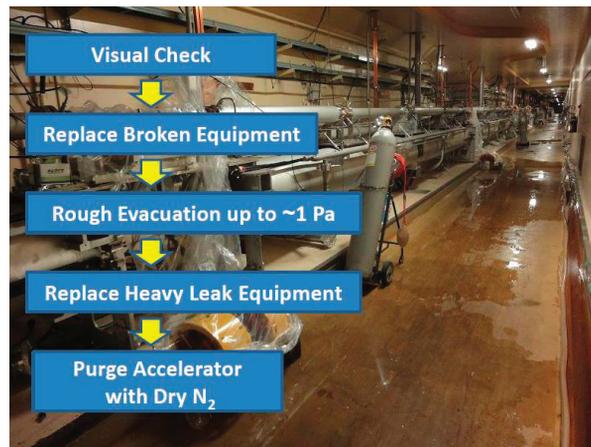
Figure 5: The linac vacuum purge with dry nitrogen.

“Nitrogen replacement” takes the process as follows: After the broken components are replaced, the accelerator is roughly evacuated. When the vacuum pressure can reach  $\sim 1$  Pa, then it is purged with dry nitrogen ( $\sim 0.1$  MPa =  $\sim 1$  atom). Though the linac recovery was prioritized over the other facilities at KEK, it was initiated under the limited condition of infrastructures, such as electricity, compressed air, and cooling water. Nevertheless, it was done within two weeks, since this task was addressed by a support from outside of injector vacuum groups.

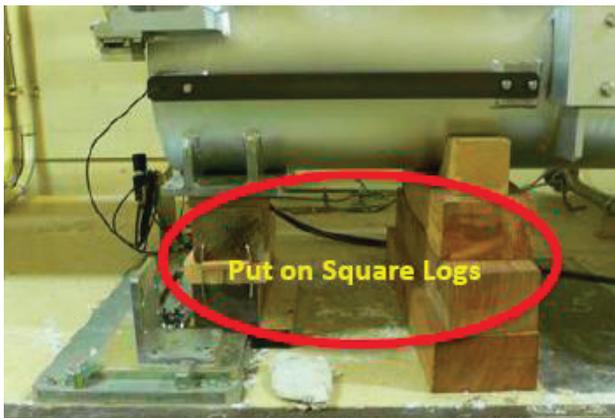
The upstream recovery necessary for the SuperKEKB upgrade was started on July 2011 and is still continuing while operating PF injections. For this purpose, it is really helpful that the upstream part had been separated by thick concrete wall in FY 2010. In the upstream part, many accelerator girders are put on square logs because their support legs are left broken. The beamline among them are not repaired. Therefore, the vacuum recovery of the upstream 40 accelerator units were made by isolating them from the beamline. Thus the accelerator vacuum was finally recovered by the end of November. A high-power test was finished by mid December and it turned out that the accelerator did not have a severe damage. It is planned the entire beamline will be restored before FY2014 when the linac commissioning for SuperKEKB start [1].

Figure 7: Broken girders are put on square logs.

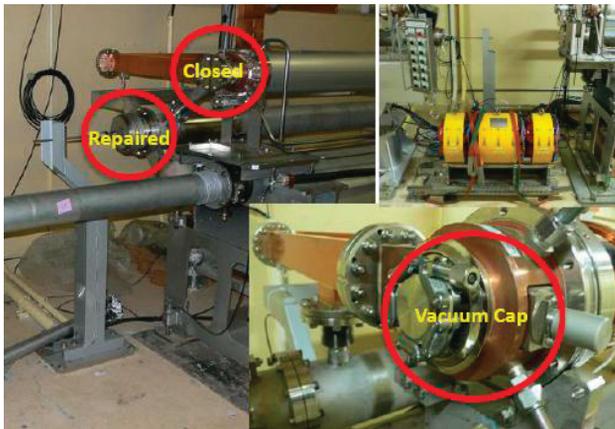
Figure 8: Beamlines are not yet connected (upstream).
