SRF2009 THPPO083

Field Flatness degradation problems and cure

Fumio Furuta, Kenji Saito

Field flatness problem of ICHIRO 9-cell cavities.

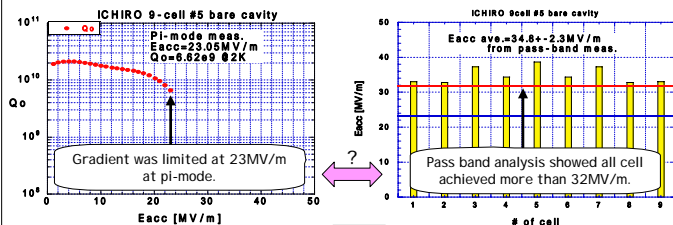
Inconsistency between pi-mode meas. and pass-band meas.

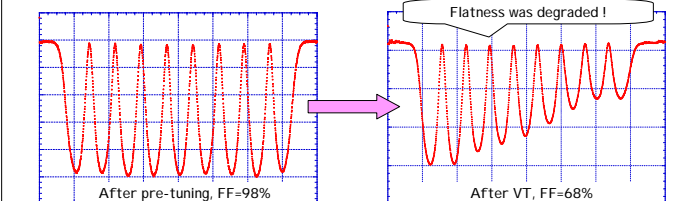
Flatness was degraded after VT.

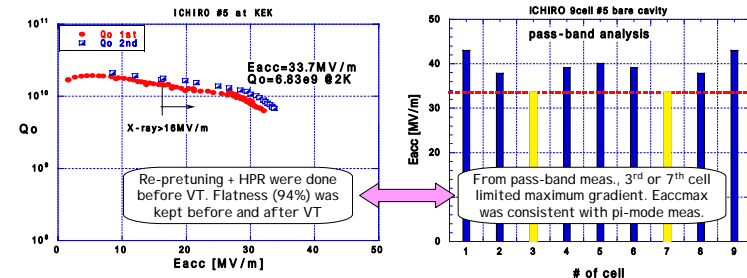
Flatness degradation by EP process was not yet improved, we are investigating it now.
To cure the flatness degradation, we tried re-pretuning on EPed cavity.
It worked well, no problem for cavity performance.

Current way of cure is re-pretuning. If flatness is degraded less than 95% after EP process, we pre-tune cavity again, then go to final rinsing, HPR. This re-pretuning process seems no effects on cavity performance so far.

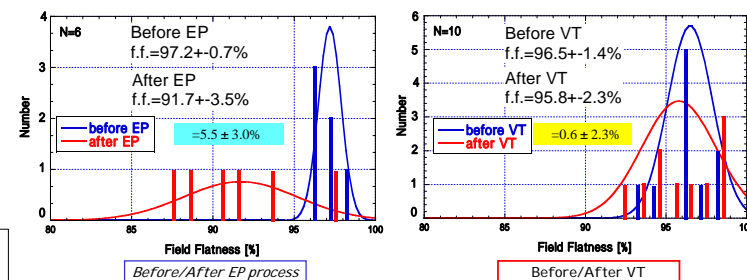
Recent statistics of flatness.

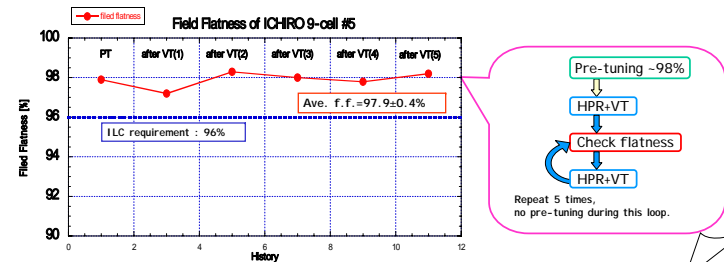
Tight loop test of flatness preservation

EP jig fittings and filling/dumping of water to cavity brought no degradation. Only EP process made ~5% degradation of flatness. We are investigating why degradation happen, and how to prevent it and cure.
