X-RAY TOMOGRAPHY INSPECTION OF SRF CAVITIES*

E. Harms#, Fermilab, Batavia, IL 60510, U.S.A
H. Edwards, Fermilab and DESY, Hamburg, Germany

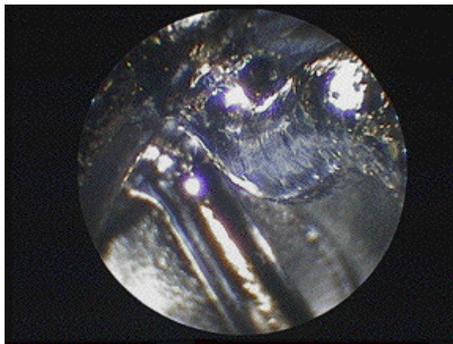
Figure 3: Borescope image of a 3.9 GHz HOM ‘Formteil’.

Attempts to condition away the degraded performance, re-processing the internal surface and image suspect locations with a borescope were unsuccessful. Figure 3 is a photograph of inspection of such a piece in a suspect region. Attempts to make some assessment with sonic means proved to be inconclusive as well.

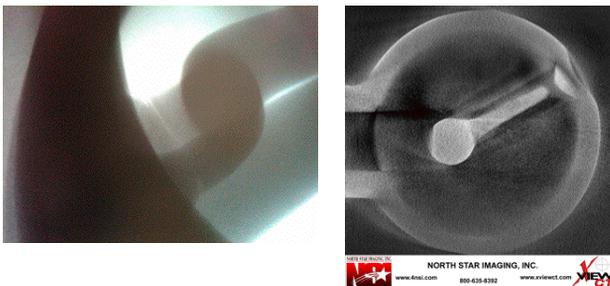
Figures 4 & 5: 2-D image (left) and 2-D reconstruction ‘slice’ view of a suspect HOM can.

Figures 4 and 5 respectively show one such 2-D radiograph and a slice reconstruction through the HOM can.

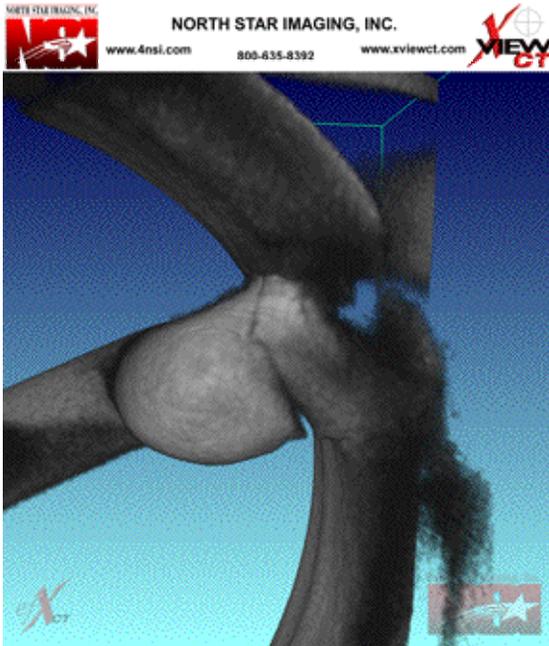
In both cases, the exercise proved to be successful as fractures near the weld joint of the back-side ‘F-piece’ leg were clearly visible. With CT reconstruction software it is possible to look at the result from virtually any angle or magnification. The size of the fracture in this case is estimated to be of order 0.1’s of a mm.

Neither cavity has been opened to make a direct physical measurement. Figures 9 and 10 are two views of the same fracture. Since the fractured leg was on the back side of the HOM can with respect to the cavity bore it would have been impossible to see without invasively accessing the HOM can.

Figure 9: Clear evidence of a 3.9 GHz cavity fractured HOM 'Formteil'.

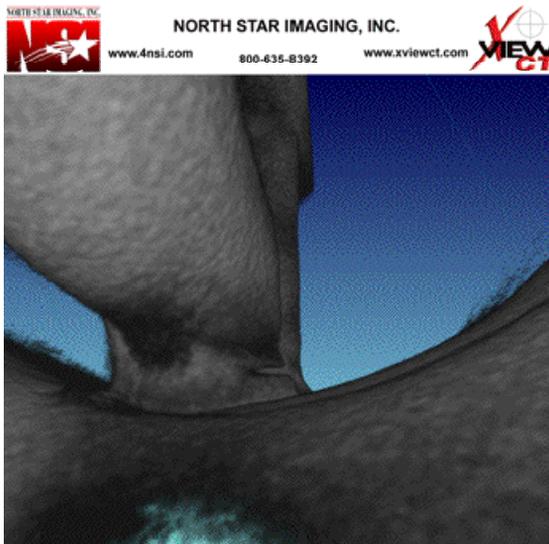
Figure 10: Alternate view of the same fracture as in Figure 9.

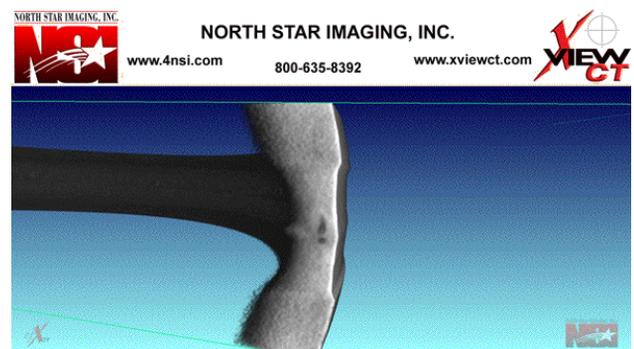
2-D slice images showed a 'sparkling' pattern of alternating light and dark spots in the region of the equator weld. This response initially caused some consternation but was finally ascribed to the X-ray beam striking weld voids and scattering off of the surface surrounding the voids. Figures 12 and 13 are 3-D CT images clearly indicating voids in the equator weld from two locations. In fact, perusing the weld region in this way indicates that much of the weld was found to have an internal void. From these images it is possible to estimate the size of the void and its depth below the outer cavity surface. Actual physical sectioning has yet to be carried out to confirm these indications.

Figure 12: 3-D CT image of an equator weld void.

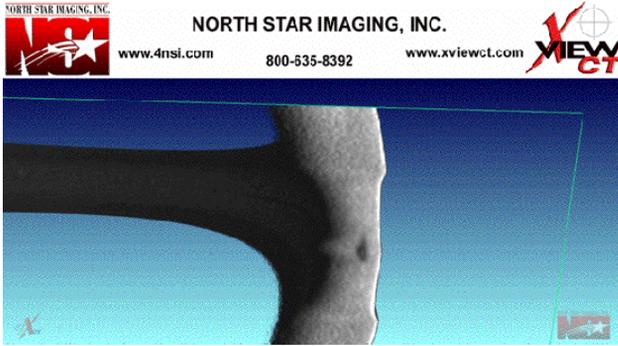
Figure 13: Second view of the void in a 1.3 GHz single cell cavity equator weld.

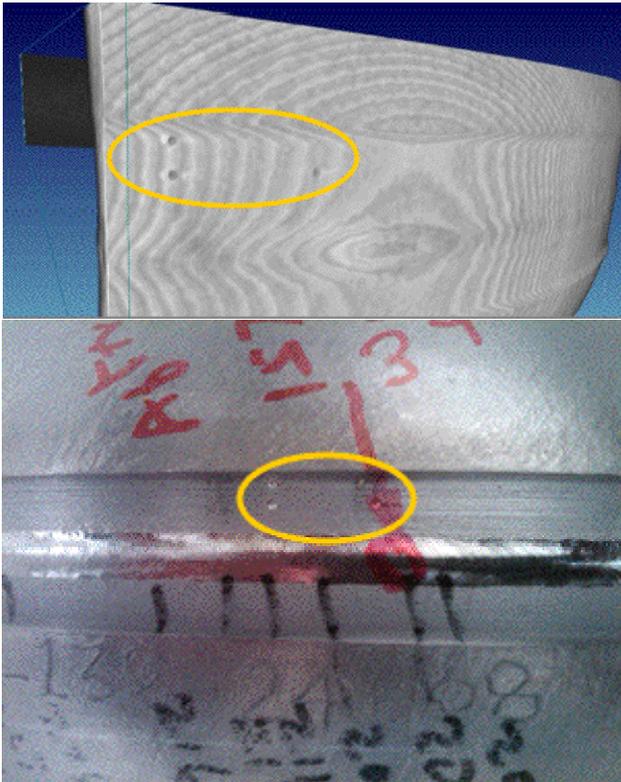
During an on-line consult with North Star's imaging expert pertaining to the cavity described above, three 'holes' were noted slightly under the outer surface of the cavity just above the weld region, as shown in Figure 14. This proved to be a quality check of sorts for the imaging process as visual inspection of the cavity revealed that a series of reference points had been scribed as shown in Figure 15.

Figures 14 & 15: Reconstructed view just under the surface of a 1.3 GHz single cell cavity and comparative photograph of the outer surface. Note the three scribe marks circled.

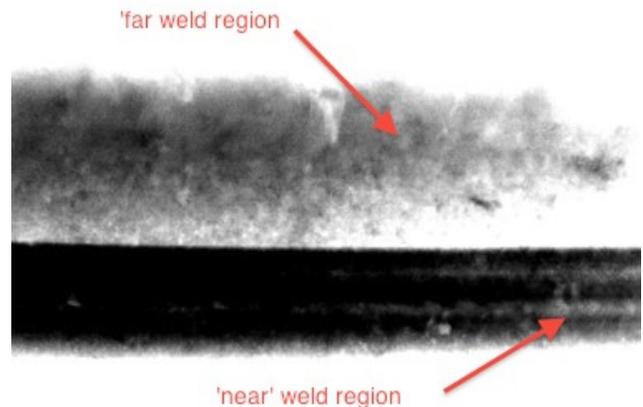
Figure 16 is a representative 2-D radiograph produced by their equipment. This view actually contains both a ‘close’ view of the weld region and a ‘far’ image of the opposite surface made possible by slightly tipping the cavity so that the incident X-ray beam is vertically off-normal to the cavity surface.

The resolution of this scan makes it is clear that 2-D images alone are insufficient to identify regions of pits and software reconstruction tools are critical in making clear views possible.

Figure 16: 2-D image of the equator weld of a 1.3 GHz single cell cavity. Two views of the weld are possible – the lower (darker) image is of the surface closest to the incident X-ray beam.
