CAVITY INSPECTION AND REPAIR TECHNIQUES

K. Watanabe[#], H. Hayano, KEK, Tsukuba, Ibaraki, Japan

Abstract

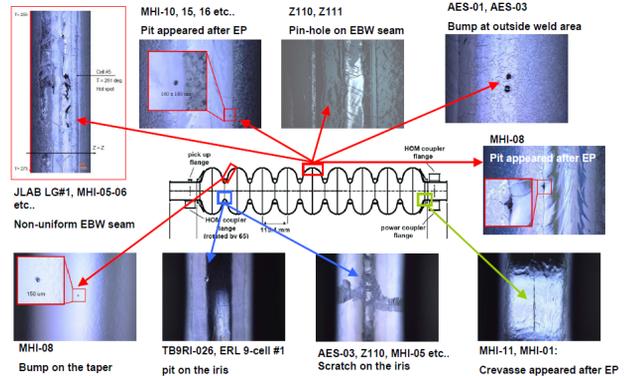
Figure 4 shows several examples of geometrical defects found by the optical inspection. They are the targets for the repair. Table 1 and 2 show the summary of repaired cavities, the results of vertical tests and their current status.

Figure 4: Found geometrical defects by optical inspection.

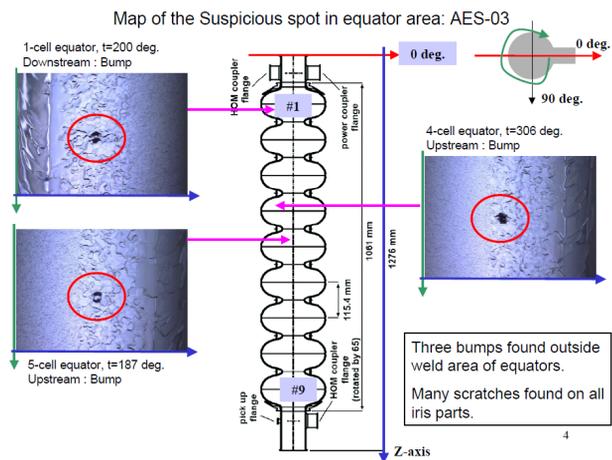
The cavity was sent to KEK for the repair work by local grinding at June 2009. The optical inspection was made for “as received to KEK”. Figure 5 and 6 show the result of optical inspection. The cavity has three bumps near the equator and many heavy scratches on iris.

Figure 5: Result of optical inspection of AES-03 at equator.

The targets of grinding are three bumps near equator and 20 heavy scratches on iris. The electro-polishing was expected to repair the small scratches on iris. The surfaces on the equator and the iris after local grinding and 50 μm EP are shown in Figure 7 and 8. The defects were removed very well. The degreasing and HPR were applied before back to FNAL.

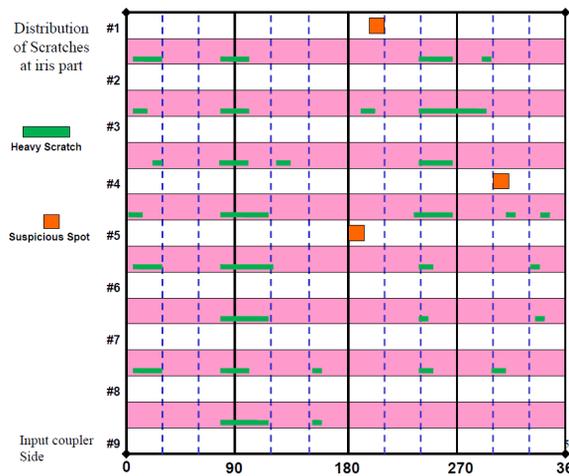
Figure 6: Result of optical inspection of AES-03 at iris.

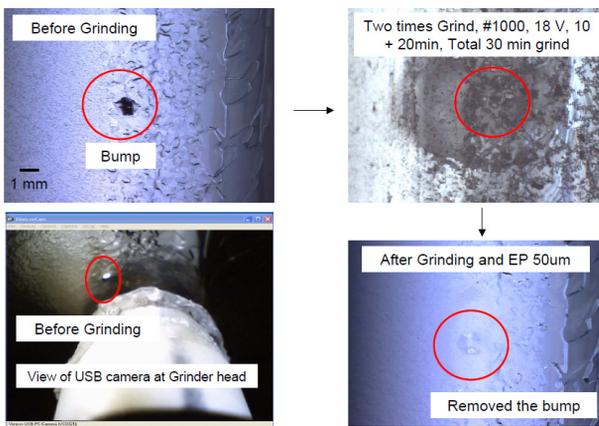
Figure 7: Grind and EP at cell #4 equator.

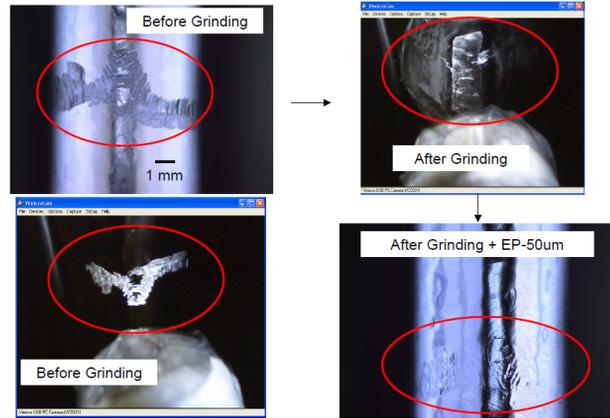
Figure 8: Grind and EP at heavy scratch on iris.

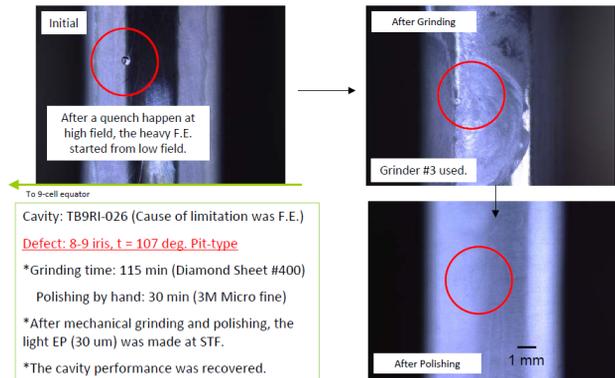
The TB9RI-026 was tested at FNAL. Initially, the field reached 28.8 MV/m with several FE burn-off events. The field emission did not reduce well. Final gradient was limited at 19.6 MV/m. A pit type defect found on #8-#9 iris by the optical inspection at FNAL.

Figure 9: Polishing of pit type defect on the iris.

The cavity was sent to KEK for the local grinding on the defect. The surface after polishing is shown in Figure 9. After mechanical polishing, 30 μm EP, the degreasing and HPR were made before sent back to FNAL.

Another HPR and baking were made before vertical test. The cavity performed 36.6 MV/m without filed emission. This is successful result [9].

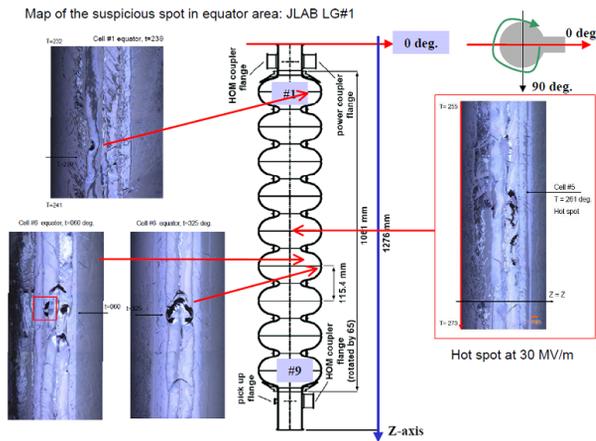
This cavity was fabricated JLab in house built as large-grain 9-cell cavity. The cavity performance was limited 30 MV/m at cell #5 before sent to KEK for repair by local grind. Figure 10 shows the result of optical inspection. Three non-uniform EBW seams were found on the hot spot and cell #6 equators. The shape of defect at cell #5 was pit similar to funk hole (depth is about 300 μm). Two times grinding and three times EP were applied to make smooth surfaces for repair. The surfaces after repair are shown in Figure 11. The degreasing and HPR were applied before sent back to JLAB.

Figure 10: Result of optical inspection of JLAB LG#1.

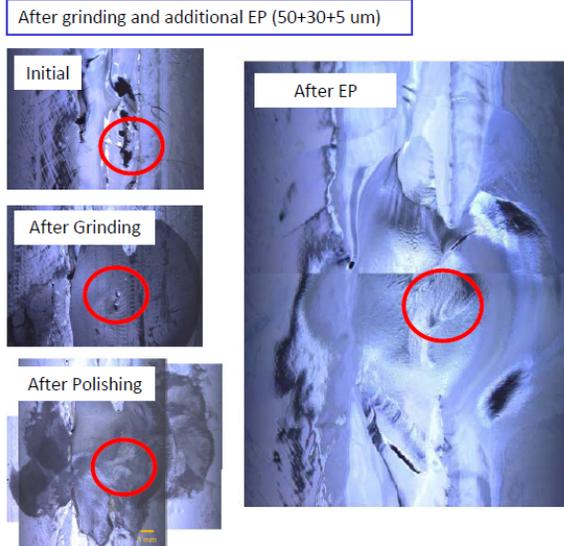
Figure 11: Grinding and EP at JLAB LG#1 cell #5 equator.

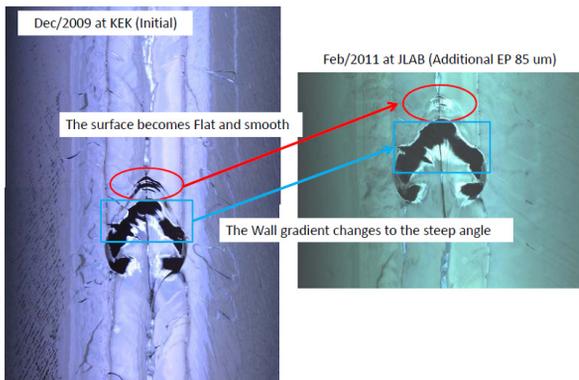
The field flatness tuning, HPR and baking were made before vertical test. The performance of cell #5 was improved from 30 MV/m to 43 MV/m in the 1st test. However, it was limited at 21 MV/m by quench at cell #6. The performance of cell #6 was degraded from 30 MV/m to 21 MV/m. Figure 12 shows the images on cell #6 before and after additional EP at KEK-STF. The dark zone in defect grew by additional EP. There is a possibility that the defect shape changed to a deeper pit, and then the quench field degraded. The edges also changed to the sharp edges around dark zone of the defect.

Figure 12: Defect deform by additional EP (85 μm).

The repair work for cell #6 is planned at August 2011. KEK's grinding machine will be sent to JLab to do repair work at JLab [10].
