Inspection and Repair Techniques for the XFEL Superconducting 1.3 GHz Cavities at Ettore Zanon s.p.a: methods and results

G. Massaro*, N. Maragno, G. Corniani - Ettore Zanon SpA, Schio, Italy ;
A. Matheisen, A. Navitski - DESY, Hamburg, Germany;
P. Michelato, L. Monaco - INFN Milano - LASA, Segrate, Italy
*gmassaro@zanon.com

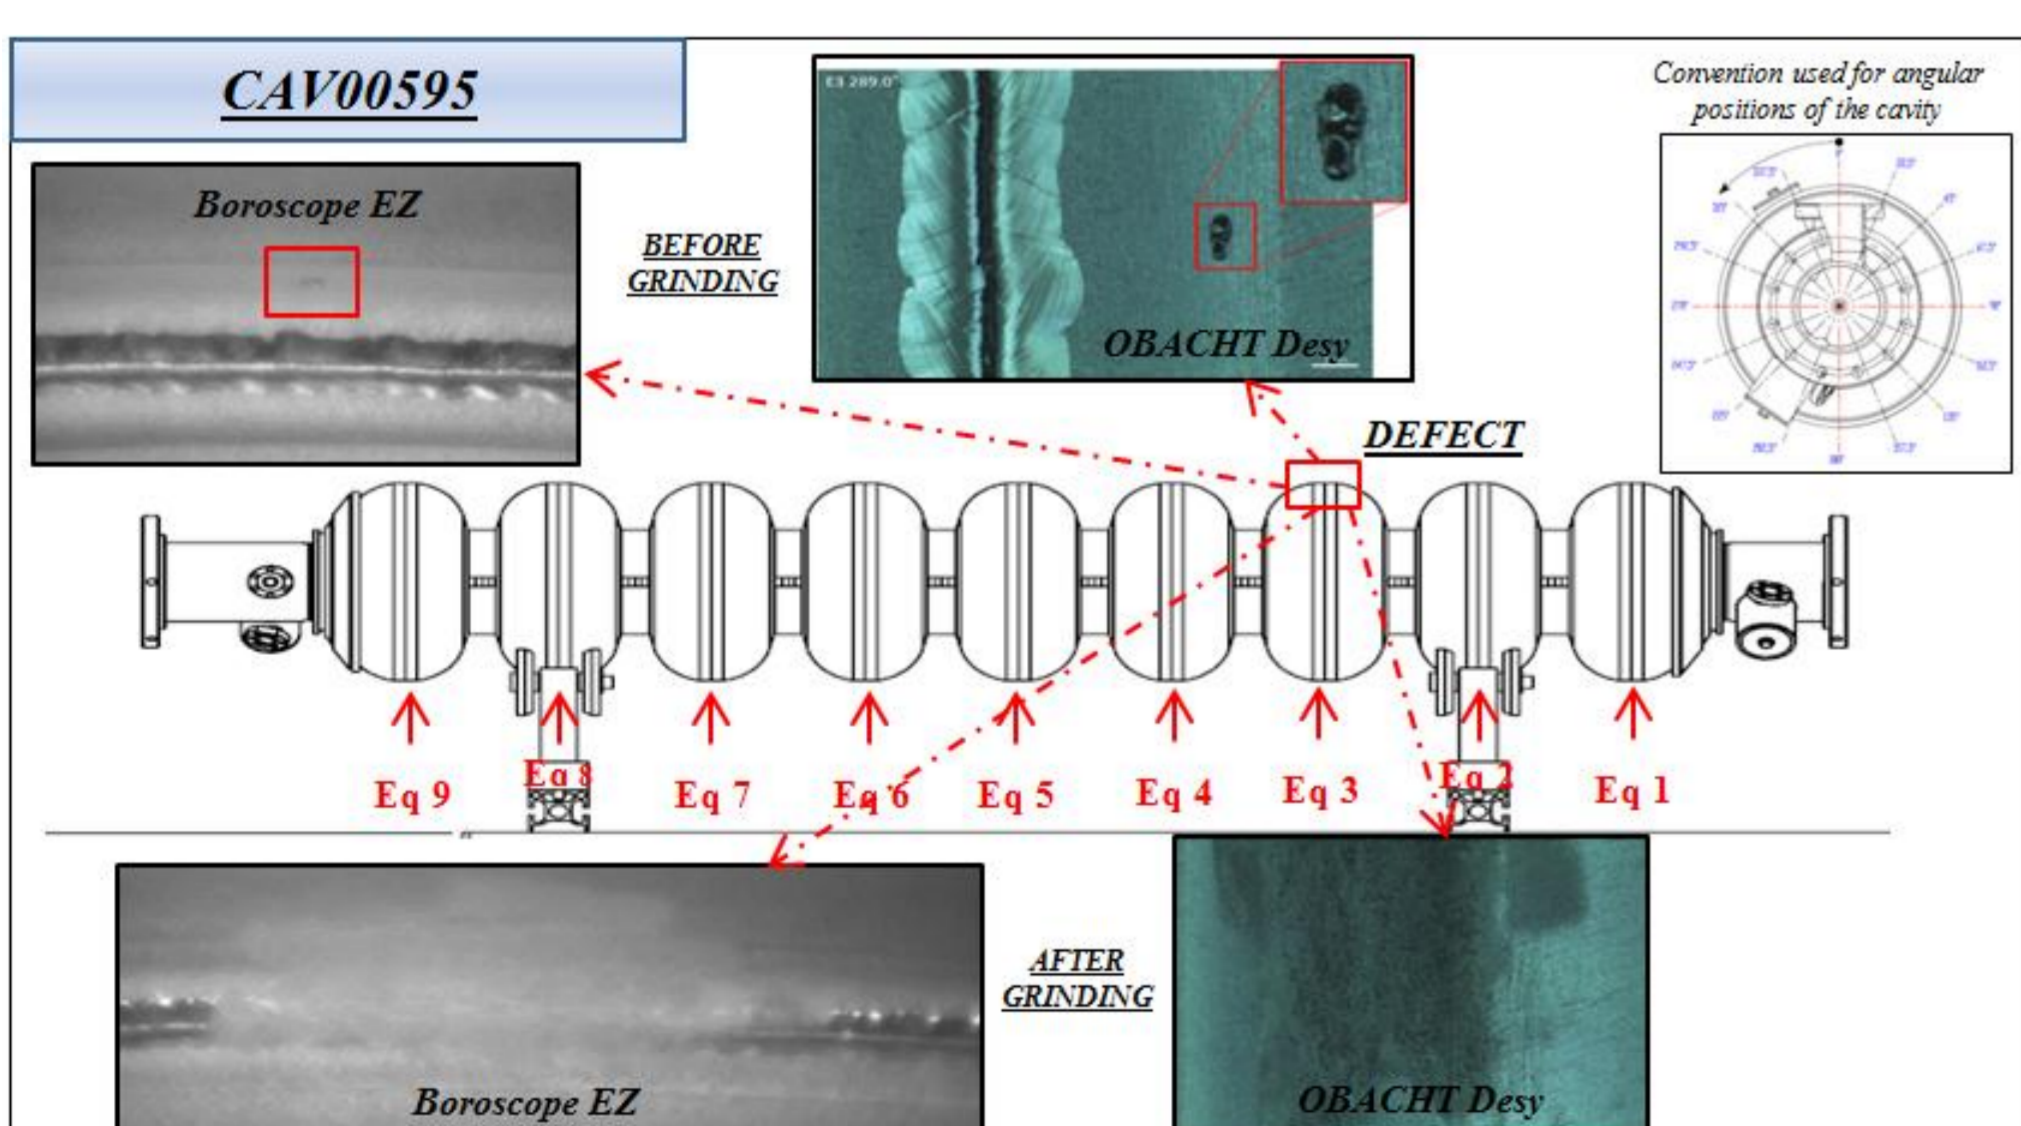
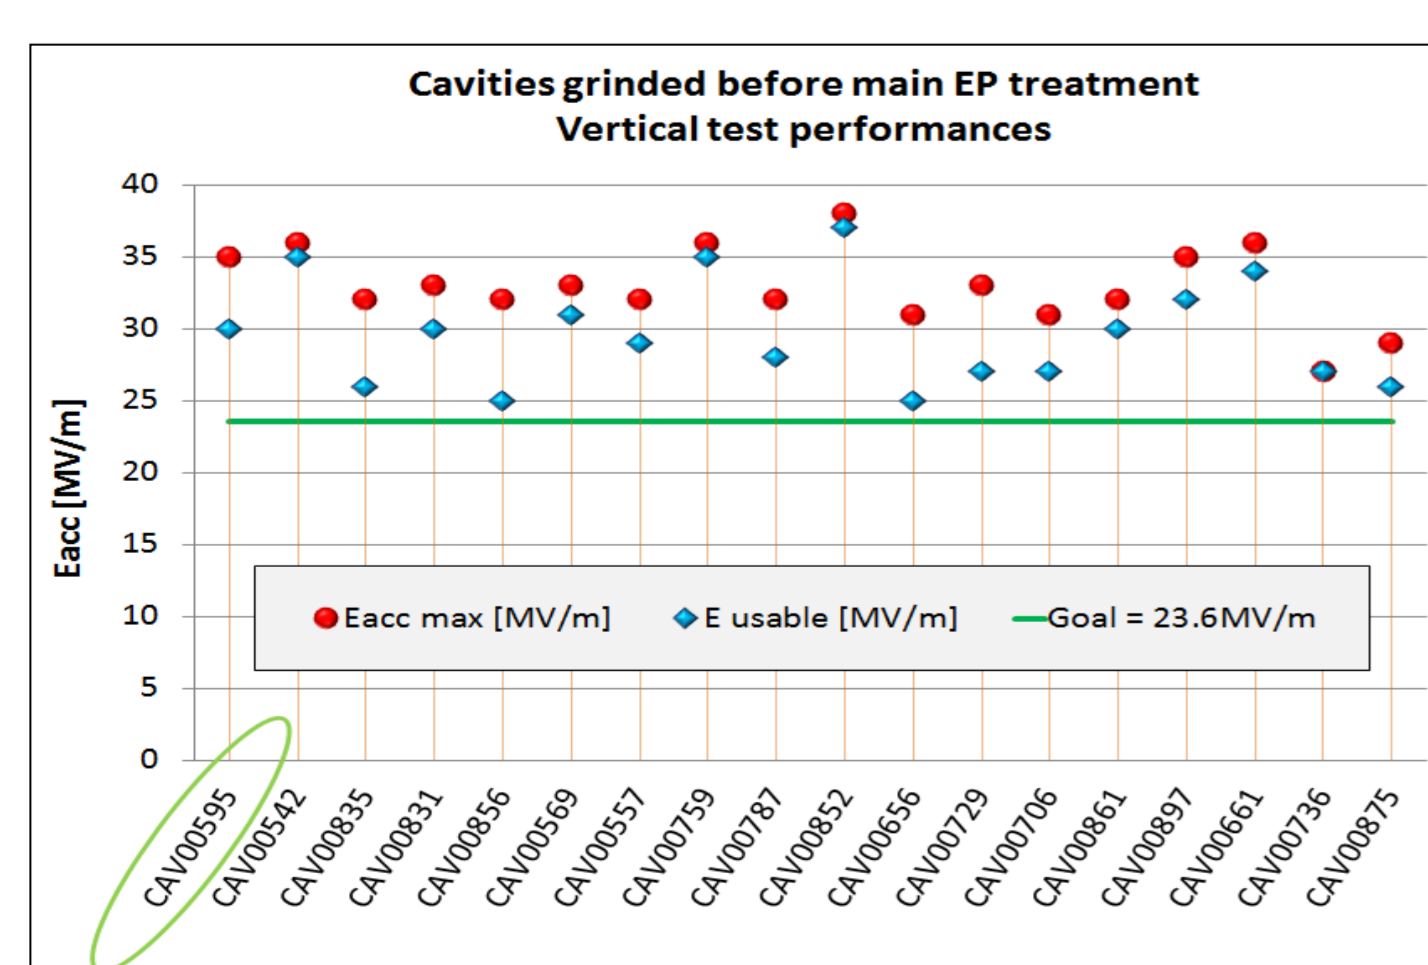
GRINDING BEFORE MAIN EP

The optical inspection of **CAV00595** showed a spatter weld close to the equator weld. The defect was removed satisfactorily. The vertical test was performed at Desy and the cavity performance was up to **Emax 35 MV/m** and **Eusable 30MV/m**, limited by some field emission. This result has qualified the procedure, which was applied on eighteen cavities afterwards. The results of vertical test of each cavity show a very good result.

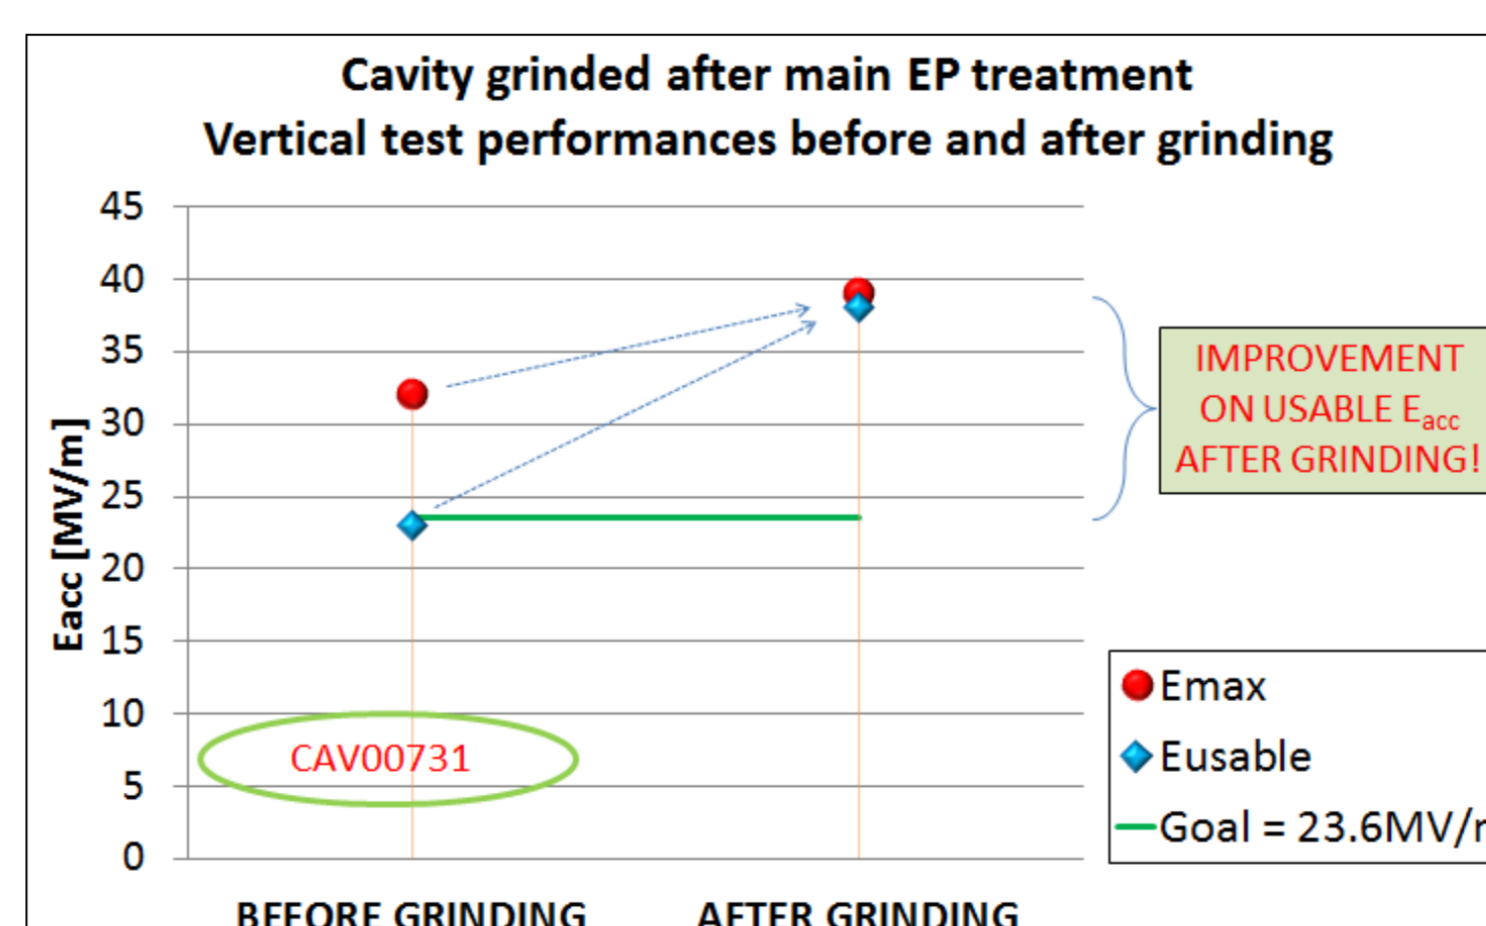
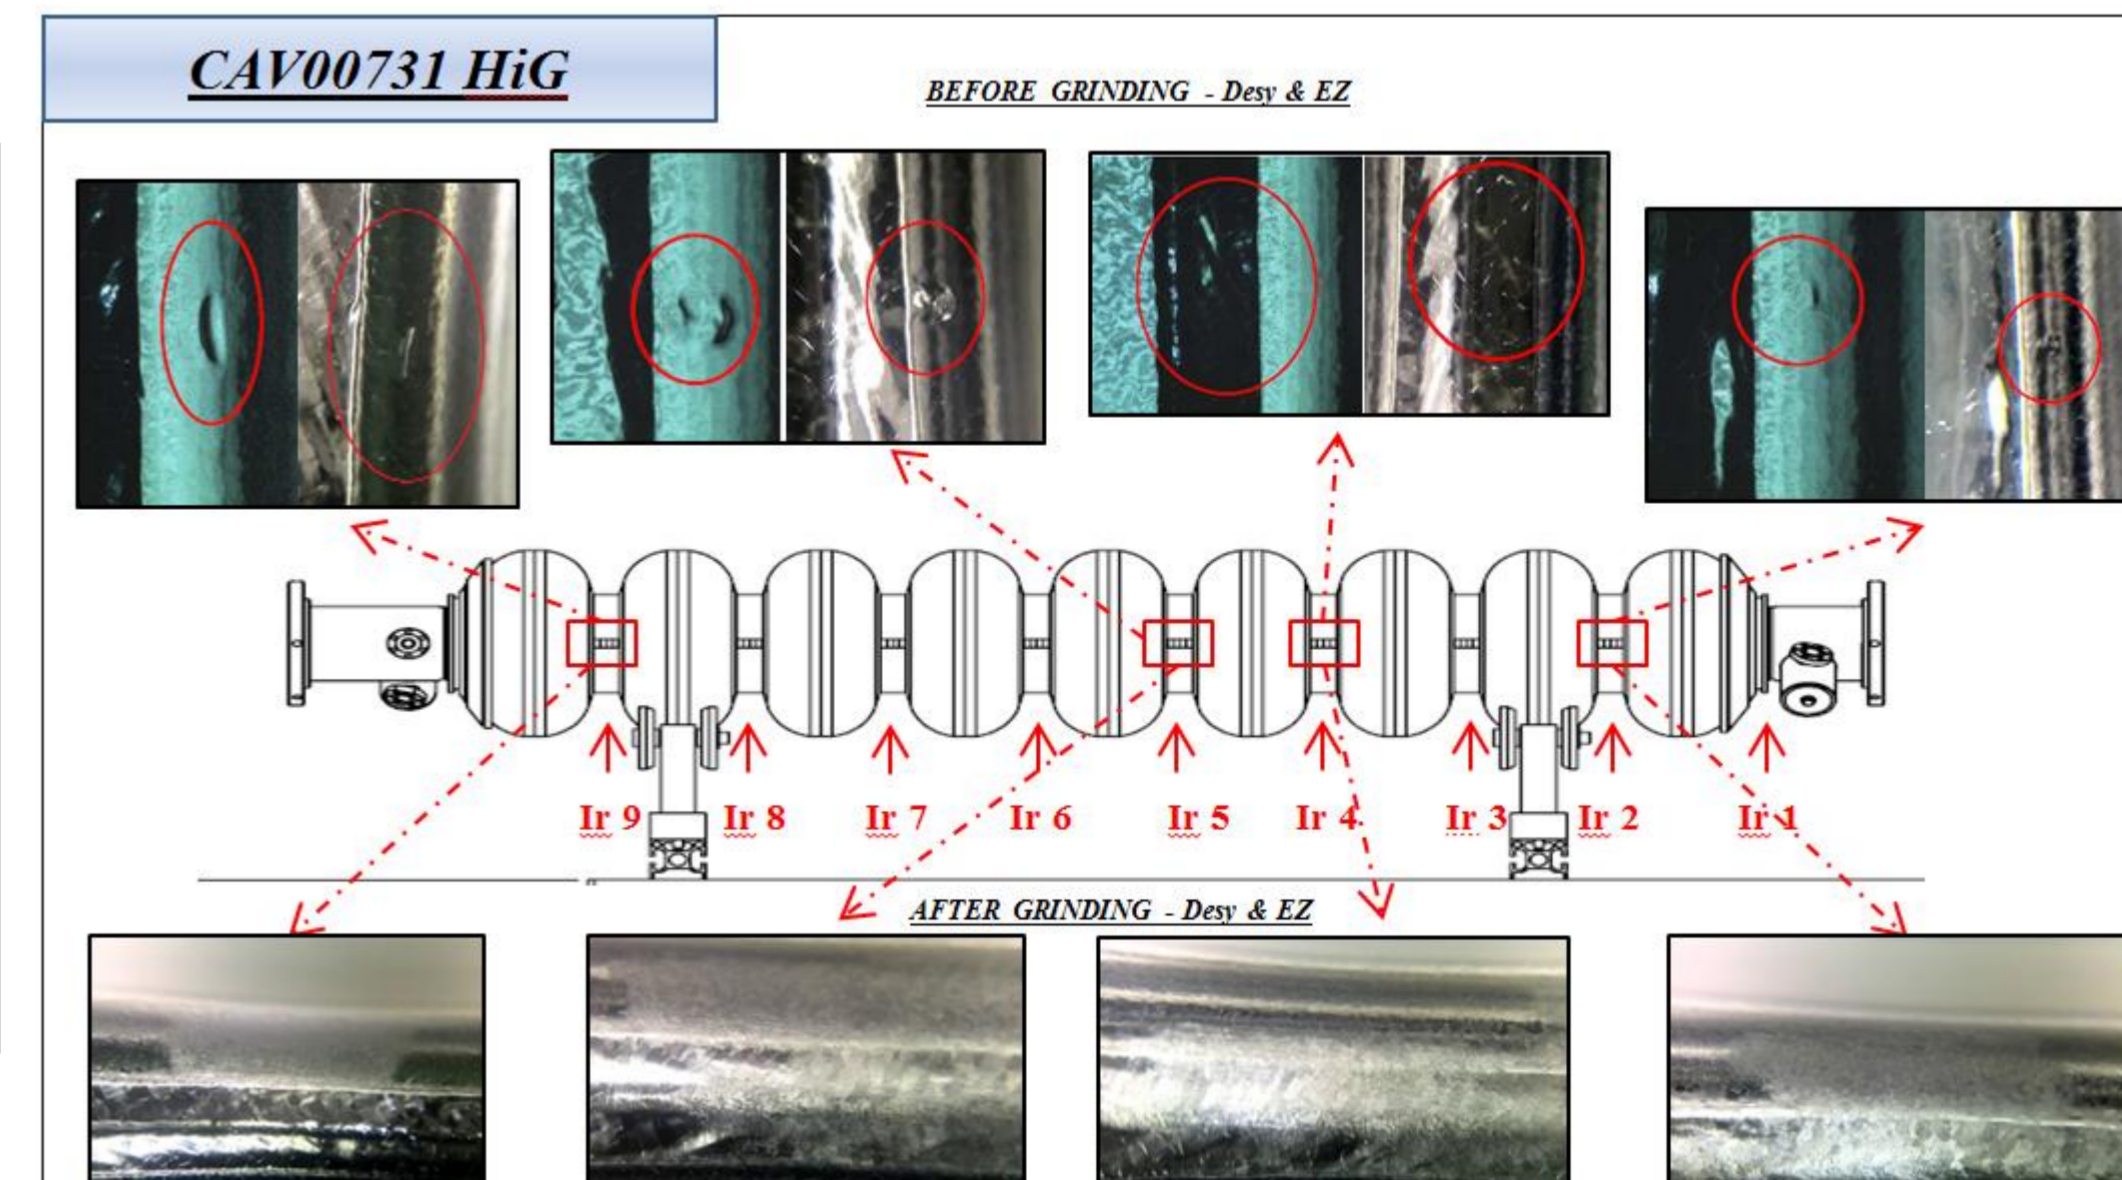
GRINDING AFTER MAIN EP

The 1st vertical test of **CAV00731 HiG** was performed at Desy and the cavity performance was up to **Emax 32 MV/m** and **Eusable 23 MV/m**, limited by quench and strong field emission. Even after HPR reprocessing at Desy this result didn't improve. The optical inspection by camera EZ and Obacht Desy system, showed scratch on Iris 2, 4 and 5 at angular position 120° and a incision on Iris 9. The defects have been removed successfully with the technique of grinding. The 2nd vertical test was performed at Desy and the cavity performance was up to **Emax 39 MV/m** and **Eusable 38 MV/m**, limited by low field emission.
