# FLOOR LEVEL FLUCTUATION IN THE KEK-PS TUNNEL

H. Sato, M. Shirakata, K. Marutsuka, N. Tokuda and S. Yamanaka\*

Accelerator Laboratory, High Energy Accelerator Research Organization (KEK),  
Oho 1-1, Tsukuba-shi, Ibaraki-ken 305-0801, Japan

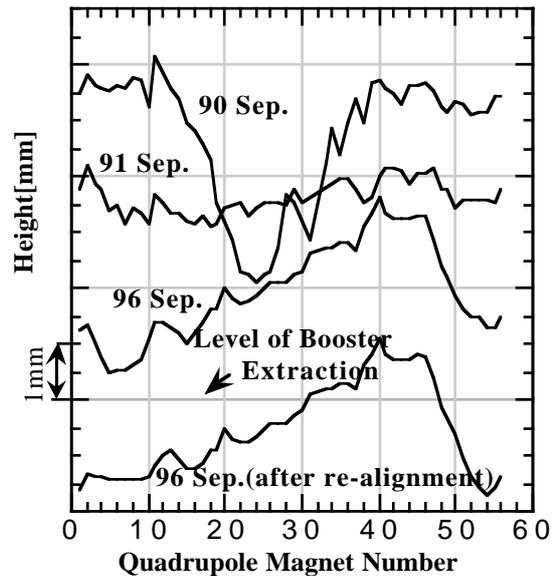
Figure 2. Height of the 56 quadrupole magnets from September 1990 through September 1996. Height is not absolute but relative value. Horizontal axis is the position of the quadrupole magnets. The first magnet is located in the injection section.

Although the magnet realignment works were carried out several times, the correction were made only for the largely deviated magnets in the main ring but the adjustment to the booster ring was not considered. Figure 2 shows the heights of 56 quadrupole magnets in September 1990; significant deviation is observed. Then, the realignment work was carried out in September 1991. After the five years, the deviation became to significant level of a few mm (the second line from the bottom in Figure 2). As shown in it, the MR tunnel is inclined and have some bumps. The magnet alignment was carried out from September 2nd to 13th during the summer shutdown. The realignment was done in concentrating the

first quadrant near injection in leaving the incline to save laborious work [3]. The resulting heights of the 56 quadrupole magnets indicated by the bottom line in Figure 2.

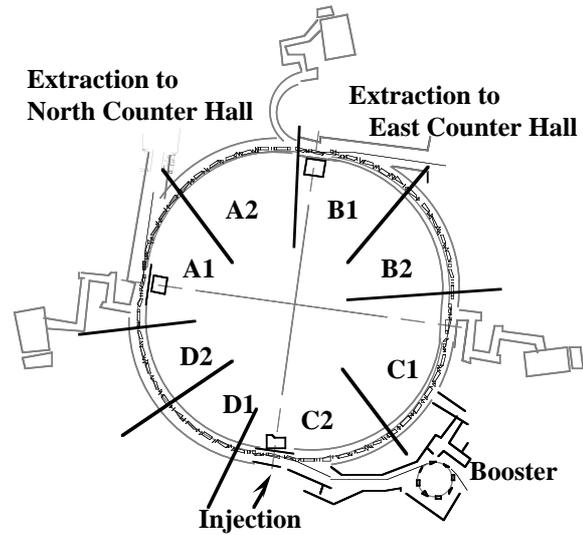
In this work, a significant unconformity of the magnet height occurred in the weekend. The height of the quadrupole magnet differed by about 1 mm after a round trip. There was a heavy rain from the Sunday to the Monday morning after long sunny days. It was supposed that plenty of water of this rain might move the floor plates in the main ring tunnel. Although the lattice structure of the KEK-PS accelerator has a four-time symmetry, the floor in the main ring tunnel comprises eight separated blocks (named A1, A2, B1, B2, C1, C2, D1, D2), and they are not symmetry as shown in Figure 3. Around the beam injection area, the floor is divided into three plates as C2, D1 and D2. The floor level unconformity can be explained by assuming following consideration:

- Plate C2 is inclined (upstream end is higher);
- Plate D1 is inclined (downstream end is higher);
- Plate D2 is raised.

Figure 3. Foundations of the Main Ring Floor, comprising eight separated plates.

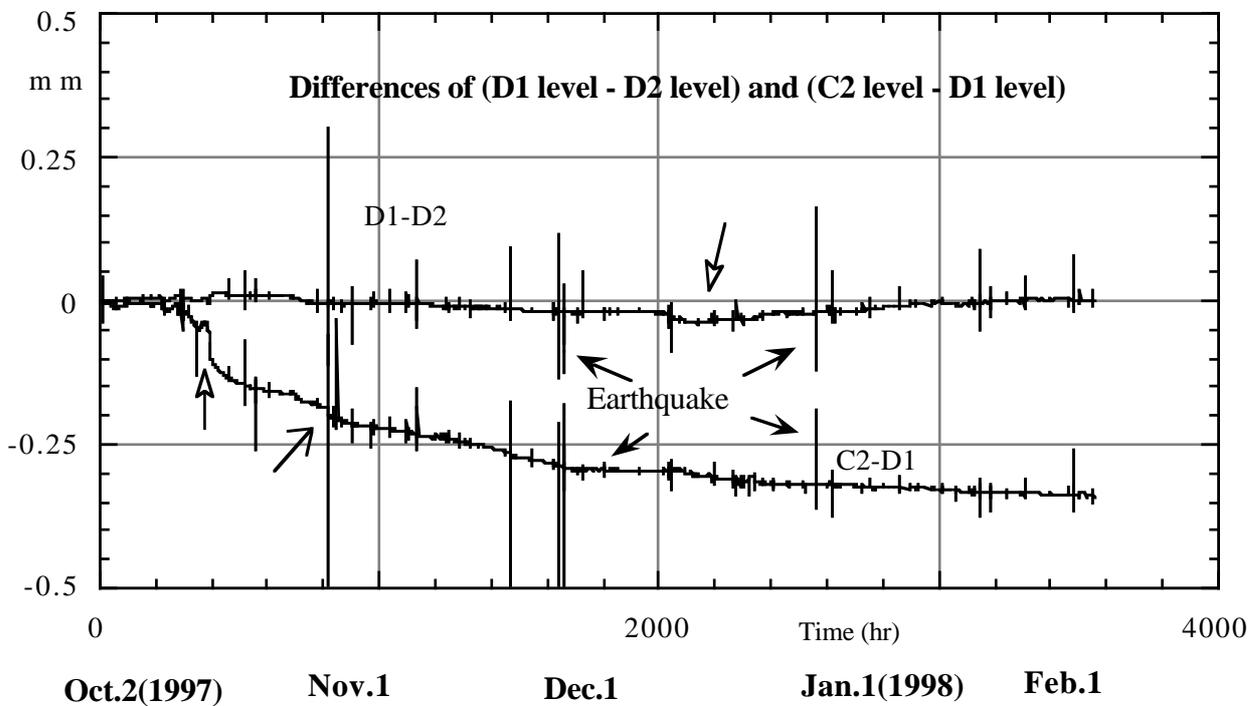
Figure 4. Time variation of the floor level differences of C2-D1, and that of D1 -D2. Floor level difference of C2-D1 changed rapidly (in fifty hours) by about 0.15 mm in the middle of October, 1997 and it increased gradually up to 0.35 mm for a few months. Many seismic vibrations were observed indicated by the dark arrows for example. At the end of October, as indicated by the simple arrow, the difference did not return to the one before earthquake.

In order to know the floor level fluctuation, the tilt meters using accelerometer are set on the border of C2-D1 and D1-D2 [5]. Figure 4 shows the deviation of these floors versus hours from the beginning of October 1997. There are several remarkable facts in this data. One is that, in the middle of October, 1997, the floor level difference of C2-D1 changed rapidly (in fifty hours) by about 0.15 mm. That of D1-D2 varied simultaneously, but very little.

One more remarks is that many seismic vibrations (spike-like fluctuation in Figure 4 indicated by dark arrows for example) are observed. The level returned to the one before earthquake in the almost cases. In the rare cases, however, the deviation remained after an earthquake, as shown by the simple arrow in Figure 4.

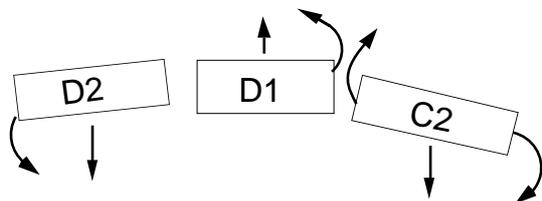
Another point is the continuous variation of the C2-D1 difference, which increased gradually up to 0.35 mm over a few months. This slowly floor movement suggests the following results and it is shown in Figure 5. This movement is opposite direction of the explain result by the unconformity of realignment on Summer 1996:

- Plate C2 is inclined (downstream end is higher);
- Plate D1 is raised (and upstream end is higher);
- Plate D2 is sunk (and downstream end is lower).

Figure 5. Speculation of the relative floor movement from October 1997 through February 1998.
