# CONSOLIDATION OF THE 45-YEAR OLD PS MAIN MAGNET SYSTEM

D. Bodart, W. Kalbreier, K.H. Meß, A. Newborough, Th. Zickler, CERN, Geneva, Switzerland

## Abstract

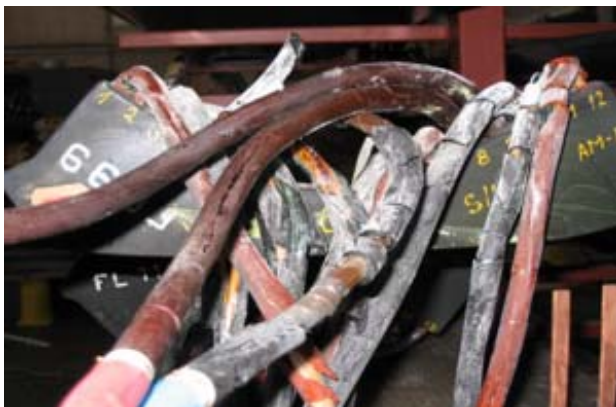
The polyurethane insulation of the PFW cables gave, at first glance, the impression to be generally in good condition. However, after an inspection it turned out that the insulation is falling apart when touched (see Figure 1). This damage results from a combined effect of degradation of the organic material submitted to high irradiation and its poor resistance against microbes.

Figure 1: Destroyed PFW cable insulation.

Once a PFW cable has been moved - accidentally or on purpose during an intervention - the insulation is completely damaged and the entire PFW has to be replaced. Since almost all PFW cables are suffering from this degradation the risk of a breakdown is considerably high. A PFW could be replaced in situ, but the vacuum chamber has to be removed, which requires a displacement of the magnet unit from its position.

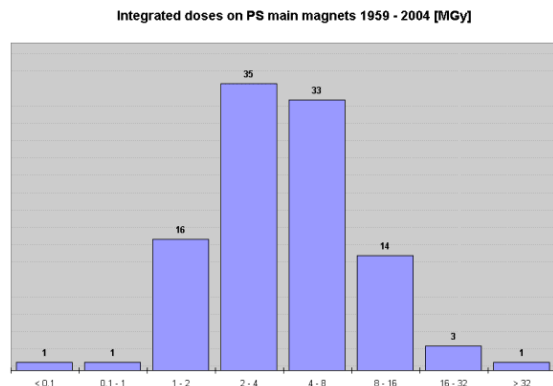
Figure 2: Histogram of integrated doses.
