THE WINDOW REPLACEMENT AND Q RECOVERY OF BEPCII STORAGE RING SCC

T. Huang†, J. Dai, R. Ge, H. Lin, S. Li, Z. Li, Q. Ma, W. Pan, P. Sha, Y. Sun, G. Wang, Institute of High Energy Physics (IHEP), Beijing, China

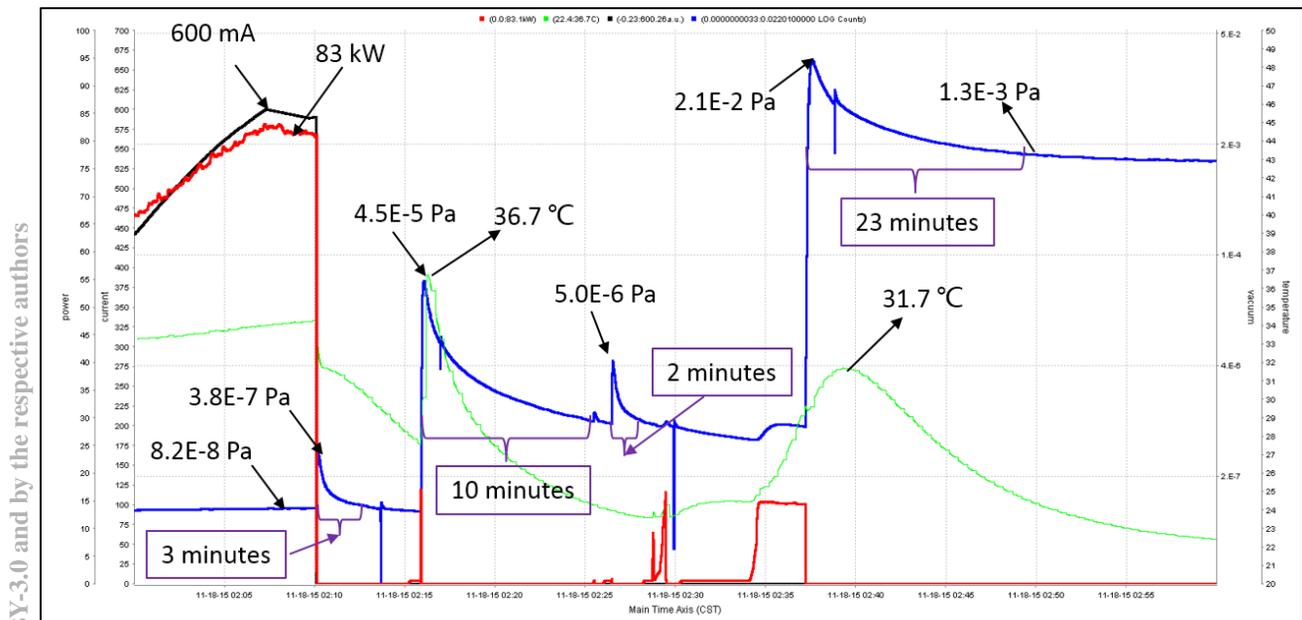
Figure 1: The vacuum pressure and temperature of the cracked window just before the vacuum leak happened. Red: forward RF power (kW); Blue: vacuum pressure of the window (Pa); Green: temperature of the window (°C); Black: Positron current (mA).

The power coupler for BEPCII storage ring SCC consists of a doorknob, a Tristan type single warm window and a 50 Ohm coaxial line [3]. After two years overheating operation, the window cracked suddenly on Nov.18, 2015. The vacuum pressure and temperature of the damaged window just before the accident happened are shown in Fig.1. As can be seen that the window operated at 80kW, with accelerating voltage 1.5 MV and positron current 600 mA; suddenly the positron beam lost and the window vacuum pressure changed from 8.2E-8Pa to 3.8E-7 Pa. After vacuum recovery, the operator tried to recover the RF power; however, the window vacuum interlock triggered and the vacuum pressure worsened from 7.6e-8Pa to 4.5E-5 Pa at the power level of 18 kW. One abnormal phenomenon was that the vacuum pressure recovered very slowly; another one was that the window temperature increased obviously, from 28 °C to 36 °C as the RF power increased to 17 kW. Finally, the vacuum pressure worsened to 2.1E-2Pa as the RF power reached to 15 kW once again.

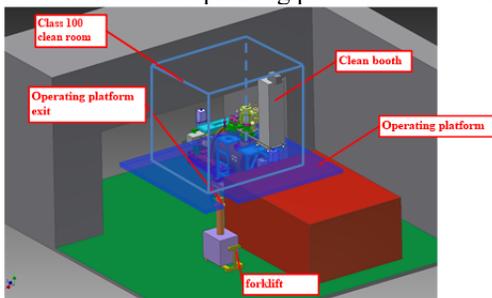
Figure 2: The sketch map of the window replacement.

In order to save time and manpower, the replacement of the cracked window was processed in a local clean booth in tunnel instead of the standard clean room in laboratory. The sketch map of the replacement is shown in Fig.2. A special designed local clean booth with slide way for window pulling out and plugging in, a removable class 100 clean room and an operating platform were built.

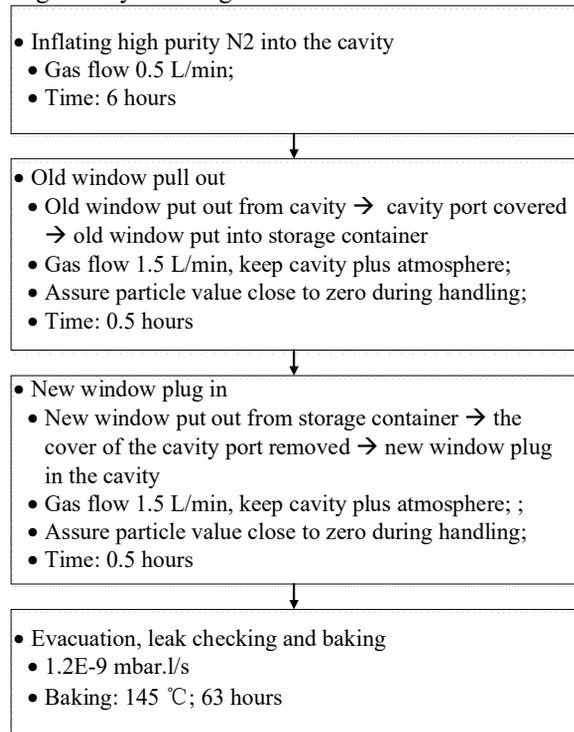
Figure 3: The entire process of the window replacement.

ments. Fig. 3 lists the entire process. The particles were measured continuously to keep the value down to zero during the key handlings.

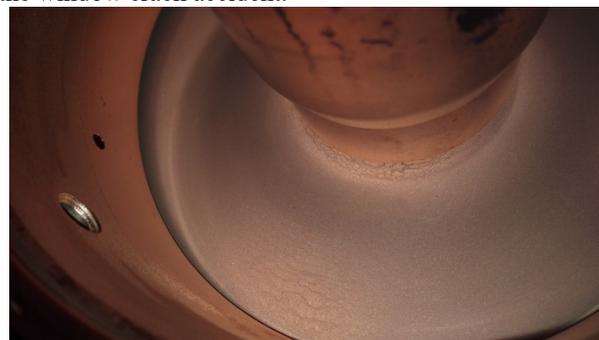
The cracked window was later inspected visually as shown in Fig.4. It can be seen that: 1) there is a fish scale ring close to the inner choke; 2) there are three snow figures on the outer conductor of the window vacuum side; 3) the surface of the snow figures feels rough; 4) the color of the ceramic turns dark on the whole. All the above characteristics indicate that serious discharging activity happened around the window area. Then we checked the window arc interlock and found that it was disabled. Further study concludes that the fiber was damaged by radiation, which considered the chief culprits of the window crack accident.

Figure 4: The vacuum side of the cracked window.

By the further study of the window crack reason, one important lesson we learned is that the fiber used for discharging interlock may be damaged by heavy radiation and should be updated at regular intervals.

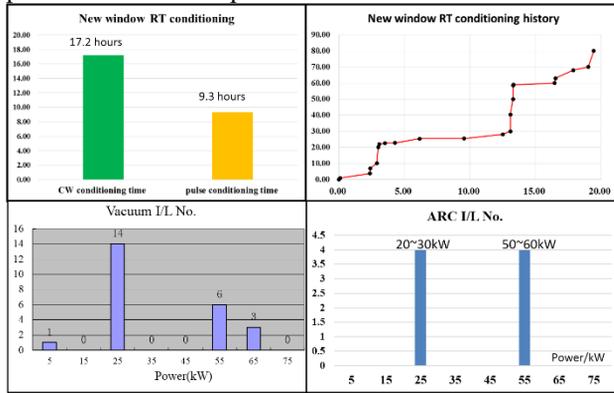
conditioning at room temperature (RT) and low temperature was done sequentially. For the RT conditioning, CW and pulse were used alternately, and it took only 26.5 hours with power up to CW 80 kW. The main outgassing and discharging happened at the power level of 20~30kW and 50~60kW, as shown in Fig.5. Then the cavity was cooled down to 4.2 K; and the conditioning with and without DC bias voltage, detuned and tuned of cavity was processed in low temperature.

Figure 5: The room temperature conditioning status of the new window.

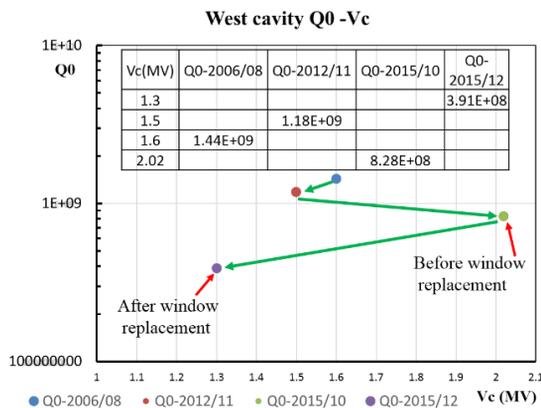
Unfortunately, the quality factor (Q) of the cavity was found almost two-thirds lower; while the radiation dose was one order higher as shown in Fig.6, which indicated that the cavity was contaminated in the window crack accident.

Figure 6: The Q of the west cavity decayed after the window replacement.

After sufficient discussion, an innovative trial, hot N2 gas baking of the cavity, was carried out in situ. The hot N2 gas was injected into the helium vessel from the liquid helium inlet pipe and filled the blue space shown in Fig.7, to warm the cavity outer surface and to speed up the outgassing. Considering the coupler and the cavity were sealed by Indium, the temperature of the N2 was controlled below 100 °C. The baking lasted nearly one week.

The outgassing of west cavity was obvious; and the window vacuum improved from 1.1E-6 Pa to 3.6E-7 Pa at the end of baking. After baking, the cavity conditioning and beam commissioning started. The acceleration voltage (Vc) of the west cavity was increased step by step, while the radiation decreased greatly: from 172 mSv/h at 1.4 MV (before baking) to 5.7 mSv/h at 1.57 MV (after baking). The most exciting effect was that the Q of the west cavity recovered obviously, from 3.91E8 at 1.3 MV to 9.52E8 at 1.5 MV.

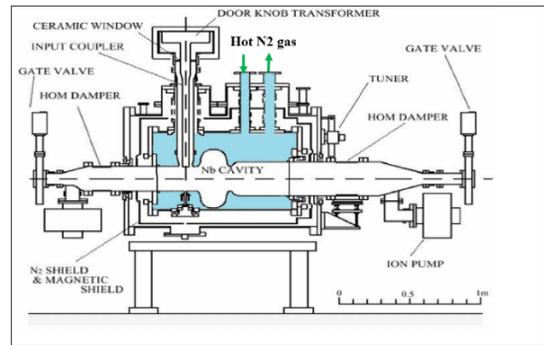
Figure 7: The schematic of the hot Nitrogen gas baking of the cavity for Q recovery: N2 fills the blue space.
