PRODUCTION OF COPPER-PLATED BEAMLINE BELLOWS AND SPOOLS FOR LCLS-II*

K. M. Wilson[†], B. Carpenter, E. F. Daly, N. Huque, and T. Peshehonoff, Thomas Jefferson National Accelerator Facility, Newport News, VA, USA

Abstract

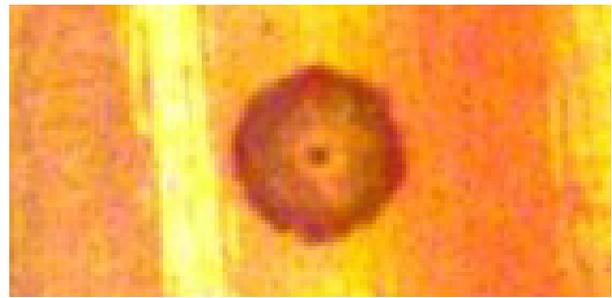
A few parts exhibited stains with unusual dark centers (Fig. 2). There was some concern that this might be an inclusion in the plating.

Figure 2: Spot with center before polish.

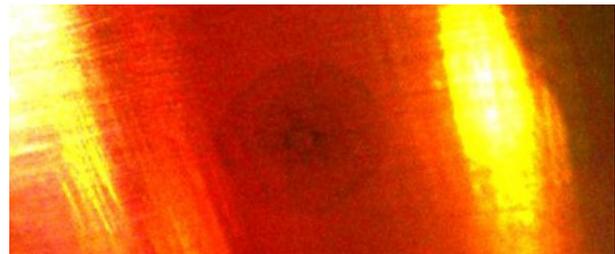
One part was lightly buffed at the location of the discoloration with a very fine Scotch-Brite cloth. With minimal plating removed, the dark spot at the center of the stain was removed, indicating that it was a very superficial discoloration (Fig. 3).

Figure 3: Spot with center after polish.

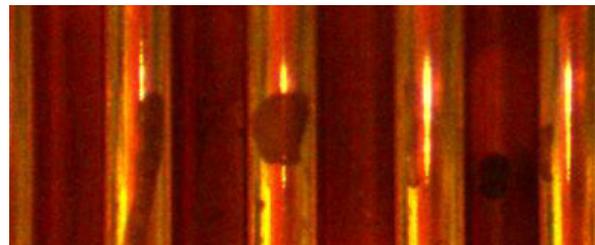
Small dark spots, generally believed to be “water spots” or oxidation from moisture were commonly observed on the plating (Fig. 4). Some investigation was undertaken to determine the best way to remove the discoloration and verify that the spots were cosmetic and not indicative of contamination.

Figure 4: Typical spot at incoming inspection.

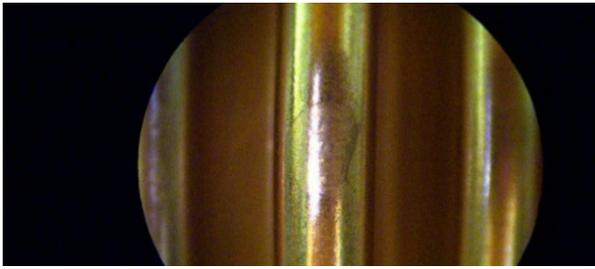
Several parts showing dark spots were baked in a vacuum furnace at 400° C for one hour, which is the recipe for a blister test on these plated parts. The spots showed variable levels of fading, but were generally lighter. Parts were baked again at 600° C and at 800° C for three hours. Spots faded progressively, and were considerably lightened by the end of the process (Fig. 5).

Figure 5: Same spot after 800° C bake.

Similar results were obtained by cleaning with citranox: bellows and spools were wiped with a 100% citranox solution and then cleaned in an ultrasonic tank with 2% citranox and ultrapure water for one hour.

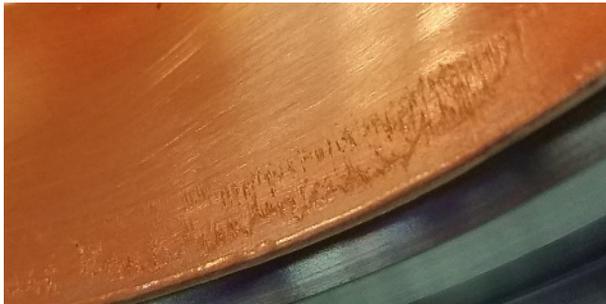
A few parts exhibited an unusual roughness in the plating near the flange; the roughness was usually striated along the part axis (Fig 6).

Figure 6: Striations in plating.

Conversation with the plater revealed that this was caused by water leaking past a seal during the strike process. An irregular weld between the body of the bellows convolutions and the flange made it difficult for the gasket used by the vendor during the strike and plating process to seal correctly. Water outside of the bellows was able to leak past the seal into the strike bath, causing uneven concentrations of the bath. This resulted in striations in the strike, which were then plated over. Because the bath is circulated during the plating process, the same effect was not seen with the plating itself.

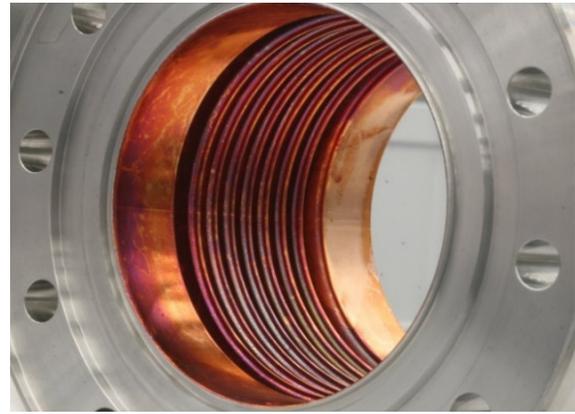
For reasons unrelated to the bellows and spools, the first three cavity string assemblies were disassembled after being pumped down to the beamline vacuum range. It was found after the first two disassemblies that several of the bellows had a purplish tint to them (Fig. 7).

As the prototype bellows had been plated by a different plater using a different procedure, it was theorized that the discoloration was unrelated to the plating process and instead caused by cleaning or handling [3]. Attempts to recreate the discoloration were only successful when the plating was dipped in water, bagged, and allowed to dry. The discoloration, which appears to be only oxidation, was completely cleaned off by a standard citranox rinse. For the third cavity string, the high-pressure rinse procedure was modified to ensure that water was thoroughly drained from the cavities. The benefit was seen after disassembly of the third string, when there was much less discoloration of the bellows.

Figure 7: Oxidized bellows.
