REWORK RECIPE DEVELOPMENT, ANALYSIS AND RESULTS OF SELECT 9-CELL CAVITIES FOR LCLS-II*

TIMELINE FOR VENDOR A REWORK LCLS-II PRODUCTION

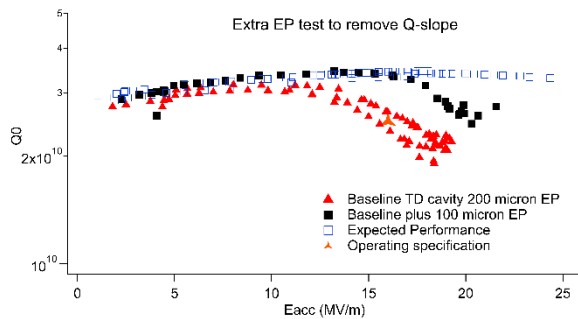
μm EP cavity showed a minimal change in quench field with the Q-slope remaining, Fig. 1.

Figure 1: New TD cavity with correct 200 μm electro-polishing from the vendor showed strong Q-slope (red solid triangles), after receiving another 100 μm EP at FNAL the Q-slope remained (black solid squares). The expected performance of a newly manufactured cavity is shown for reference (open blue squares).

The three tests combined suggest the remaining Q-slope is not related to a single physical defect, or “bad EP”, but possible due to a normal conducting inclusion.

During the initial test (Fig. 1 red triangles) there was rather strange quench processing behaviour, without any radiation or sign of multipacting, with the quench field actually going up by 1 MV/m. Although the change was small, this is similar to quench processing of a normal conducting inclusion field emitter [6]. Again suggesting a normal conducting inclusion in the high peak magnetic field region which can't be dissolved with electro-polishing - aluminium and possible stainless steel are prime candidates.

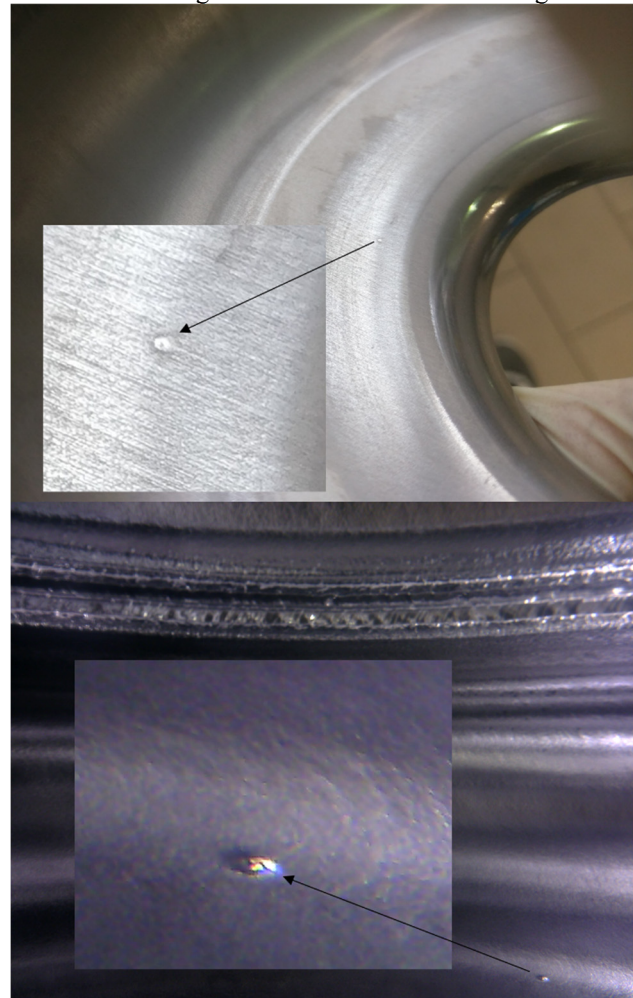
There were two main findings. One, multiple workcenters showed a high risk of embedding material with each progressive center showing more and more defects. The amount of defects found and some of the techniques being used were outside the generally accepted practices in the field, see example of aluminium defect found in dumbbell before grinding in Fig. 2, top. Two, right before final weld prep chemistry, a final grinding step is done to remove any accidentally embedded material or handling defects. The industry standard and contractually enforced protocol is to perform local grinding on the defect area only with encapsulated abrasives. This ensures minimal material removal as well as reducing the chance of smearing the soft niobium over the embedded defects. The Vendor was instead performing a global polish with a

non-conforming abrasive. The tooling made the surface look better from a visual inspection point of view, but could smear the niobium over itself and cover the embedded foreign defect without removing them.

Figure 2: Top, large embedded aluminium defect found in dumbbell right before grinding. Bottom, embedded metallic looking defect in the sidewall of a finished cavity after 275 μm EP.

At the same time 4 cavities which received 200 μm of non-conforming EP (EP done in the etching regime) plus an additional 75 μm of the correct EP (done in the polishing regime) went through internal inspection. In three of the four cavities metallic looking embedded defects were found on the internal side wall, see example in Fig. 2 lower image. This suggested the foreign material does not react to the electrochemistry and must have been embedded at the vendor after eddy-current scanning at DESY which detect foreign material $\sim 500 \mu\text{m}$ into the surface[7].

30 μm BCP, flip the cavity + 30 μm BCP + 35 μm EP then standard doping and finish manufacturing.

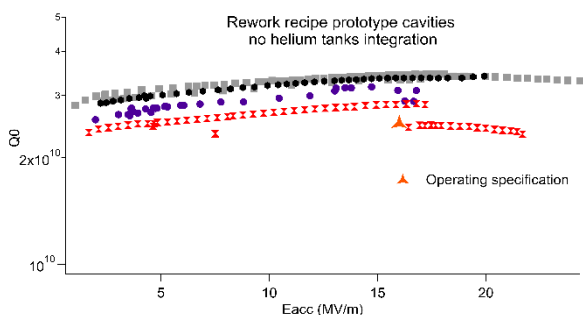
Figure 3: Rework recipe prototype cavities, all cavities passed the operating gradient specification of 16 MV/m with three passing the vertical test specification of 19 MV/m. One cavity shows a Q-drop from quench processing which is normal.

Based on the recipe above, four cavities went through the vendor's production line with Jefferson Laboratory experts on site to supervise the changes. This was done in parallel to new cavities being produced with new procedures. The results from the four cavities are shown in Fig. 3.

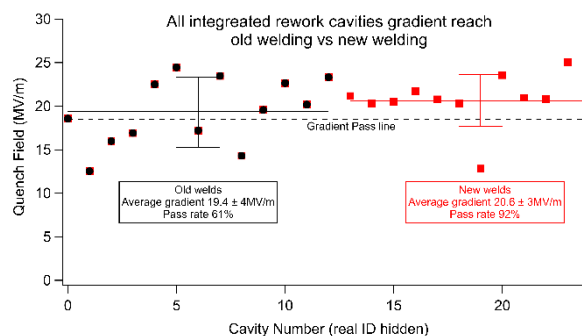
As of April 12th 2018, 26 cavities have been tested with a pass rate of 76%. The results are rather different based on when they were welded. The first set of rework cavities were made from cavities welded after the production shutdown and the second set is before the production shutdown. Almost all of the old weld cavities showed some internal or external welding spatter, while none of the new welds had any sign of internal or external weld spatter. The results and statistics from each lot are shown in Fig. 4:

Figure 4: Quench field gradient and pass rate statistics for two subsets of cavities that received the rework recipe; one welded with old preparation procedure and ones welded after the production shutdown with new procedures.

There is a clear statistical difference between the vendor's old welding preparation technique and the new one used after the production shutdown.
