# MECHANICAL CONSOLIDATION OF THE LHC INNER TRIPLET MAGNET SUPPORTING SYSTEM FOR REMOTE ALIGNMENT

F. Micolon, N. Bourcey, J. B. Deschamps, A. Herty, S. Le Naour, T. Mikkola, V. Parma, D. Ramos, V. Rude, M. Sosin, CERN, 1211 Geneva 23, Switzerland

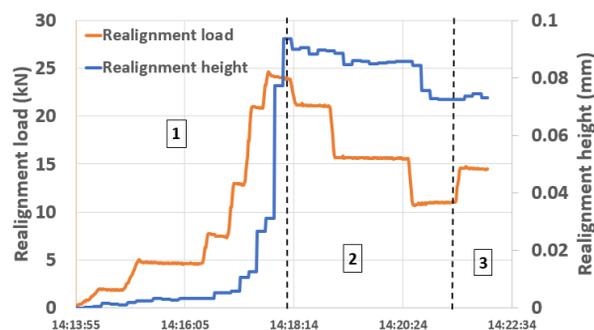
Figure 3: Realignment height vs load – 5R Jack Q2D.

In 2012, a first alignment issue was found on the jack Q2D when a tentative vertical realignment was made of the triplet 5R (Fig. 3).

The realignment system was slowly lifted with a progressive load transfer from the LHC jack onto the alignment system (Fig. 3 label 1). Noticeable cryostat lifting started at a realignment system load of 21 kN.

Since the final alignment height was overshoot, descent orders were sent to the realignment system (Fig. 3 label 2). The load on the realignment system then decreased to about 11 kN with no correlated cryostat movement.

The realignment load was down to around 11 kN, so the realignment sequence was aborted, and a lift order was sent to recover some load on the realignment system (Fig. 3 label 3).

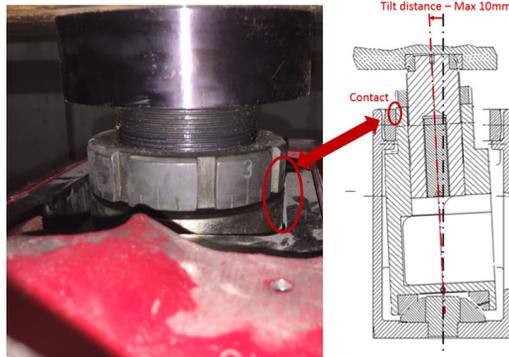
Figure 4: (left) Triplet 5R Jack Q2B in contact (right) schematic cross-section of the jack.

Subsequent tunnel inspections showed that the jack Q2D was tilted to a blocking position in the longitudinal direction (Fig. 4) and was in contact with its frame.

Further underground inspections showed that, six out of eight triplet strings had at least one realignment jack in contact with its frame on the Q1 magnet (similar to Fig. 4). This showed that the Q1 magnets were all subjected to a longitudinal movement greater than their allowable jack design capability of +/- 12 mm leading to an unwanted internal contact.

A longitudinal movement of the Q2 magnet was then manually carried out thanks to the interconnection tie-rods in order to recover some jack clearance. As a result, the jack recovered its alignment capabilities.

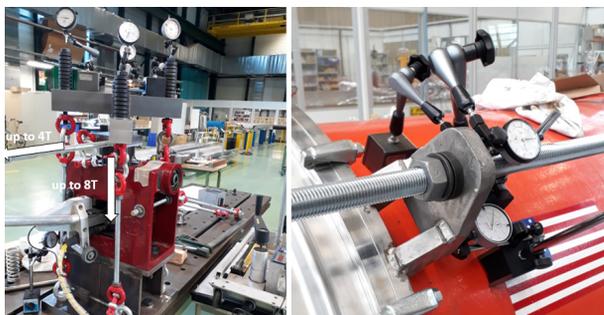
Figure 5: Dedicated testing of (left) standalone jack test (right) tie rod ear stiffness.

The jack was put in contact with its frame, similar to the situation witnessed in the tunnel and was progressively loaded transversely on a dedicated test bench (Fig. 5 left). It was then operated for a vertical realignment operation and the operating load was measured with a load cell. Early results showed that when loaded transversely, a large friction load was to be overcome to get a vertical jack motion [3]. However, no measurable stick slip was witnessed,

the jack movement remained smooth within a 0.01 mm resolution. These results were consistent with the pattern seen on Fig. 4.

Later, the tie rod ears of the spare triplet magnets were loaded up to 20 kN each to measure their respective longitudinal deflection in operation (see Fig. 5 right). The longitudinal deflection at the level of a single tie rod was in the order of 3.5 mm [4]. Cumulating the displacement due to the tie-rod ear deflections, the Q1 magnet longitudinal movement under vacuum was expected to be in the order of 17.5 mm before reaching a steady state situation. This is more than the 12 mm of jack design capacity.

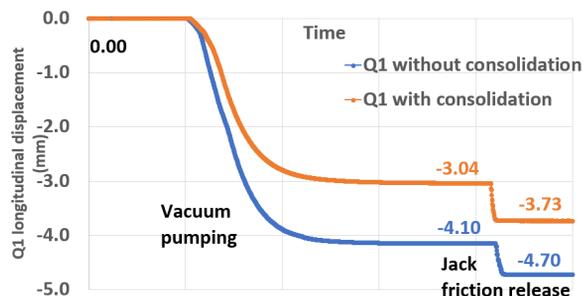
Figure 9: Comparison of the longitudinal travel of Q1R5.

After cycling the insulation vacuum, the overall triplet longitudinal stiffness was found to have increased as expected (see Fig. 9).
