VACUUM ISSUES WITH ARGON GAS IN THE LANSCE ACCELERATOR*

T. Tajima[†], J. Bernal, D. Byers, J. Chamberlin, P. Pizzol, A. Poudel, K. Stephens
Los Alamos National Laboratory, Los Alamos, NM, USA

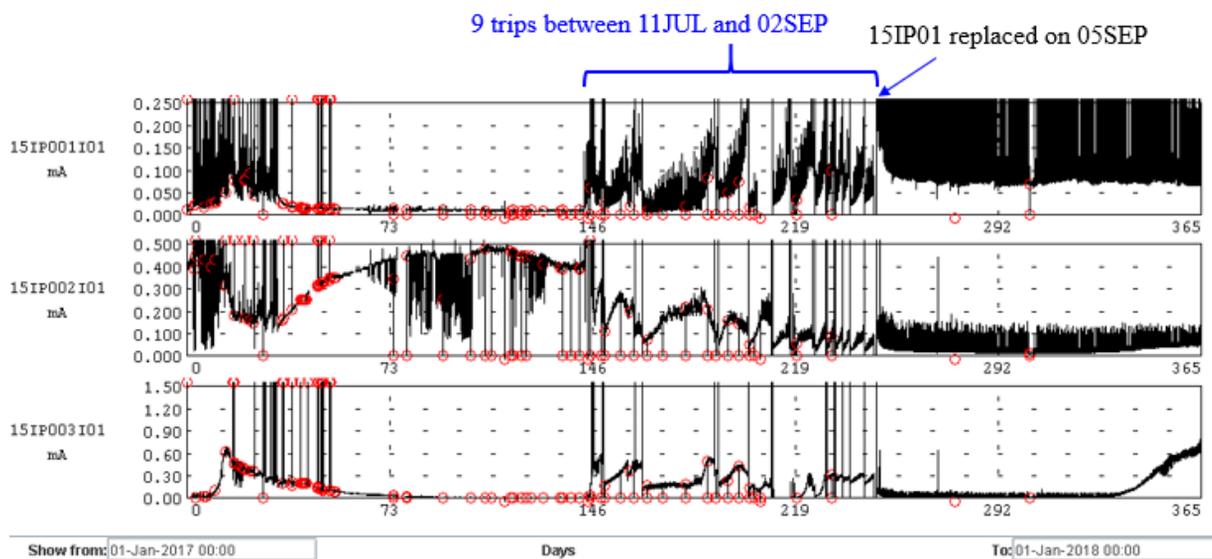
Figures 1, 2 and 3 show the currents of 3 ion pumps on M15 in 2017, 2018 and 2019, respectively. The pump current of 0.7 mA corresponds to ~1E-7 Torr and 0.06 mA corresponds to ~1E-8 Torr. Note that the average total pressure for all 3 pumps is <1E-7 Torr before it starts to rise. In 2017, we had a total of 9 trips and it stopped when we changed out a pump 15IP01 (Fig. 1), which made us think that it was this pump that was causing the trips. In 2018, however, the trips started again on May 14th and there were a total of 7 trips until July 27th (Fig. 2). It is unknown why it stopped. In 2019, the trips started again on Sept. 19th and there were a total of 4 trips until Dec. 1st (Fig. 3). We leak checked the module at an early stage with no leaks found and it was rather easy to recover vacuum by pumping down the module with a pump cart, then turn on the ion pumps, but they were significant disturbance to the accelerator users. As an attempt to mitigate it, we vented the module with UHP nitrogen gas and left it for a few hours to change the condition of the surfaces of the ion pump elements. It sometimes reduced the pump current, but it did not help prevent the trips much as shown in Fig. 3.

Figure 1: The currents of 3 500-L/s ion pumps on M15 in 2017. A total of 9 trips occurred between 11 July and 02 September during the run cycle. It stopped when 15IP01 was replaced. Red circles show lost data.

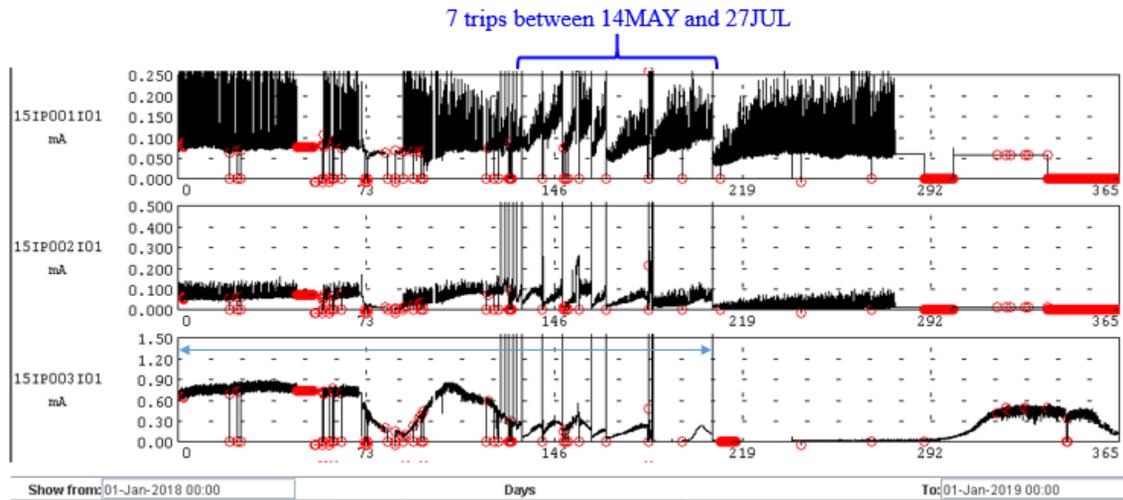
Figure 2: Ion pumps currents in 2018. A total of 7 trips occurred. The reason why there was no trip after 27 July 2018 is unknown.

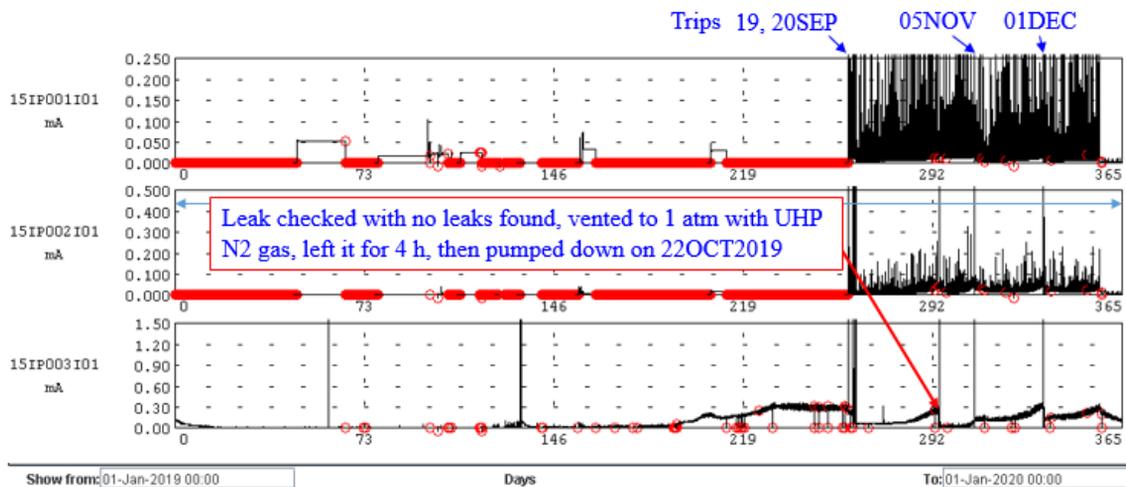
Figure 3: Ion pumps currents in 2019. A total of 4 trips occurred in 2019.

which is usually from January through April, but this is just an anecdotal observation and no evidence for that so far. We replaced 15IP03 that was baked in February 2020 during the extended maintenance period with a new pump in January 2021 and we will see if that will affect something.

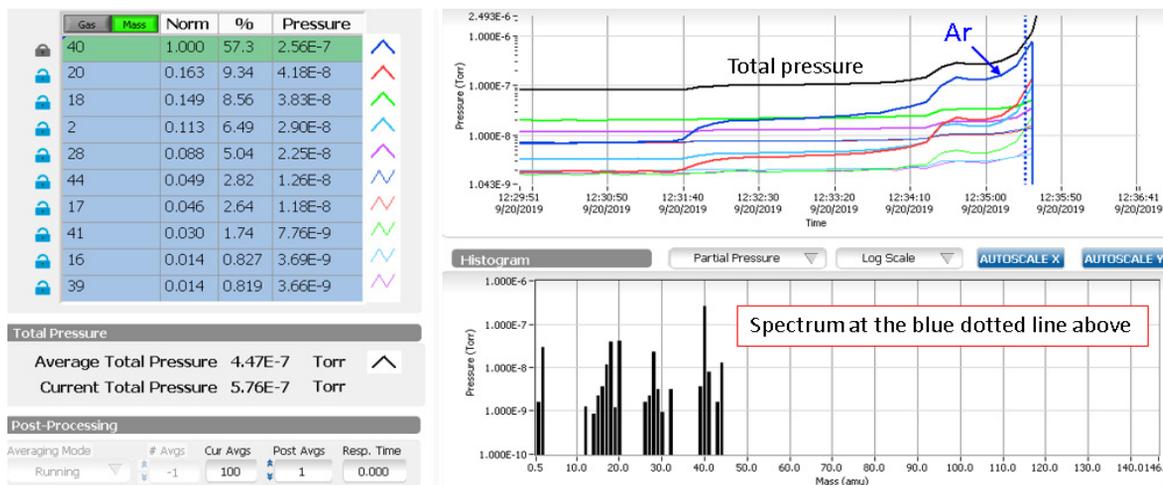
We use 835 VQM from MKS Instruments, Inc. as our RGA [5]. We have installed RGA sensors at some sections of the accelerator, especially where we had vacuum issues such as pressure spikes and suspected water-to-vacuum leaks. We normally do not run it constantly. Figure 4 shows the RGA data that captured the rise in argon gas partial pressure right before the ion pumps tripped in M15 on September 20th, 2019.

The partial pressure of argon gas started to rise rapidly about 4 minutes before all the ion pumps tripped. Since then, we obtained similar RGA data with argon gas causing the ion pump trips a couple more times in 2019.

Figure 4: RGA data right before ion pumps tripped on 20 September 2019.

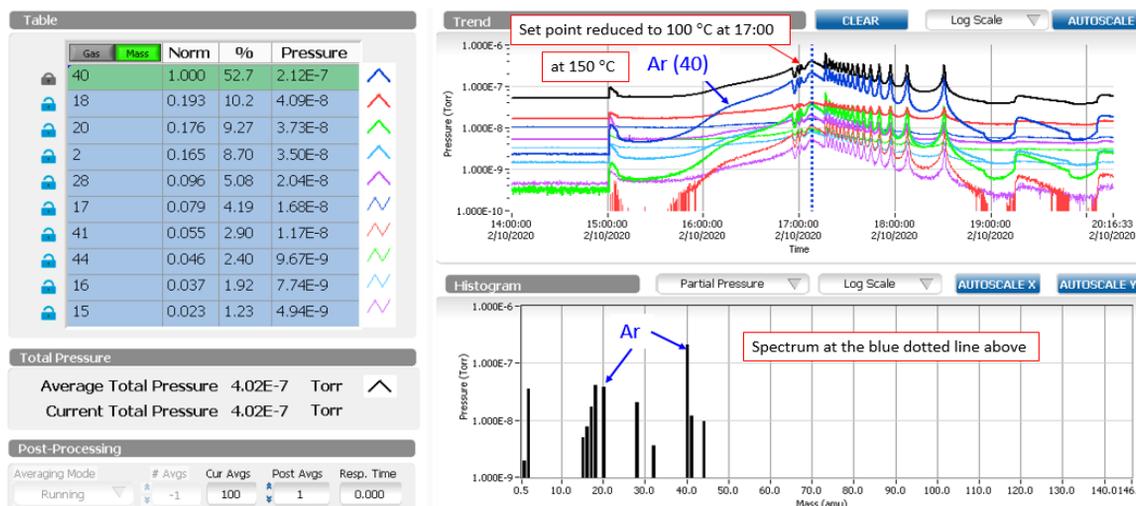
We rarely bake our vacuum systems in the LANSCE accelerator since we do not need ultra high vacuum. The pressure of the accelerator modules, however, has gone down to low E-8 to E-9 Torr range at some sections since they have been pumped down continuously for decades. Since we had not had any issue with argon gas until 2017, we had not considered to replace our Diode type ion pumps with other types of ion pumps such as Noble Diode and StarCell [4] that have better pumping on argon before. As an attempt to mitigate this argon issue, we decided to bake out one ion pump to see if it helps eliminate or reduce the number of trips. We chose 15IP03, the oldest pump in module 15 that was installed in 1996. We raised the temperature up to 150 °C while watching the RGA data. We started to see a rise in argon partial pressure in ~4.5 hours after raised the temperature from 135 °C to 150 °C as shown in Fig. 5.

Figure 5: Detailed RGA data from 14:00 to 20:17 on 10 February 2020. At 15:00, something triggered the increased level of gas release and the pressure was going up fast. We decided to reduce the temperature to prevent RGA from tripping at 1E-5 Torr.

To remove this released argon gas, we attached a turbo molecular pump and pumped down at 150 °C for about 6 days. We had not had any trips of M15 ion pumps since this pump was baked in February 2020 until 15IP03 was replaced in January 2021. Determining whether baking out the pump is an ultimate solution or not will require more time to monitor the ion pumps currents and take RGA data for a longer period of time, but it seems to have helped reduce the change of trips by removing some argon gas from the pump elements by baking. We hope there will be no trips of any ion pump due to argon gas during this upcoming run cycle.
