EUROPEAN XFEL HIGH-POWER RF SYSTEM – THE FIRST 4 YEARS OF OPERATION

M. Bousonville[†], S. Choroba, S. Göller, T. Grevsmühl, A. Hauberg, V. Katalev, K. Machau, V. Vogel, B. Yildirim, Deutsches Elektronen-Synchrotron, 22607 Hamburg, Germany

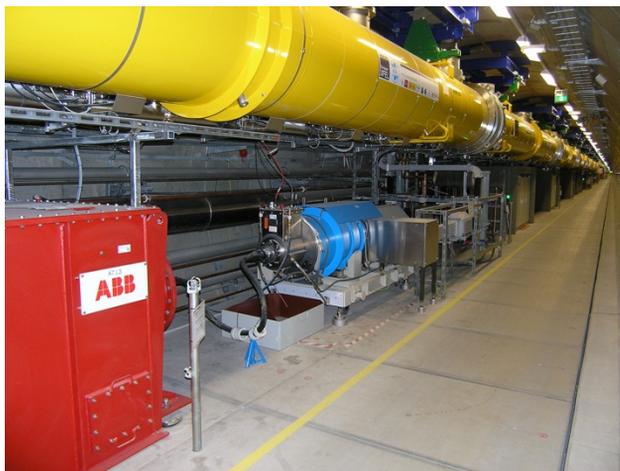
Replacing a klystron in the XFEL is more complicated than in other accelerator facilities because they are located under the accelerator modules in the tunnel (Fig. 3).

Figure 3: The klystrons are located below the accelerator modules.

- First of all, a new, much smaller transport vehicle was constructed that can be brought into the tunnel much faster than the one used during the installation phase.
- Spare klystrons have been deposited in the XFEL to shorten the transport time.
- Each spare klystron has all the necessary accessories for the installation.
- The klystron lead shields have been optimised so that they can be dismantled and reassembled as quickly as possible.
- A bag with all the tools needed for klystron replacement is provided.
- The klystrons have been equipped with wheels that allow them to be pushed sideways into the transport path (Fig. 3 on the right).
