Recording: Chunguang Jing, Euclid Techlabs, LLC

Side coupled accelerating structures are popular in the industrial realizations of linacs due to their high shunt impedance and ease of tuning. We designed and fabricated a side-coupled X-band accelerating structure that achieved 133 MOhm/m shunt impedance. This structure was fabricated out of two halves using a novel brazeless approach. The two copper halves are joined together using a stainless steel joining piece with knife edges that bite into copper. This structure had been tested at high power at SLAC National Accelerator Laboratory. The performance of the structure had been limited by magnetic breakdowns on the side-coupling cells. In this paper we will present results of the high gradient tests and after-test analysis. Scanning electron microscopy images show a typical magnetic-field induced breakdown.

# X-band Brazeless side-coupled accelerator

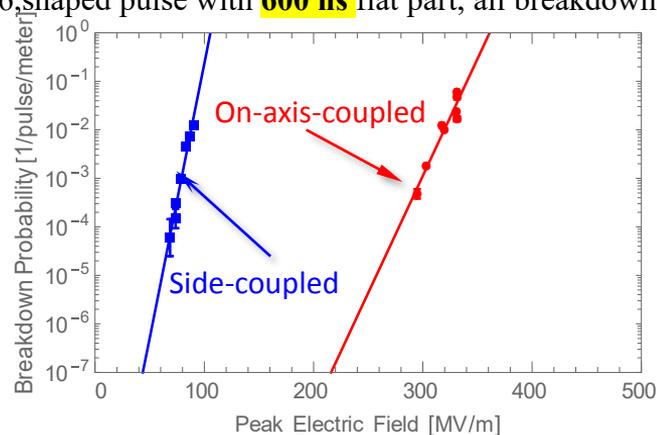
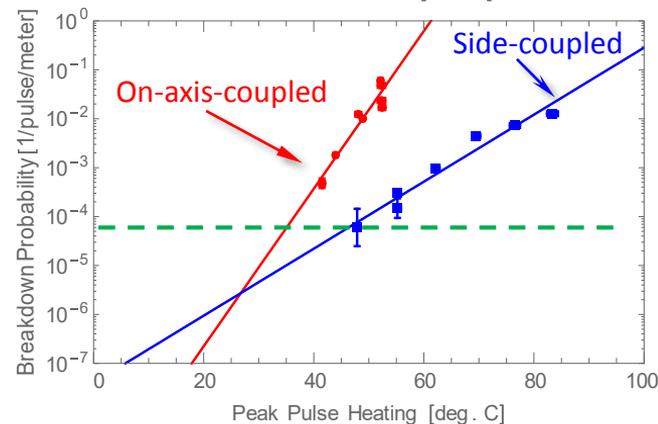
When we compare structure with the same  $E_{peak}/E_{acc}$  and wildly different  $H_{max} * Z_0 / E_{acc}$  (3.3 in side-coupled vs 1.1 in on-axis coupled), we see that peak magnetic field or associated with it peak pulse surface heating is much better predictor of breakdown rates than the peak surface electric field.

Comparison of performance of this prototype side-coupled and SLAC on-axis coupled (SLAC A3.75-T2.2-Cu) structures with similar ratio  $E_{peak}/E_{acc} \sim 2.6$  shaped pulse with **600 ns** flat part, all breakdowns

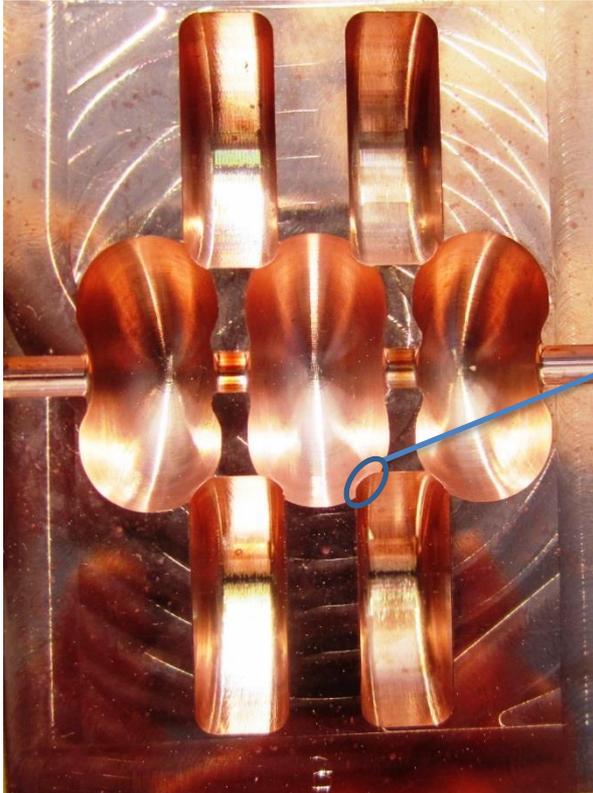
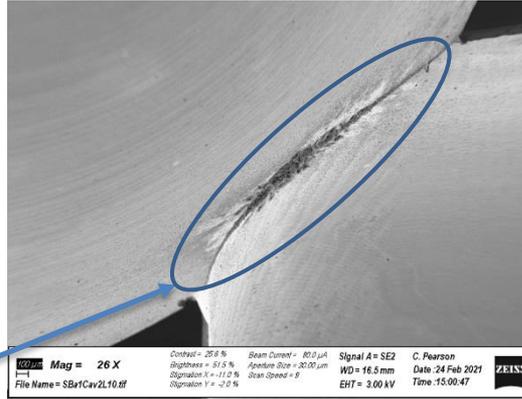
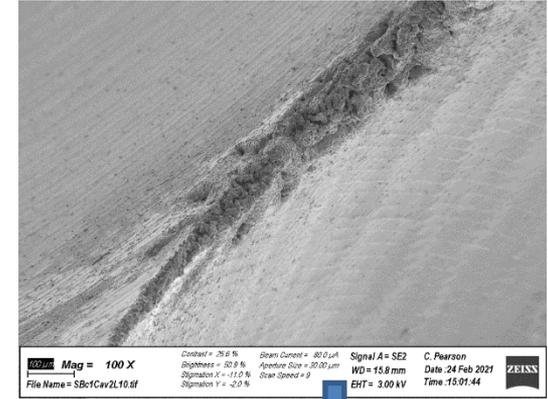
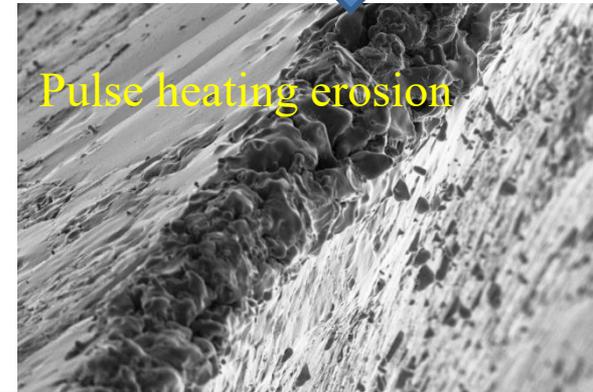
## Coupling holes have significant rf damage

The sharp edge located at the coupling hole between the side cavities and the main cavities have the most severe rf damage

Pulse heating erosion

Remarks: The side-coupled cavities require special attention to the high magnetic fields; need to avoid the sharp edge of the coupling cell.
