Collector Failures on 350 MHz, 1.2 MW CW Klystrons at the Low Energy Demonstration Accelerator (LEDA)

D. Rees, W. Roybal, J. Bradley III, LANL, Los Alamos, NM 87545, USA

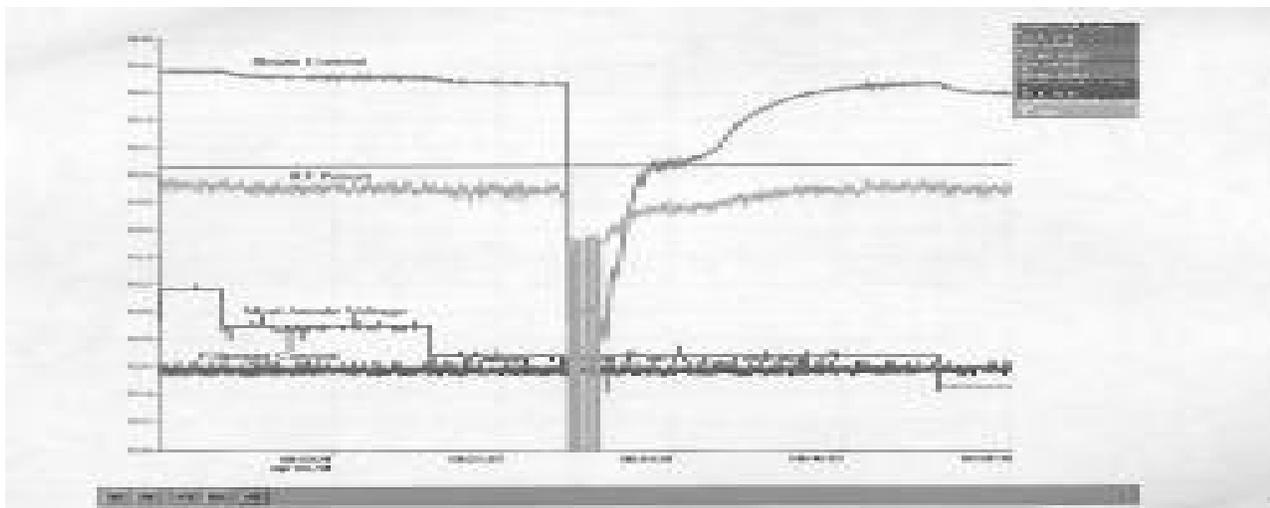
Figure 2: Strip chart record illustrating variable emission with changes in collector power.

several amps when increasing or decreasing the RF drive. We could also cause this same variation by small changes in cathode voltage. Our system operates with a mod-anode regulator tube that maintains the mod-anode voltage at a fixed setpoint relative to the cathode voltage and we carefully monitored this voltage, as well as the filament current, to verify neither of these factors were causing the change in cathode current. Finally, we did a series of tests where we triggered our arc detectors which inhibit RF drive to the klystrons.

Fig. 2 shows the results of one of these tests. In the figure, the RF power is observed to go to zero and a corresponding plunge in cathode current is observed. When the RF power is reestablished, the cathode current is observed to slowly return to its previous value. The filament current and mod-anode voltage relative to cathode voltage is observed to be constant over the variation in cathode current. From this data we concluded copper vapor from the collector was poisoning the cathode emission as we increased the thermal load in the collector. It was also interesting that the vac-ion pump power supply did not register an increase in vacuum and indicated very low current throughout this test.

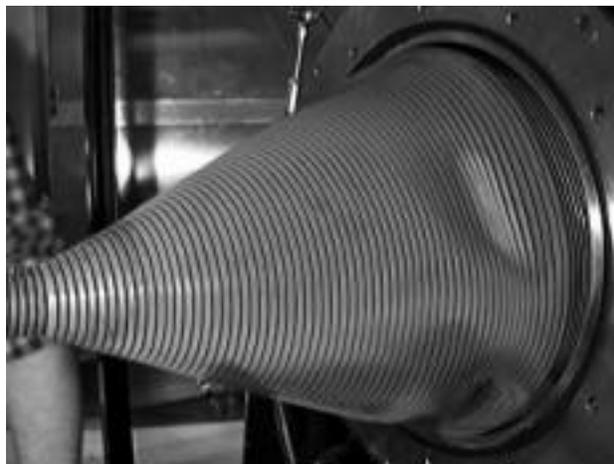
Based on this result and conversations over the duration of our testing, EEV had two klystron engineers visit our site. We removed the end of the collector water jacket from the klystron and observed the damage shown in Fig. 3. From Fig. 3 it is observed that several portions of the collector had become quite hot and dimples had resulted from a combination of the heat, water pressure, and vacuum forces. The general collector shape had also distorted. It was now elliptical in cross section rather than round. Also, the collector end had drooped and the bottom of the conical shaped portion of the collector was actually resting on the water jacket.

We inspected the collectors of all the klystrons and all showed various levels of damage ranging from minimal to the significant damage shown in Fig. 3. All collectors showed indications of droop and three of the four collectors were becoming elliptical rather than round in cross section. All collectors had less than 1000 high voltage hours and one had only 60 high voltage hours since delivery.

Figure 3: External view of collector damage.

The klystron in Fig. 3 was returned to the factory for rebuild still under vacuum and operable at low beam powers. The collector jackets of the remaining three klystrons were adjusted to center the collectors in the water jackets in order to compensate for the droop, and supports were welded on the inside of the water jacket to support the end of the collector to avoid further droop. An acoustical measurement system was installed on the collector to validate the effect of the bucking coil and to characterize safe regions of operation. The sensor was a microphone on the collector cooling return. These results are presented in Fig. 4. The four curves in Fig. 4 show some unexpected results. The mixed phase boiling that the collector was designed to accommodate manifests as an increase in the higher frequency audio components of Fig. 4. This increase can be used as a qualitative indication of peak collector heat load. From Fig. 4 it can be seen that the localized collector heat load at 77 kV, 14.5 A is actually higher than at 85 kV, 17.1 A. This suggests that the beam power is better distributed over the collector at 85 kV. The plots in Fig. 4 were measured without RF power with the full beam power dissipated in the collector. Fig. 4 also shows that application of the bucking coil lowers the localized collector heat load. Using this tool we were able to define an allowable safe operating region and also regions to avoid. Operation with three klystrons at an 85 kV voltage provides sufficient power for the RFQ with full accelerator beam current and sufficient control margin.

EEV has redesigned the collector so it is capable of achieving the initial requirements. The details provided below are intentionally vague to protect proprietary information. Additional modeling was conducted using a recently released, new version of one of the beam dynamics codes originally used in the collector design. The beam was discovered to penetrate further into the collector than originally thought. Additional length has been added to the collector in the new collector design some. The conical collector end has been changed to a shape which reduces the thermal stress. The bucking coil

is now a required part of the design. The water jacket design has been changed to maintain a high flow velocity over the entire collector. The supports on the end of the collector implemented as part of the short term solution have become a part of the design. We also conducted x-ray measurements of the klystron internal to the lead shielding and discovered that the beam alignment could be improved. These results were duplicated by EEV. EEV is taking steps to improve beam alignment.

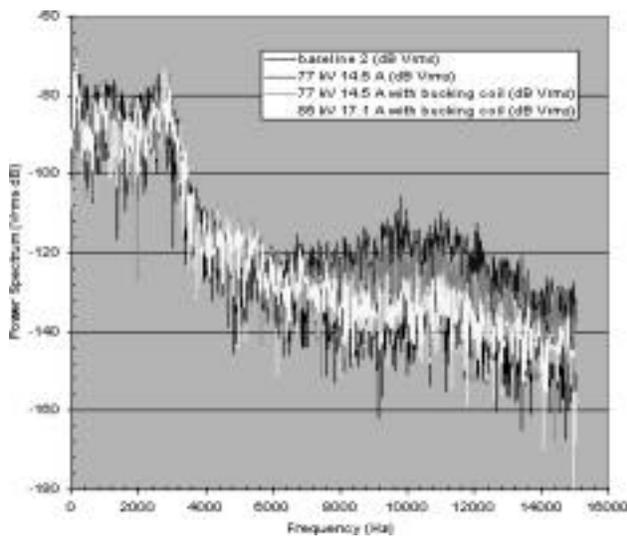
The data in Fig. 4 were measured on the klystron that had the second most significant amount of collector damage. The other two klystrons showed a similar behavior but not the same magnitude of acoustical variation. For all klystrons, operation between 70 kV and 80 kV resulted in audio indications of increased localized heating.

Figure 4: Collector audio profile.

In addition to the steps taken above, we also implemented a beam interlock such that above 70 kV of beam voltage, 100 kW of RF power was required or an interlock would remove high voltage within 15 seconds.
