CLSI BMIT'S SUPER-CONDUCTING WIGGLER CRYOGENIC SAFETY IMPROVEMENTS*

L. Lin[†], T.W. Wysokinski, Canadian Light Source (CLS), Saskatoon, Canada

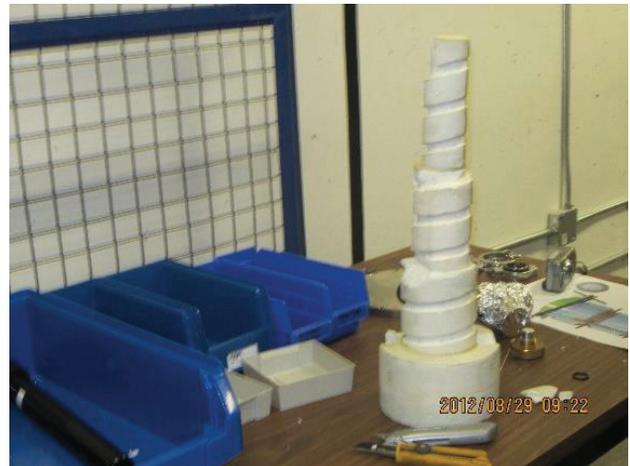
The air leaking into the cold space eventually froze at the wiggler's vent path – see Figure 1, separating the cold space from the room temperature gas space. The vent path was made of a spiral channel cut in a foam insulation installed in wiggler's central throat. The vent path/channel was about 15 mm wide and 10 mm deep, connecting dewar with the top casing where the vent outlet was located. The pressure relief valves and the rupture disk were both connected to this vent outlet. As a result of the blockage, the helium gas was not able to relief through this vent path during liquid helium refilling procedure, at the same time the pressure gauges were not showing properly the cold space pressure - a safety concern was raised.

Figure 1 Spiral vent path cut in the insulation foam.

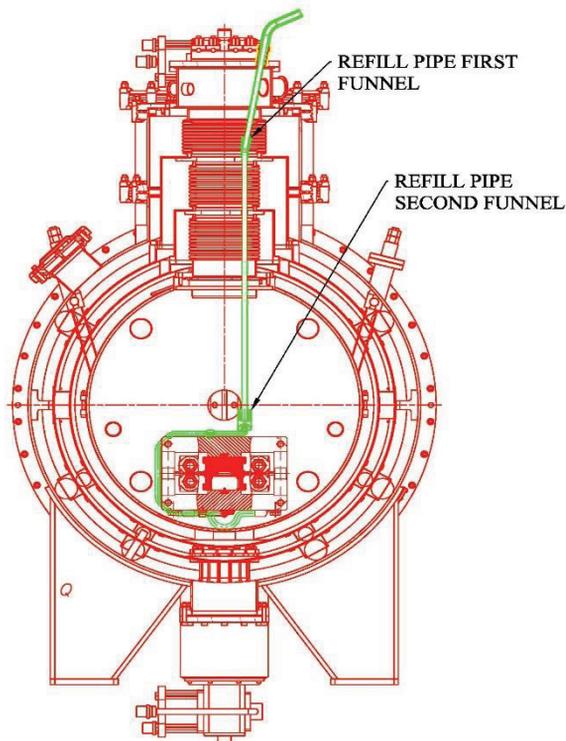
The wiggler refill path is constructed with three-sections: external LHe transfer line is inserted into the wiggler through the top section and sits on the first funnel. The middle section is made of an internal LHe transfer tube that leads LHe to the second funnel located on the top of the magnets. The bottom section is a bended LHe transfer tube built around the magnets that discharges the LHe to the bottom of the cryostat (see Figure 2). Ice has formed at all three refilling path sections. A heated copper pipe was used to successfully remove the ice at the top and the middle sections. However, if ice-block formed at the second funnel or the bottom section it was not removable without the warmup. When attempting to refill with vent path blocked, LHe would boil-off at the transfer line sections and at the top section of the cryostat. Pressure therefore would build up until refill tube was removed. A large amount of cold helium gas came out from the cryostat at high pressure at this point, cryogenic hazard occurred.

Figure 2 BMIT's wiggler initial refill path.

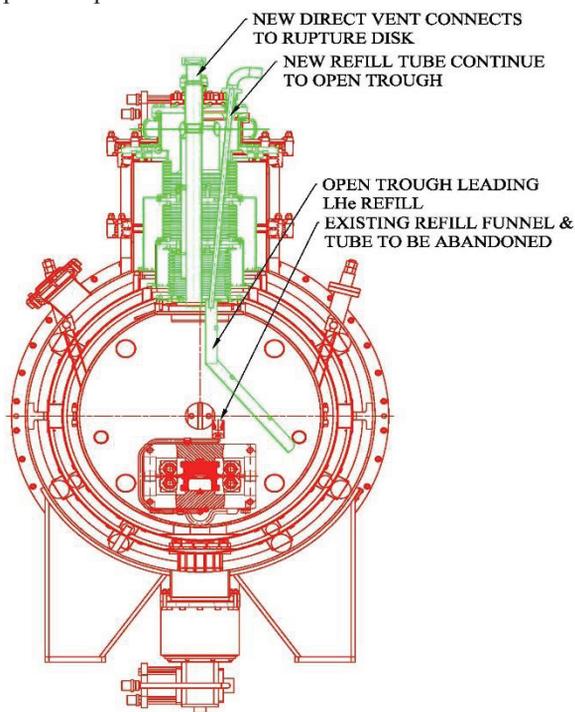
Figure 3 A new vent path & refill path.

- Rupture disk was replaced with the new one and equipped with rupture indication signal.
2. Major modifications at the wiggler vent path and refill path – made by BINP group.
 - A separate and direct vent path was added - 1.5" DIA pipe connected the wiggler cryostat cold and warm space through the central throat. This hollow pipe runs from the top of the cryostat to the new rupture disk located on the top of the wiggler and provides a barrier free direct exhaust for emergency pressure relief.
 - The vent path for the pressure relief valves uses improved spiral channel at the foam insulation.

- Two heaters were added into the pressure relief vent path to the two narrow points of the central throat - at the two copper flange plates (20 K & 60 K) to mitigate potential ice built up.
- A new LHe refill path was constructed to replace the existing one with two sections. The top section is a single tube runs straight into the bottom section - an open trough that leads the LHe to the lower side of the wiggler cryostat (Figure 3). This change is to eliminate potential ice blockage at the bends.
- Liquid helium transfer line was permanently connected to the wiggler – This became a huge problem as discovered later.

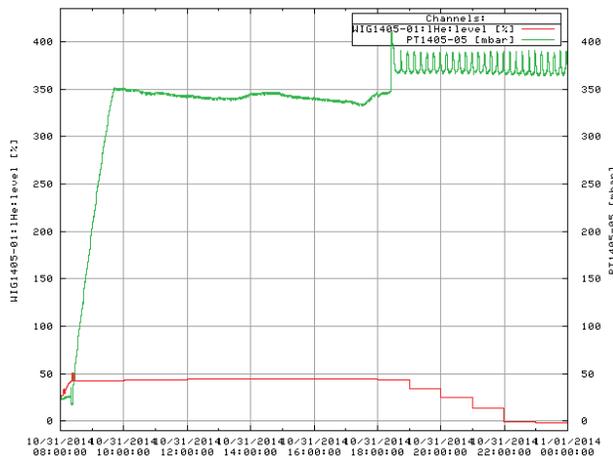
1. The wiggler experienced thermal acoustic oscillation problems at refill after the upgrades [4]
- The problem was discovered at the first refill: pressure at the cryostat built up to 350 mbar two hours after the refill was completed and stabilised for about 5

hours then started oscillated. The LHe started evaporating right after and the LHe level in the cryostat dropped from 43% to 0 in less than 2 hours (see Figure 4).

Figure 4 Pressure & level changes at oscillation.

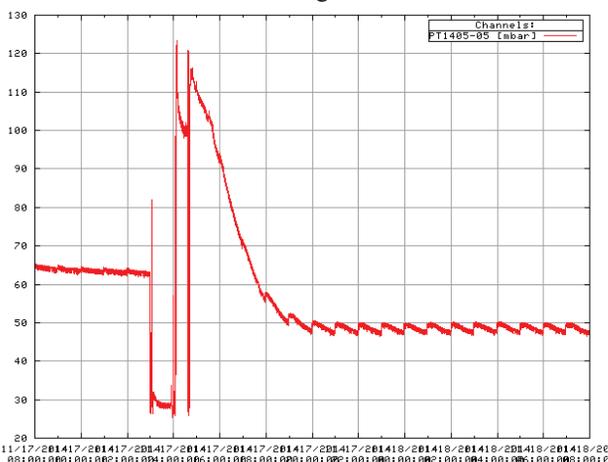
- The second refill repeated and confirmed the same problem: 7 hours after the refill, pressure built up to 350 mbar and stabilised for about 4 hours then started oscillations again.
 - BINP indicated that the thermal acoustic oscillation was most likely caused from the long, warm, LHe transfer line that was connected to the cryostat.
2. Several steps performed to fix the thermal acoustic oscillation problem
- LHe transfer line was removed. Pressure at cryostat built up to below pressure relief pressure (350 mbar) and was able to drop and stabilized. Small oscillation was still shown (see Figure 5). The above atmosphere pressure at no load condition indicated that heat load increased at this new configuration.

Figure 5 pressure change at LHe transfer line removed.

- A dummy plug made of G-10 FR4 (epoxy the surface) installed at the LHe refill tube to close the opening in the central throat insulation.

- Supper insulation disks designed and installed inside of the 1.5” DIA exhaust pipe using multilayer insulation to reduce radiative and convention heat-loads.
3. End results
- The secondary vent path provides a barrier free safety relief to the wiggler cryostat with super-insulation disks to reduce the heat leaks.
 - Pressure at the wiggler cryostat is able to run back to sub-atmosphere to about -160 mbar after the upgrades with no SR heat-load.
