ANALYSIS OF BEAM-INDUCED DAMAGE TO THE SLC POSITRON PRODUCTION TARGET*

Vinod K. Bharadwaj, Yuri K. Batygin, John C. Sheppard, David C. Schultz, P.O. Box 4349, SLAC, Stanford, CA 94309, USA

Abstract

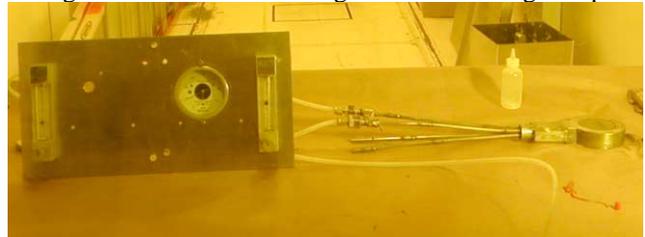
After the target arm was removed from its housing, the target cooling water lines were pressurized with helium to 10 psi (see Fig. 1) and Snoop liquid leak detector fluid was applied to both sides of the target. A small leak was observed on the exit side of the target.

Figure 1: SLC Positron Target Leak Checking Setup

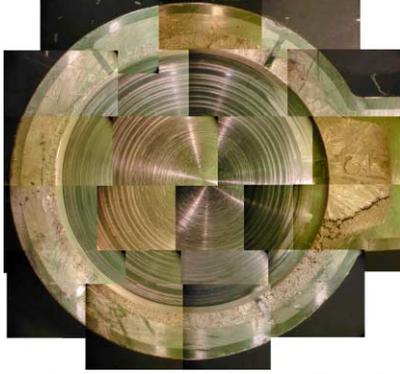
Next, the target was transferred to a hot cell containing a microscope and photos at magnifications up to 20X were taken. Photos of the beam entry face of the target are shown in Figs. 2a-b and the beam exit face in Figs. 3a-b. The beam entry face showed areas in the silver with a dendritic solidification pattern. This area corresponded to the top of the silver casting after it was machined to size. The beam exit face showed a circular crack where the beam exited through the W-26Re. Additional cracking was present in the silver especially in areas where the beam was closer to the W-26Re/Silver interface.

Figure 2a: Target - Beam Entry Face

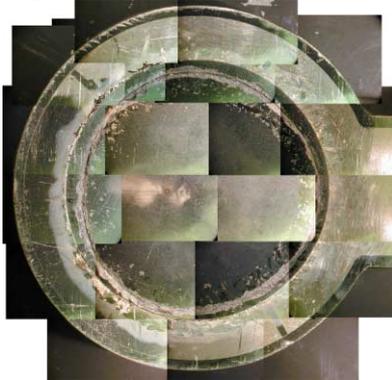
Figure 3a: Target - Beam Exit Face

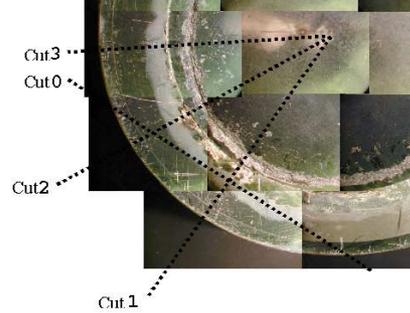
These optical micrographs were used to determine the locations where the target would be sliced. Fig. 4 shows the exit face of the target and the location where the cuts were made. Cut0 went tangentially through the cooling tubes near where the leak was observed. Cut1 went radially through the location of the leak. Cut3 was chosen to look at an area far away from the location of the leak. Cut2 was chosen to cut the wedge into two pieces for mounting. Each cut was performed with a high speed diamond cutting saw and took approximately 4-6 hours.

Figure 4: Target Cuts

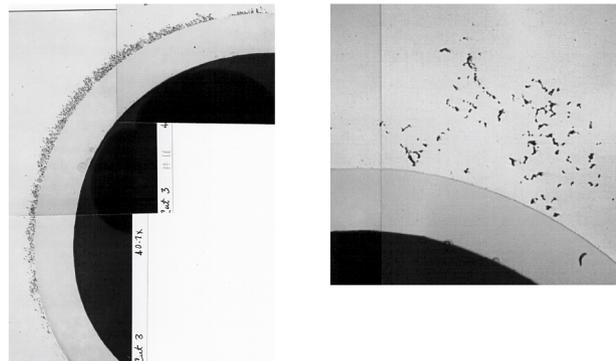
Cut3 goes through the stainless steel tubes, the silver matrix and the W-26Re. When viewing this cut using higher magnification, two features are noted in the silver. There is porosity in the silver, which seems to be associated with the dendritic cast structure. Areas in the silver at the stainless steel/silver interface show the presence of fine porosity or a second phase. Cracking was observed in the W-26Re, see Fig. 5 (left), and there is also the presence of a fine second phase on the edge of the silver.

Figure 6: Porosity and evidence of second phase in the silver

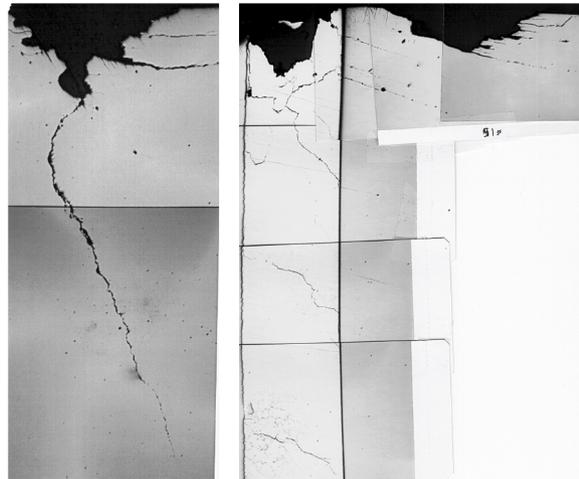
Cut1 went through stainless steel tubes, followed by silver matrix, then through a stainless steel spacer, through the silver matrix again and finally through the W-26Re. Higher magnification pictures of Cut1 show two interesting areas, see Fig. 5 (right). First there are many cracks present in the tungsten-rhenium and in the silver. Second material has spalled off of the tungsten-rhenium and the silver at the edge of the specimen. It should be noted that the analysis showed no irregularities at the stainless steel water cooling tubes.

Figure 5: Target Cracking, Cut1 (right), Cut3 (left)

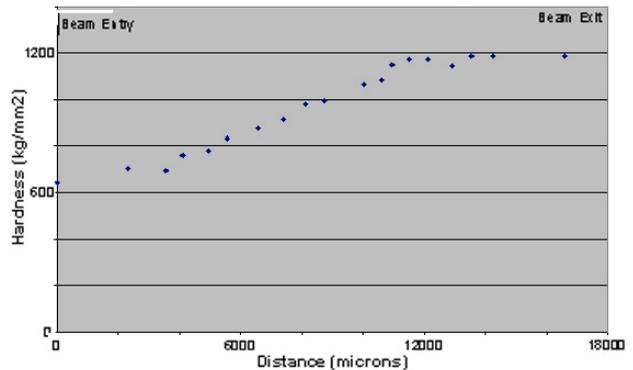
Very little change was observed in the hardness of the stainless steel and the silver matrix due to the effects of irradiation. A significant variation of hardness, however, was measured in the W-26Re where the electron beam irradiated the target. Hardness traces were performed making sure that each hardness indentation was a significant distance (at least five indent diameters) away from the previous indent to avoid interaction with the damage zone associated with the measurement. Figure 6 shows the variation of the hardness measured on Cut1 moving from the beam entry area toward the beam exit area near the center of the beam path. This figure shows that the hardness increases significantly (approximately twice its original unirradiated value) as one moves toward the beam exit face of the specimen (higher radiation dose). Evidence of fresh cracking was observed around an indentation made on the beam exit side of Cut1, indicating that the hardness increase is also accompanied with a decrease in ductility. The hardness also varied as one moved transversely away from the area where the beam went through the tungsten-rhenium. Figure 7 shows this variation measured on Cut1 and Cut3. The hardness was measured in the location where the beam interacted with the tungsten at the height of the center of tube A along a line toward the silver/W-26Re interface.

Figure 6: Hardness variation along Cut1

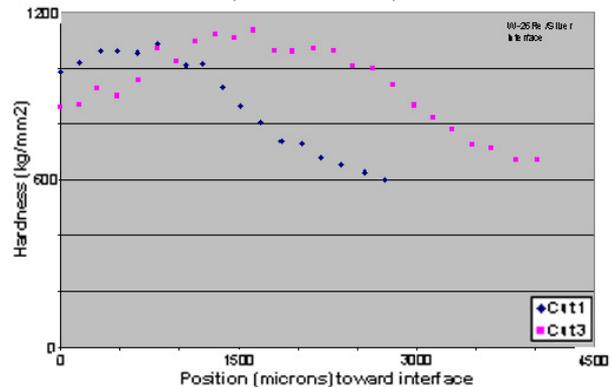
Figure 7: Hardness variation towards interface (Cut1 and Cut3)
