## PRACTICAL OPERATING PROBLEMS AT THE R.P.I. LINAC\*

R. Krasse, R. Fullwood and R. Browne  
Department of Nuclear Engineering and Science  
Rensselaer Polytechnic Institute  
Troy, New York

Practical operating problems of an electron accelerator facility will be presented with their solutions. Organization, maintenance, and training problems and procedures will be presented in general. Klystron failures, thyatron replacement, and voltage standing wave ratio as technical problems will be discussed and their solutions documented.

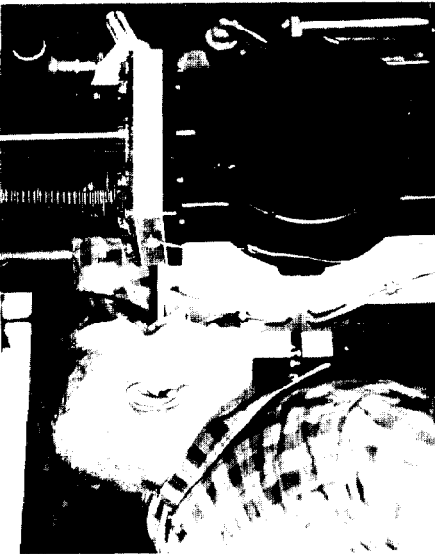
the time consuming effort of waveguide removal. In this scheme a light and mirror are put in one hole while an inspection is made visually through the other hole. Figure 3 shows the waveguide holes being utilized on a Monday morning. Periodic inspection of all klystron and coupler windows is accomplished as part of the weekly preventive maintenance schedule previously mentioned.

Fig. 3. Technician inspecting klystron window through observation port.

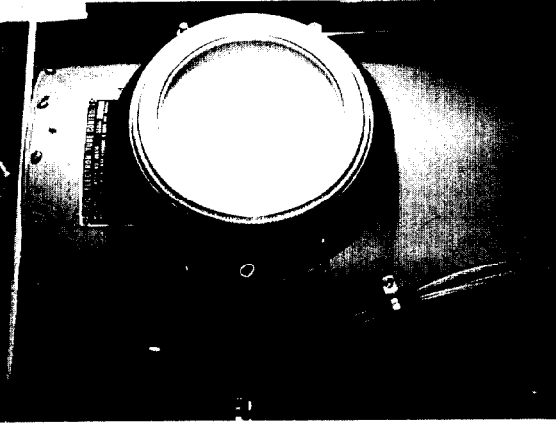
Fig. 5. Clean ceramic window of L-3944 klystron.

6. The final step to minimize this puncture problem was the ordering of new klystron tubes, the Litton L-3944 which is the ceramic window version of the original tubes used at R.P.I. This new design does not require forced cooling of the output window, since its average power capability is considerably higher than that of the glass window of the L-3250.

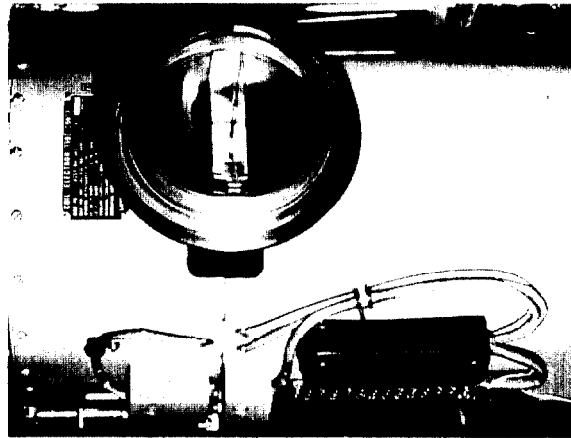
Fig. 4. Clean glass window of L-3250 klystron.

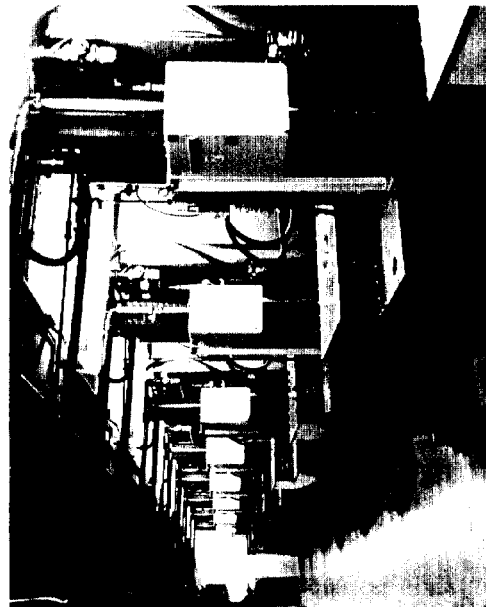
1. Replacement of all components in the freon system that could produce hydrocarbons. For example, the rubber hose carrying freon to the klystron windows and to the accelerator input coupler windows. This hose was replaced with polyethylene tubing. This can be observed in Figure 2 going into the lead shielding box and originating from the overhead copper tubing which carries the freon to the klystron windows.

Fig. 2. View of klystron and modulators showing polyethylene tubing for freon.

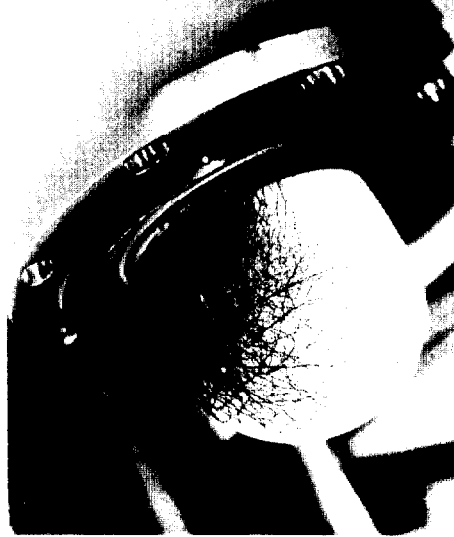
As one can see by Table II, since these procedures were initiated last spring, not a single klystron has failed due to window puncture. We anticipate that by the end of 1966 all our klystrons will be of the latest design and the freon blower system will be replaced by a pressurized dry air system. As a summary to this problem; your observation is directed to Figures 4, 5 and 6. Figure 4 is of a clean glass klystron window. A new ceramic window is pictured in Figure 5. To give an approximate idea to the reader, Figure 6 shows a ceramic window in the input coupler of the accelerator with severe carbon tracks. Unfortunately no pictures are available of a dirty or punctured klystron window.

Fig. 6. Dirty input coupler window with carbon tracks.

2. A complete cleaning of klystron windows, waveguides and coupler windows was undertaken. The windows were polished and washed with solvent while the waveguides and freon plumbing were steam-cleaned using a commercial unit. After the steam-cleaning the waveguides were swabbed out manually with solvent.

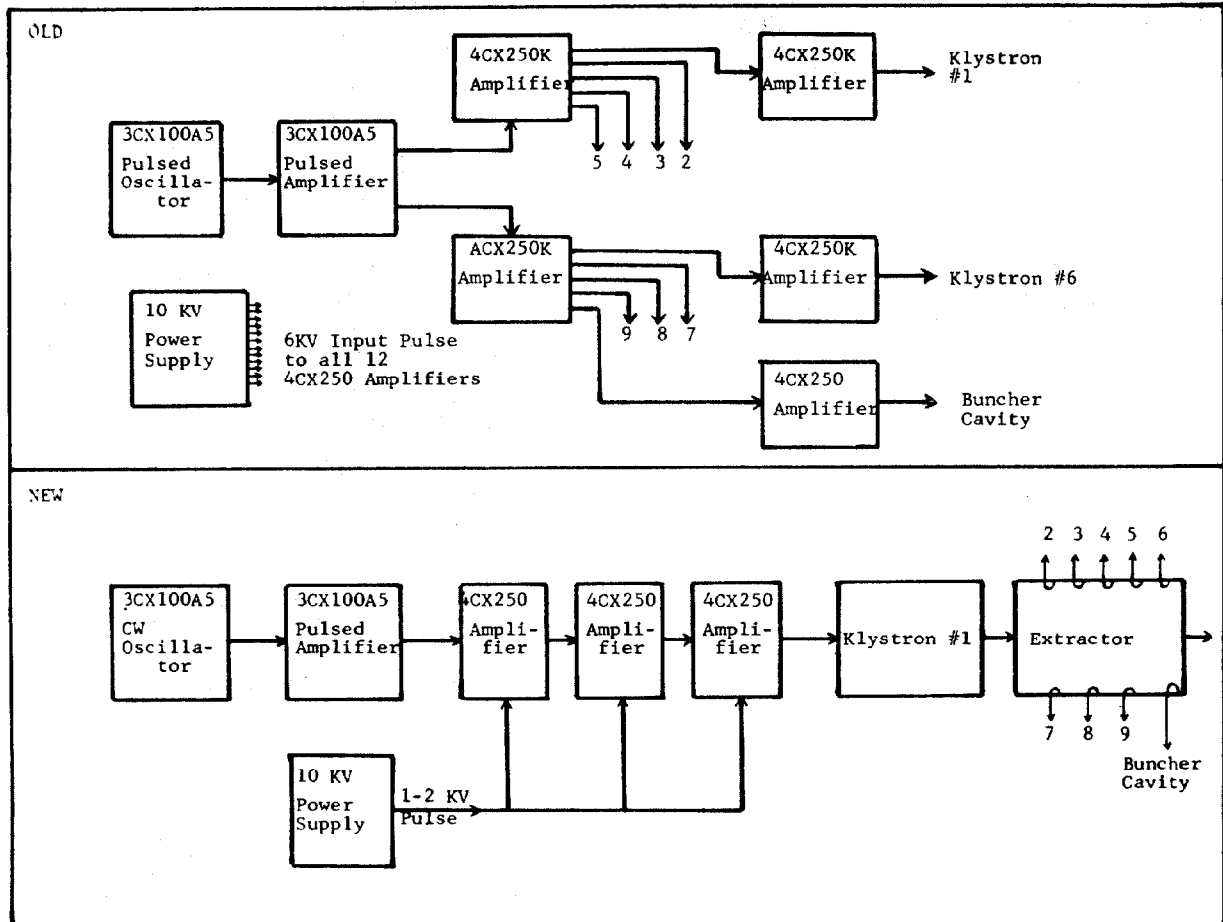
Many of our other operating problems are related to reliability. Reliability is a measure of time lost and can be appraised in monetary terms. One such problem was the RF drive system originally provided on the R.P.I. Linac. Downtime averaging one to two hours a day was not uncommon. A comparison of the old and new systems is shown in Figure 7. Due to the large amount of "fan out" inherent in the design, a relatively high individual amplifier gain was required to provide enough signal to overdrive each klystron. To obtain sufficient gain the plate voltage

of these tetrode amplifiers had to be raised to 6 kv. This is quite close to the maximum rating on the tube which is 7 kv. In addition, the failures of bypass capacitors in the cavities of these amplifiers caused severe on-line maintenance for plate voltages over 4 or 5 kv. By using an RF extractor system we were able to reduce this 6 kv plate pulse to 2 kv, thereby reducing failures and increasing our reliability factor. The extractor system is basically a piece of L band waveguide with loops rotated remotely by motors. The extractor system is placed at the output of klystron #1 and power is extracted by each loop which in turn supplies drive power to its corresponding klystron. A loop is also provided to supply RF power to the buncher. This scheme eliminated 9 driver chassis. The down time was reduced to an average of 2 hours per month which represents an increase in reliability by a factor of 15. One small problem encountered with this system was that the extractor loops could not deliver enough RF power to overdrive the klystrons. This condition was rectified by increasing the cross sectional area of the loops by a factor of 1.5. After this change, enough RF drive power was obtained to exceed the klystron saturation point.

Fig. 7. Comparison of old and new RF driver system for R.P.I. Linac.
