THE FAILURE OF THE ALTERNATORS OF THE NIMROD MAIN MAGNET POWER SUPPLY

H. G. Brooks  
Rutherford High Energy Laboratory, England

A. B. D. Reed  
English Electric Co., Ltd., England

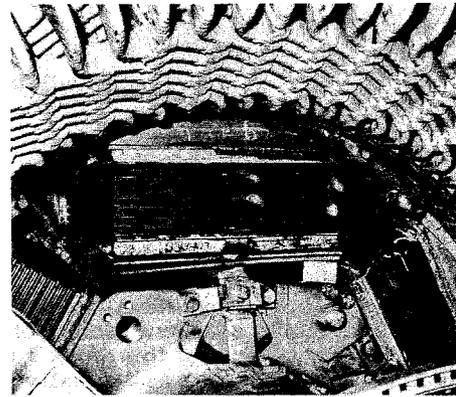
The fault was caused by the fatigue failure of a rotor pole endplate across the neck region (Figs 3 & 4). Both drive motor rotors had rubbed on their stator laminations. All pedestals and the endplates of No. 2 alternator were examined for cracking and found to be sound.

Fig. 3 Damaged pole and stator

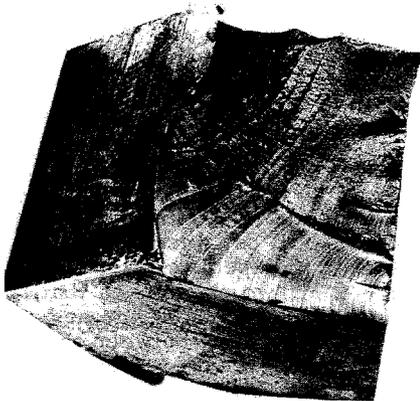
Some of the cracks in the endplates had propagated in the areas of fretting damage at the top corner of the key. The torsion of the shaft and the small changes of centrifugal loading could both produce the required oscillatory movement for fretting fatigue damage to occur. The necessary pressure is inherent in the arrangement. Further theoretical analysis of this aspect was difficult and experimental work was essential.

Fig. 4 Lower half of fractured dovetail

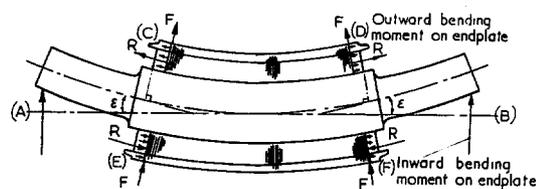
The effects of gravity on the pole stresses had been examined but the variable stress on the neck due to the self weight of the pole, was small. It however acts in a more subtle way. Due to the sag of the shaft there is a very small angle  $\epsilon$  (Fig. 5) between the catenary line at the endplate and the axis A B. This means that the effective pole length oscillates between C D and E F producing changes in lamination pressure and a resulting rotational frequency bending about the X X axis (Fig. 2). This stress variation is a feature of all horizontal machines of keyed laminated pole construction.

Fig. 5 Shaft stress catenary effect

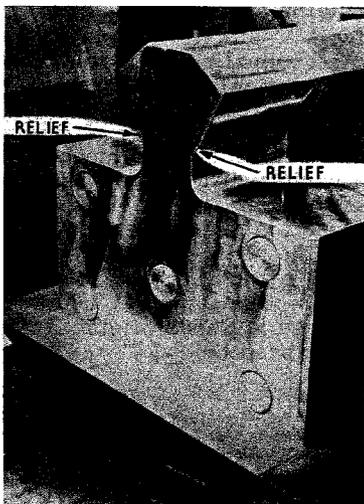
Fig. 6 Part of re-designed endplate pole assembly showing reliefs

- 4.2 The neck thickness was increased from 5 ins to 6 ins to reduce neck stresses.
- 4.3 The dovetail geometry was modified by introducing a relief (Fig. 6) so that both fretting and stress concentration problems were reduced. Additionally the key was extended axially past the pole.

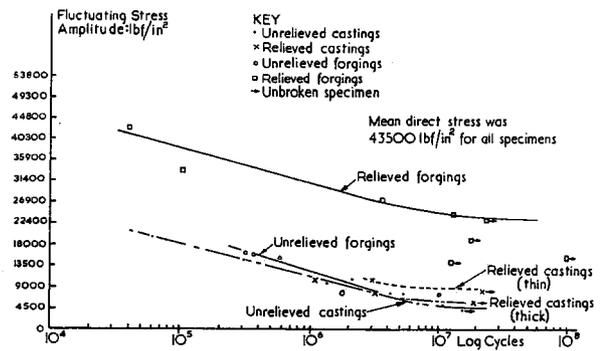
The first step was to attempt to reproduce the conditions of the failure. Tests were carried out at a mean nominal stress of 43,500 lbf/in<sup>2</sup>. The cyclic stress component was varied from 19,500 lbf/in<sup>2</sup> to 14,000 lbf/in<sup>2</sup> over 8 unrelieved cast endplate specimens and the results of these runs gave a stress-life curve and mode of failure (Fig. 7), which was acceptably consistent with the actual one.

Cast steel specimens with relief, and forged steel specimens with and without relief were prepared. A test programme along similar lines to the original was laid down for each and Fig. 7 shows the results obtained. It was found the fatigue limit was equivalent to 29,000 lbf/in<sup>2</sup> for the new endplates compared with about 14,500 lbf/in<sup>2</sup> for the original endplates, both at the same steady stress level.

Fig. 7 Fatigue curves obtained from test rig results
