In-Situ Non-Destructive Testing of Superconducting Dipoles in the Tevatron,

B. HANNA, H. JOSTLEIN, D. PLANT and S. PRUSS

*Fermi National Accelerator Laboratory

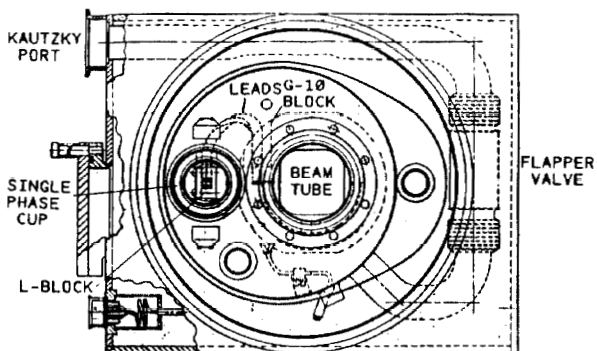
Fig 1. TeV Dipole end

There are two types of dipoles; TC and TB. The difference between the two is that the collared coil is rotated 180 degrees in a TC magnet. This results in a much longer length of cable in the end cans. It is because of this longer lead that the TC's were the first to fail when the leads were not tied. During the 1984 shutdown all TC upstream ends were repaired. It was realized that the TB magnets suffered from the

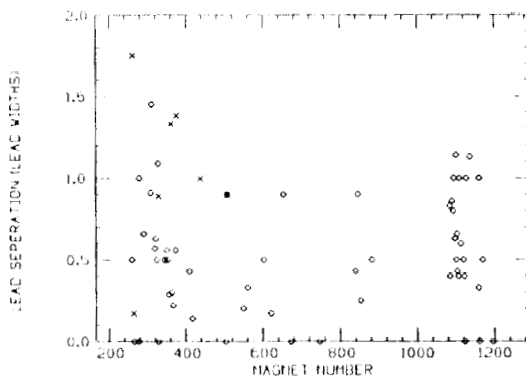
Fig 2. Lead separation vs magnet serial number

could not image the ties). Of equal interest, especially since we were not repairing the entire ring, is to try to determine if a magnet has broken strands. Neither method of inspection was capable of directly finding broken strands. An indirect method was to use the x-rays to determine how much the leads were separated. We would expect broken strands to occur in magnets that have : 1) large lead separation 2) been in the tunnel a long time and 3) G-10 block or the L-block with sharp edges (the broken strands were generally found to be at one of these places since they are the two points where untied leads would be constrained). A further constraint could be added by looking at the serial numbers of all the magnets which have failed, including the TC magnets that failed in 1984; all the failed magnets had serial numbers below 800 (magnet numbers in the tunnel ranged from 200 to roughly 1160). Figure 2 is a plot of lead separation vs serial number for the set of magnets which were repaired.

The x marks indicate magnets with broken strands. The lead separation is in units of measured lead widths (this was done to avoid taking magnification factors into account). From this plot if we make a cut above 75% lead separation and magnets below # 800 there are a total of 12 magnets of which 6 had broken strands. Notice that for magnets above 800 no broken strands were found (presumably because later magnets had the L-blocks and G-10 blocks tumbled to eliminate sharp edges).

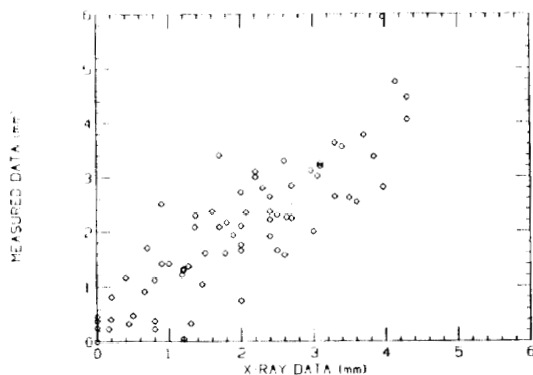
Fig 3. Measured vs Calculated clearance

For determining clearances, an equation was derived which took into account the magnification factor and any parallax due to the source not being directly over the gap. After choosing the best picture for a given end three measurements were made: 1) the visible clearance from the G-10 block to the end plate, 2) the G-10 block size (to determine the magnification factor; the block is one inch wide) and 3) the measured width of the end plate. From these three numbers the actual clearance was calculated. In addition bore scope data was sometimes obtained which gave us an additional source of information on the clearance (getting to the G-10 block wasn't always possible especially on the TC's). Although we couldn't measure a distance via the bore scope we could determine if it was greater than the working channel scale. Comparing the measured clearance with the bore scope data we find only three cases out of 50 where there was a discrepancy. Of these the x-ray data was in agreement with the measurement in two cases and in the third case both methods gave significant differences from the measured value.
