Improved High Voltage Coax for Antiproton Source Kicker Pulse Forming Networks and Pulse Transmission

J. Petter
Fermi National Accelerator Laboratory*

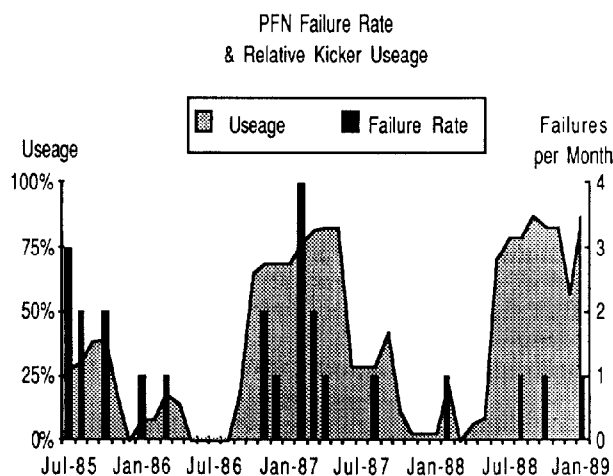
FIGURE 2

PFN's were the generic cable. The first 9 PFN failures were replaced with this same cable. Of the last 14 PFN failures 2 were replaced with the special cable and 12 were replaced with the mil. spec. cable. Of these later replacements 1 of each type failed. The other 21 failures were the generic cable. Figure 2 shows the PFN failure rates and a best guess of PFN usage.

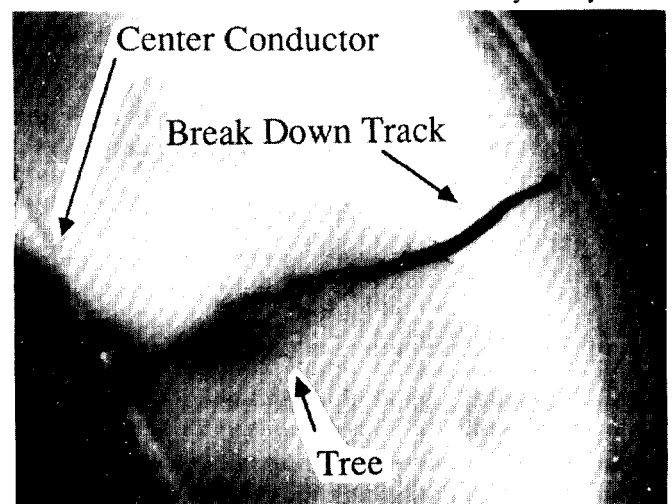
Figure 3

If there are trees in a piece of cable, they must be the weak points. 100 kV d-c was applied to 12 ft. pieces of cable, hoping they would break down at a tree. Nothing happened. It was realized that trees could be located using the 60 Hz life tests. A circuit was design to turn off the high voltage within one a-c cycle when a failure occurred. It was hoped that if there was a tree at the point of breakdown one arc would not be enough to destroy it. The result was 5 breakdowns and 4 trees. When the cables failed the burnt material stained the trees very nicely.

The failure mechanism in our case was treeing brought about by and enhanced by poor quality cable and in the case of our transmission cables poor handling during installation. From the investigation into these failures the things we learned were not at all surprising.

Based on the knowledge gained in this cable failure study a cable specification was written. Cable was ordered to replace all PFN's and transmission cables. The resulting specification [11] was the same as MIL-C-17/81C except for the items listed on the next page:
