352-MHZ KLYSTRON PERFORMANCE AT THE ADVANCED PHOTON SOURCE*

D. Horan[#], G. Pile, A. Cours

Argonne National Laboratory, 9700 South Cass Avenue, Argonne, IL 60439 U.S.A.

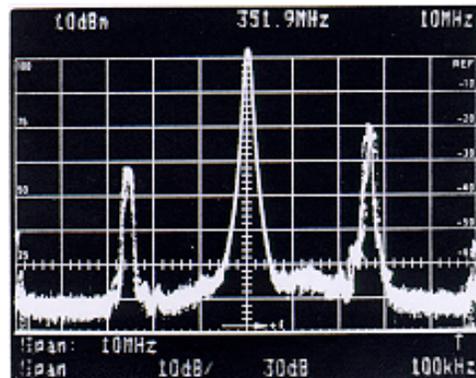
Figure 2: Klystron sidebands

Klystron #030 is the only APS klystron that has been proven to generate sidebands (see Fig. 2), which began to

appear at approximately 5,000 hours of operation. Two cavity tunings were performed to eliminate the problem, but ultimately it was determined that the klystron must operate at a minimum cathode voltage of 92 kV to be free of sidebands. This klystron had other operational problems (see the next section) that may be related to the tendency to produce sidebands.

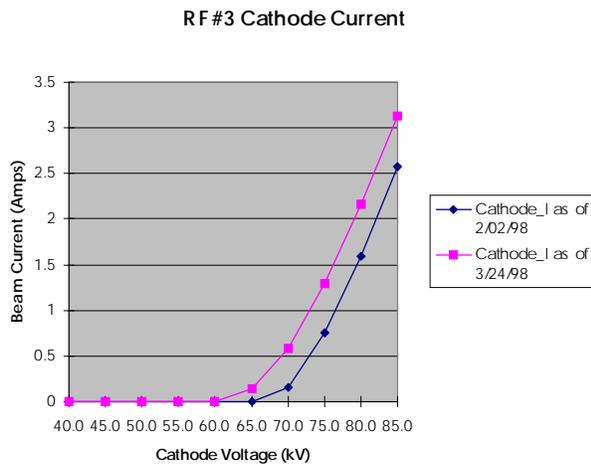
Figure 3: Effect of gun leakage

At approximately 4500 hours of operation, klystron #030 developed a substantial DC leakage condition between the mod-anode and tube body. High reverse mod-anode currents (5 mA at $V_{\text{mod-anode}} = 40\text{kV}$, electron current flowing into klystron) were the first indication of the problem. The leakage path allowed klystron beam current to flow without any mod-anode bias applied to the tube (see Fig. 3). Subsequent gun leakage current tests indicate that this leakage condition has a very nonlinear voltage-current relationship, suggesting a field-emission discharge point somewhere in the gun. However, the klystron vacuum does not degrade when this leakage becomes measurable. This klystron is in storage until it can be HV-conditioned in an attempt to characterize and eliminate the leakage path.
