EUROPEAN XFEL INPUT COUPLER EXPERIENCES AND CHALLENGES IN A TEST FIELD

F. Hoffmann, D. Kostin, W.-D. Moeller, D. Reschke, M. Wienczek, DESY, Hamburg, Germany

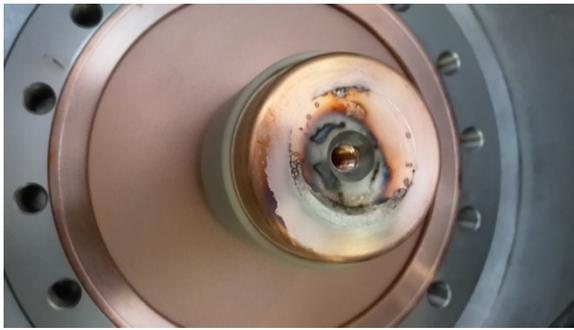
During the module tests in AMTF 13 warm parts (WP) were replaced because of contact problems of inner conductor of warm part to antenna of cold part. The reason of that was, that the screw of inner conductor was loose or not tightened with the right torque. The problem was, that we could recognize it only after switching on high RF power and with a low power everything seemed to be ok. The next problem was, that for repair we had to disconnect all connections (also cryogenics and vacuum) and put the damaged module to extra repair places not to handicap the tests of other modules and to have the required time for repair. All the power couplers with the defect connection of inner conductor showed nearly the same behavior and damage picture.

Figure 4: Burnt contact of the cold antenna.

Because of RF discharge damaged warm part inner conductors (Figure 5) we had to exchange the warm parts, but the cold parts with damaged interface (Figure 4) could not be exchanged without full module disassembly. (Change of cold part means putting the cavity string into cleanroom again, and before that full module dismounting). The disassembly of warm parts was done in a mobile cleanroom to keep it as clean as possible. We covered the cold part surfaces (Figure 6) as good as possible, closed the threaded hole with special screw (to seal it against dust) and grinded the surface with a very fine sandpaper. All work had to be done with a cleanroom overalls, gloves etc. After grinding we cleaned the surface with citric acid, isopropanol and dry ionized nitrogen flow. After that we did the assembly with a new conditioned warm part. In all of these cases a new conditioning was necessary and was done in most of the cases in one of the three test stands in AMTF.

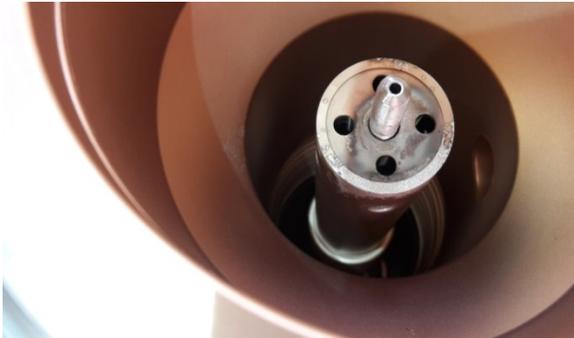
Figure 5: Burnt inner conductor of the warm part.

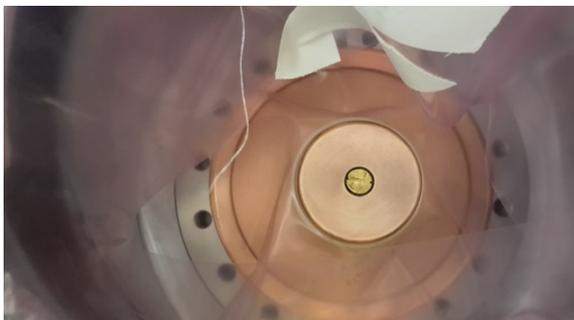
Figure 6: Cold antenna after grinding and cleaning.

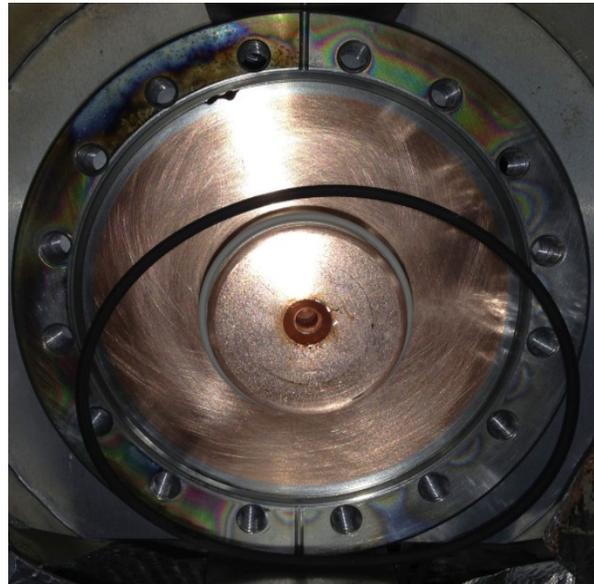
connection from warm to cold part. After disassembly of warm part we found a damaged CF100 flange knife edge of cold window (Figures 8, 9) and a forgotten rubber seal (Figure 7), which was on top of the normal copper gasket, and in combination of all parts it was leak tight before test and so we were not able to find this problem before switching the RF power on. The only chance to avoid disassembly of the whole module was to try to repair. We did several tests with some special gaskets, with some soft gaskets and at the end with a special gasket, which sealed at the shoulder of the CF100 flange knife and that was successful at the end.

Figure 7: Forgotten O-ring on top of copper gasket.

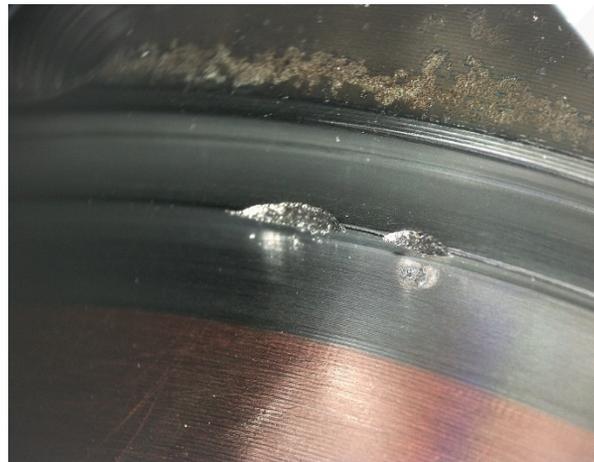
Figure 8: Damaged CF100 flange knife edge.

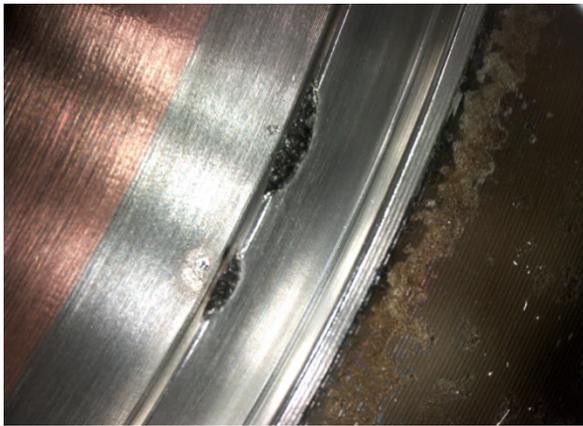
Figure 9: Burnt CF100 flange knife edge.

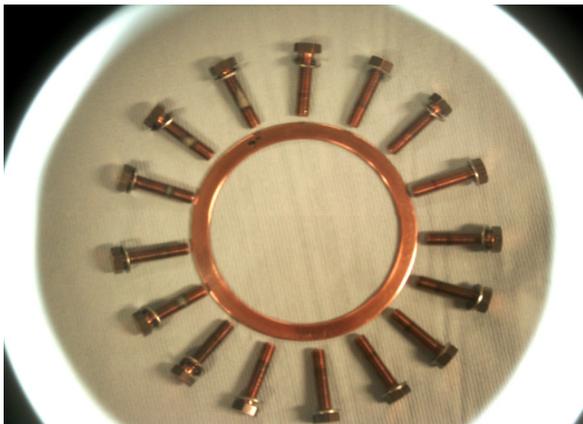
Figure 10: RF discharge stained CF100 flange screws.

In Figure 10 one could see the RF discharge stained CF100 flange screws, used for the connection of cold and warm parts. Also visible damage on the copper gasket and leftover of the rubber seal.

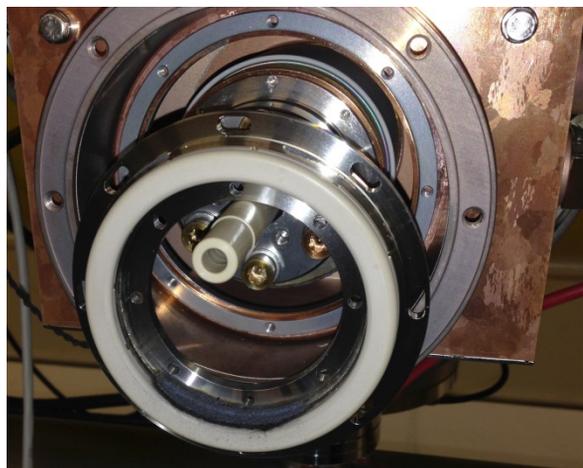
A problem of a different type, caused by not properly tightened HV-bias capacitor screws and thus created RF discharge, did also need some repair action (Figure 11).

Figure 11: Burnt HV-bias capacitor.

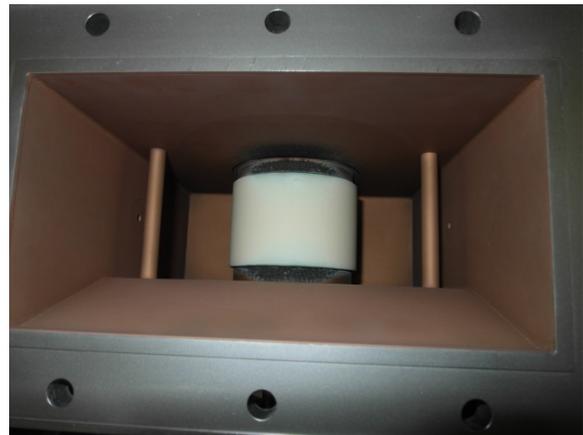
high spark (light) detector signal a special test with a disabled interlock action on that signal was done. Discharge traces were found after the disassembly on and near the coupler warm window and in the waveguide box (Figures 12, 13). Both parts had to be replaced.

Figure 12: Waveguide-box view on warm window.

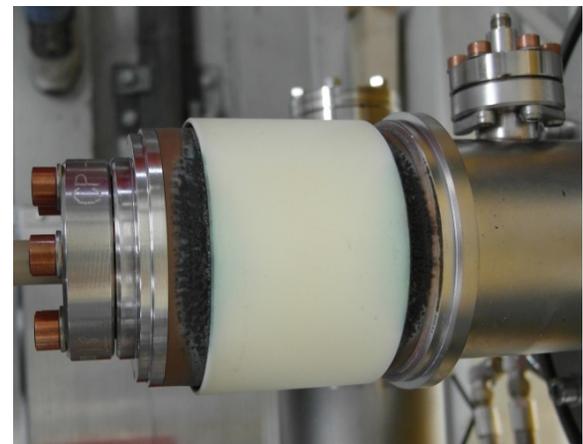
Figure 13: Burnt warm coupler window.
