## SRF Accelerating Modules Repair at DESY.

D. Kostin\*, J. Eschke, B.v.d. Horst, K. Jensch, N. Krupka, L. Lilje, A. Muhs, D. Reschke, S. Saegbarth, J. Schaffran, M. Schalwat, P. Schilling, M. Schmoekel, S. Sievers, N. Steinhilber-Kuehl, E. Vogel, H. Weise, M. Wiencek, DESY, Hamburg, Germany.

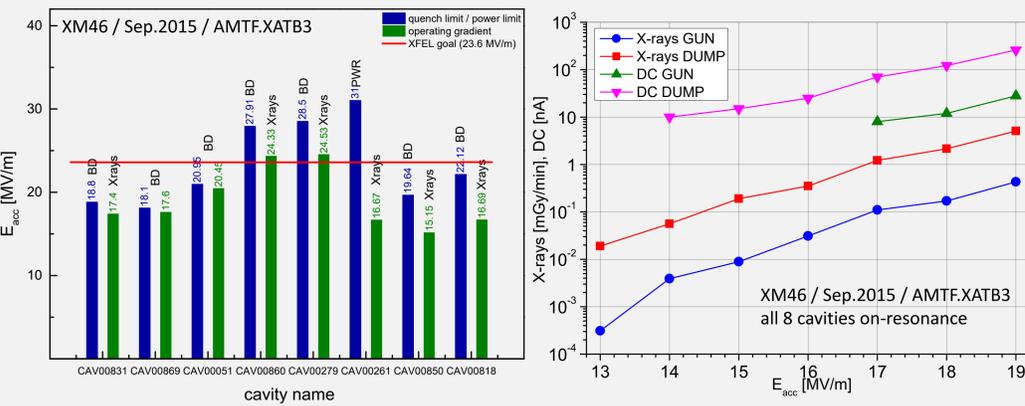
### XM46.1 testing history

- Module XM46 was delivered to DESY in Sep. 2015 after the assembly at CEA (Saclay).
- Module XM46 1<sup>st</sup> test in Oct. 2015 showed a degradation of the cavity performance with a very high Field Emission.
- Decision was taken not to install/use the module in the Eu-XFEL and re-assemble it after cavities' re-treatment.
- After disassembly XM46 cavities underwent HPR at DESY and after Vertical Test (VT) were accepted for XM46.1 assembly.
- XM46 was re-assembled at DESY to XM46.1 and successfully tested in Sep. 2020.
- The module was tested on two test-stands at DESY: AMTF and CMTB: successful module repair is confirmed on both. Currently a CW module test on CMTB is ongoing.

- Module XM46.1 showed good performance: the repair was immediately successful. Also transport from AMTF and installation on CMTB did not change this. Module was stored and transported with cavities string under vacuum.

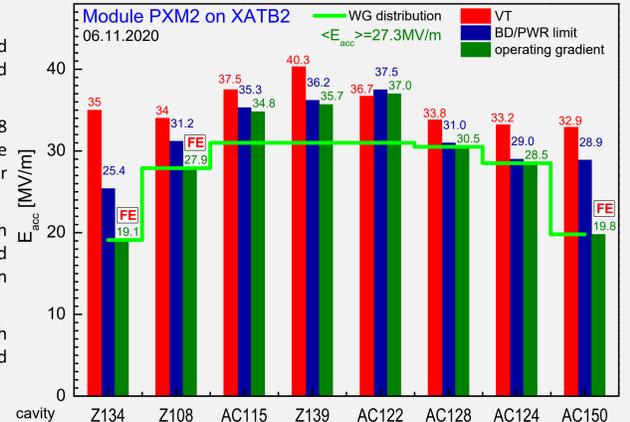
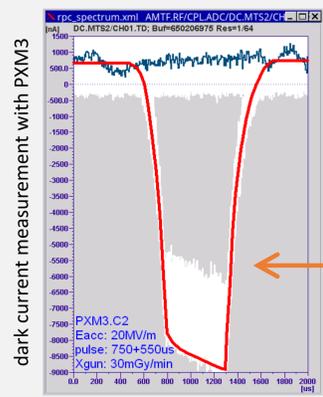
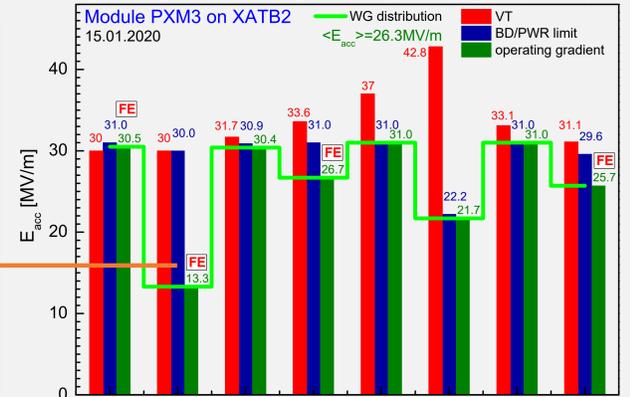
### FLASH / PXM2 and PXM3 Modules

- Modules PXM2 and PXM3 are planned for the FLASH linac upgrade in 2022 and will replace two older modules there.
- PXM2 suffered from C1, C2 and C8 degradation with increased FE. Module PXM2 was stored and transported under dry N<sub>2</sub> gas pressure, not under vacuum.
- PXM3 C1/C2 coupler antennae did touch the cavity through an incident, C6 cold coupler part was exchanged in the clean room. PXM3 cavities 2 and 6 degraded.
- It was decided to re-assemble both modules after re-treatment (HPR) and partial exchange of their cavities.

- Modules PXM2 and PXM3 planned for FLASH linac upgrade in 2022 both got degraded cavities after assembly. Modules storage and transport under dry N<sub>2</sub> pressure, compared to that under vacuum conditions, might explain problems faced later, as contaminating particles may move in gas from string ends. For the first two cavities of PXM3 the fundamental power coupler antennae did touch the cavity surface through the accident during coupler cold parts bellows adjustment, also coupler 6 cold part was exchanged in the clean room. Module PXM2.1 is being currently assembled.

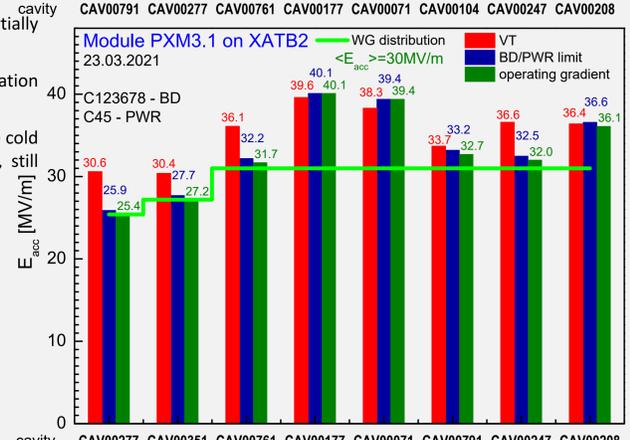
- PXM3 cavities were re-treated and partially exchanged and installed in PXM3.1.
- Cavities test was successful: no degradation between VT and module test.
- Coupler 6 (CAV00791) suffered from the cold part problem: it degraded during test, still under investigation.
- PXM3.1 re-assembly will follow.

- Module PXM3.1 cavities re-treatment and re-assembly was successful: cavities did not degrade anymore. But the new cold part of FPC, cavity 6, showed a degraded performance in the module test in AMTF with strong RF discharge. Faulty FPC cold part must be exchanged, new module test will follow.

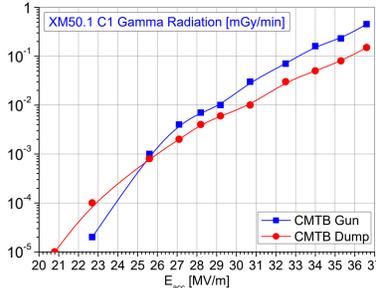
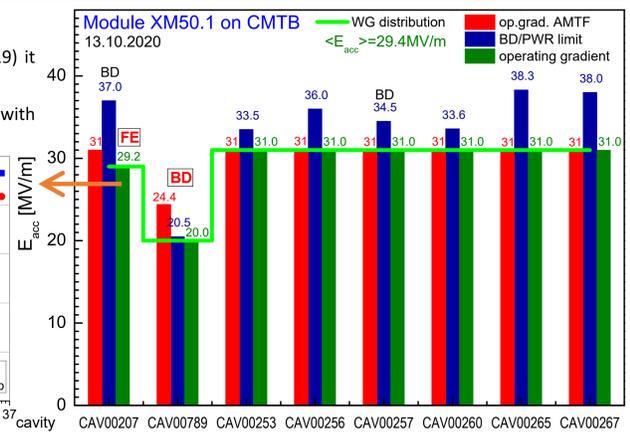
### Module XM50.1 case

- After test in AMTF (reported at SRF2019) it was installed and tested on CMTB.
- C1/C2 suffered some degradation: C1 with high FE and C2 with earlier breakdown.

- Module XM50.1 successful repair was reported at SRF2019. After transport and installation on CMTB for CW test first two cavities did suffer from some degradation. The cause is not exactly defined. But the module performance is still in specs.
