# RADIATION DOSE MEASUREMENTS AND A STUDY OF DAMAGE TO ACCELERATOR COMPONENTS IN THE TRISTAN e<sup>+</sup>e<sup>-</sup> COLLIDER AT 27.5 GeV

T. Momose, H.Hirayama, T.Ieiri, K.Takayama, Y.Ohsawa, K.Endo, H.Ishimaru, Y.Mizumachi, S.Takeda, T.Kawamoto and K.Uchino National Laboratory for High Energy Physics, 1-1 Oho, Tsukuba-shi, Ibaraki-ken, 305, Japan

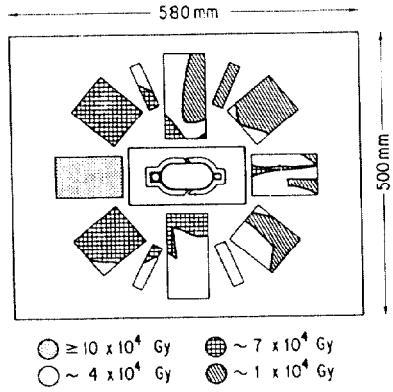
The vacuum chamber in the arc sections is covered with lead shields, but there are many gaps in the shields which allow radiation to escape. A typical example of such radiation leakage is shown in Fig. 5, which was obtained from the exposure of radiation sensitive color sheets ("Radcolor") to 1.5 Ah of beam. In other places, such as the wiggler section and the experimental straight sections, the vacuum chamber is not shielded. Magnet coils have been exposed to up to  $1.5 \times 10^7$  Gy and suffered serious damage, while other areas receiving  $10^5$  to 7 x  $10^6$  Gy escaped damage. Higher radiation levels are anticipated as both the beam intensity and the machine energy will increase. Unless the radiation attenuation around the machine is improved by two orders of magnitude many components will reach their radiation tolerance limit since the radiation dose appears to increase about tenfold each year.

Figure 5 Typical example of radiation leakage between a sextupole and a bending magnet.

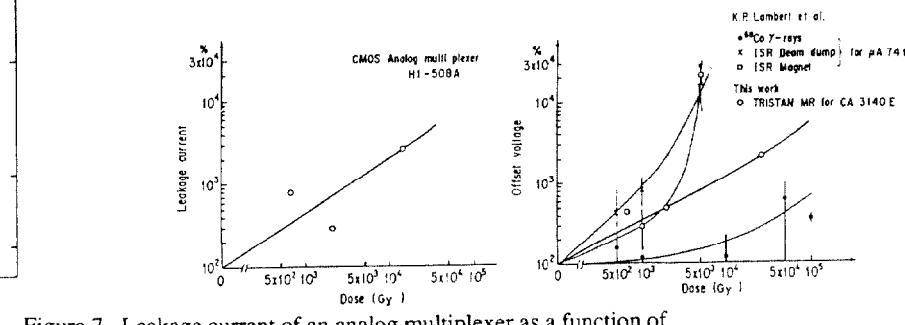
Figure 7 Leakage current of an analog multiplexer as a function of dose.

Figure 6 The shunt resistance of an Rf attenuator in an arc section as a function of operating time.

Table II shows analyses of corroded BPM components, where the cables and connectors were insulated with Teflon. Teflon in the cables shrinks under irradiation. Fluorine from the Teflon is also seen to corrode metal parts of cables and connectors. Similar damage is observed on the pins and sockets of DIP's. We are now changing these components over to polystyrene and polyethylene. Connectors with ceramic insulation are also being developed. Rf attenuators used between the BPM's and their cables are also attacked by fluorine gas. The shunt resistance of these attenuators is shown in Fig. 6 as a function of operating time.

- Reading and writing functions of 64 kbit -RAM and EPROM chips were lost at only 700 Gy.
- The temperature of a transistor (2SA504-GR, Pc=800mW) rose at 3 x 10<sup>4</sup> Gy, but it continued to function normally.
- A TTL inverter (74ALS04A) functioned normally, except that VOH became +5V at 700 Gy.
- The leakage current of an integrated CMOS analog multiplexer (HI-508A), with the gate off, rose at 700 Gy.
- 5) The offset voltage of an operational amplifier (CA3140E) increased at 700 Gy and the amplifier failed at 3 x 10<sup>4</sup> Gy.
