# **Retreatment of European XFEL Series Cavities at DESY as Part of the Repair of European XFEL Accelerating Modules.**

## Abstract

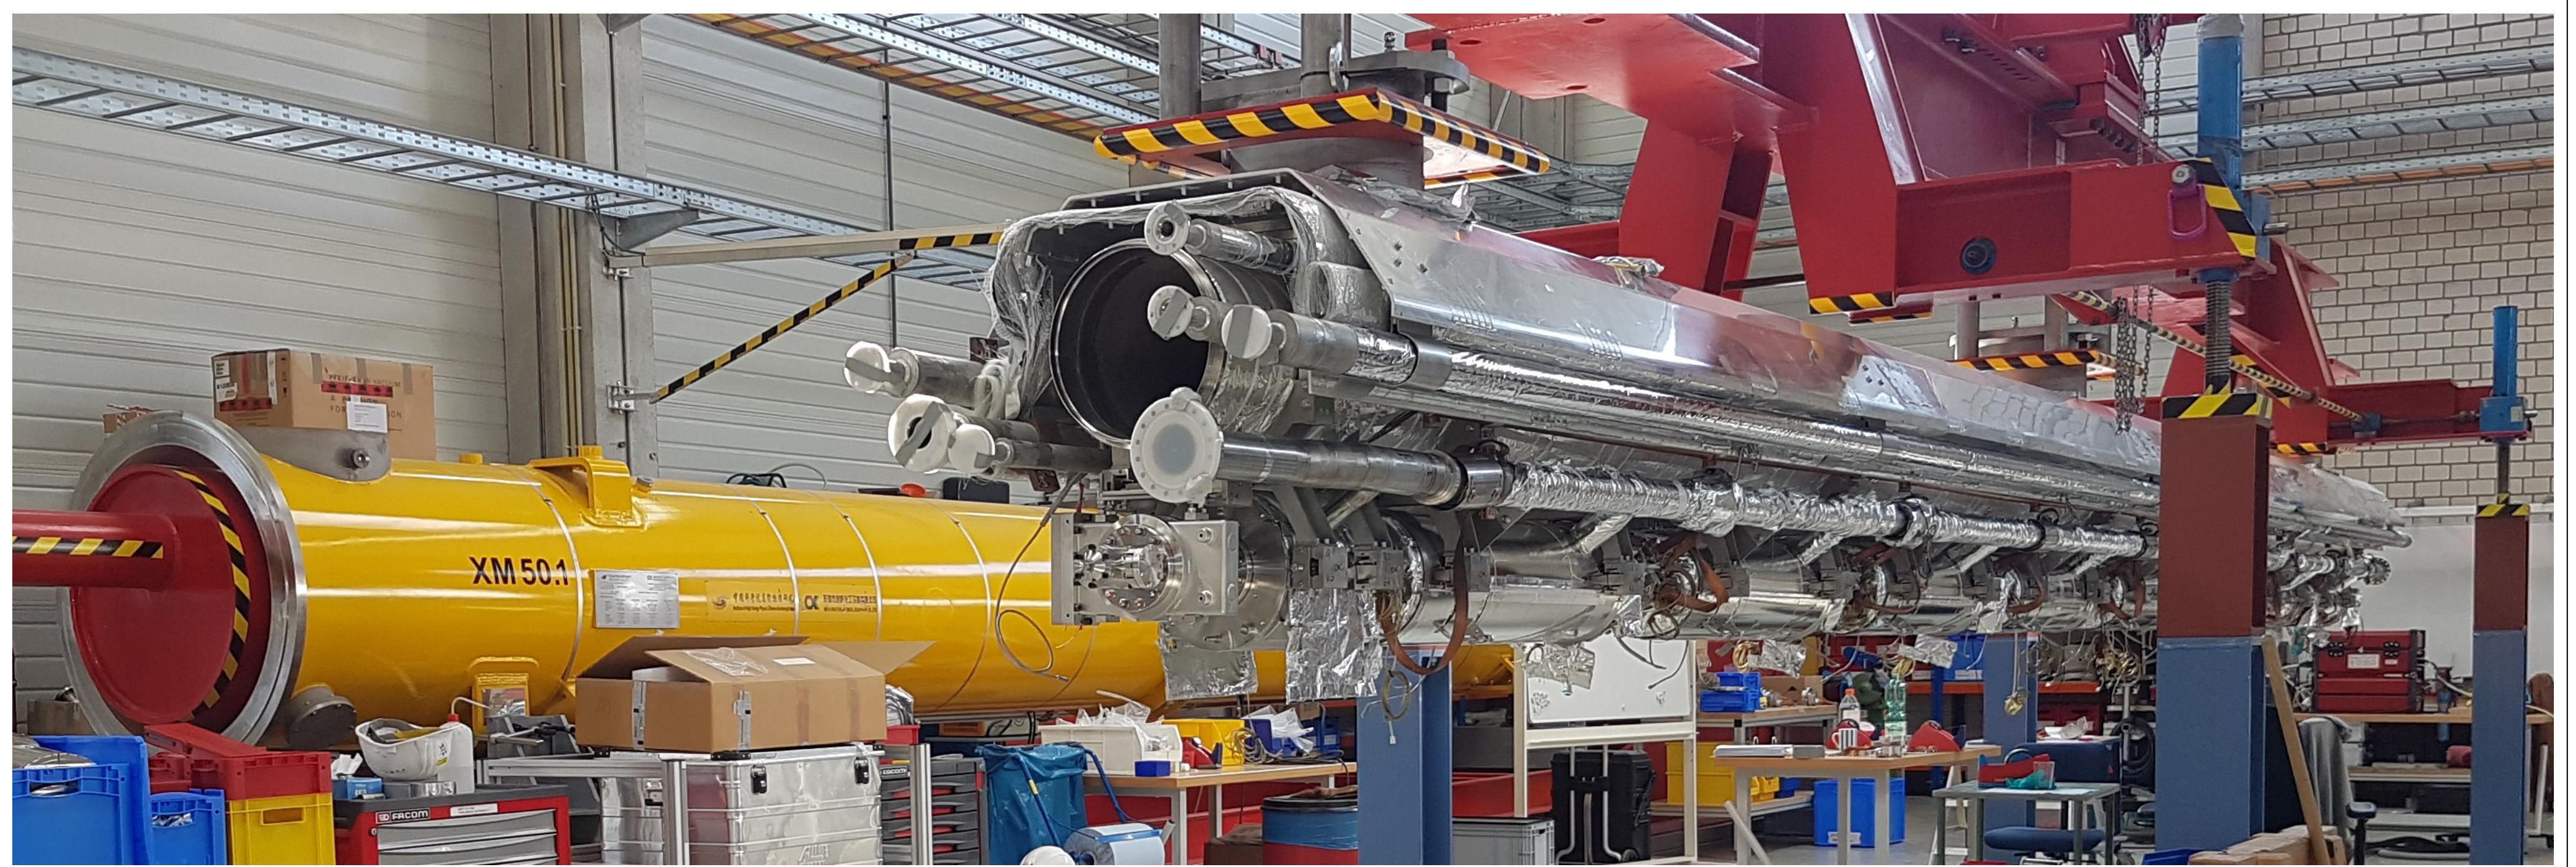
Reassembly of accelerating module XM50.1 (former XM50) in the Accelerator Module Test Facility AMTF

- Leak in 2K area could not be verified
- Module was reassembled
- Disassembly of the cavity string 7 of 8 cavities recovered was not necessary
- XM50
- Beam vacuum leak
- String disassambled and cavities retreated
- 8 of 8 cavities recovered
- Reassambly in progress

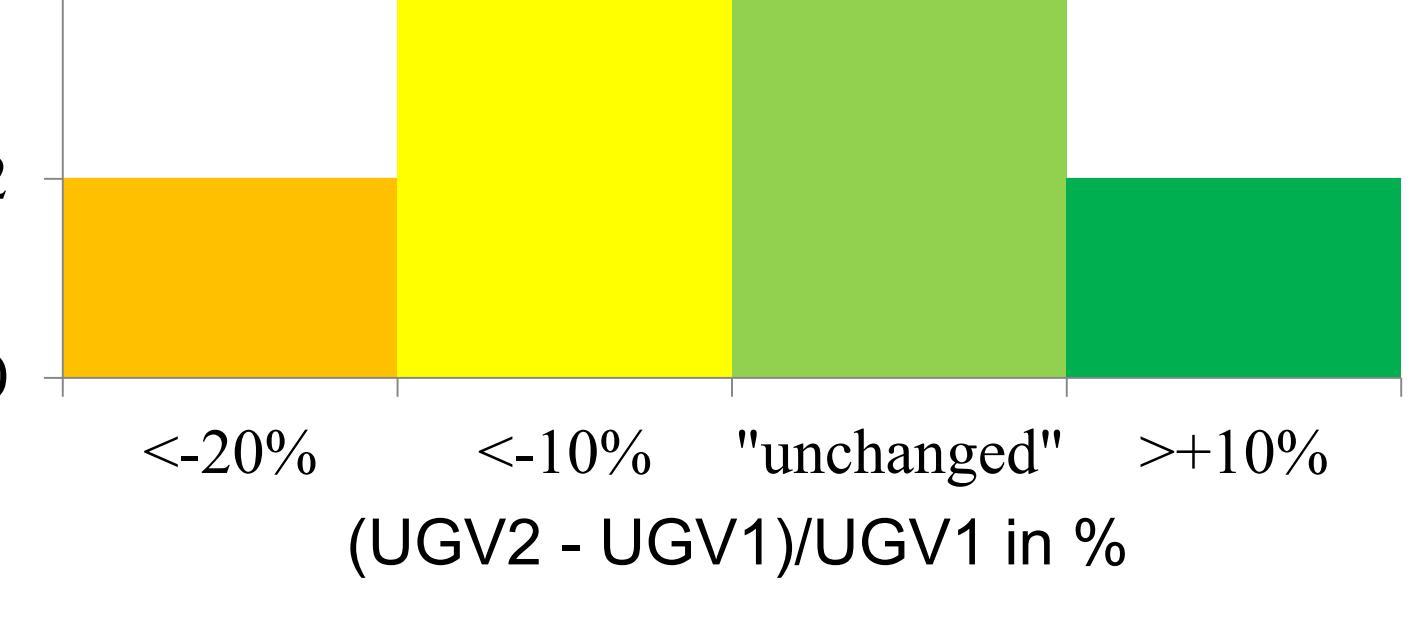
performance. The difference between of the usable gradient in vertical test before accelerating module assembly **9** 2 and after the retreatment in the framework of the accelerating module repair efforts is compiled in the figure beside. Due to the typical uncertainties of cold rf measurements, a variation of  $\pm 10$  % of the previous performance is marked as "unchanged".

Difference in usable gradient in vertical tests before accelerating module assembly and after retreatment.

All 16 cavities from the disassembled accelerating modules XM46 and XM50 were retreated by HPR according to retreatment pass RP1. Two of the cavities, CAV00831 and CAV00869, did not recover and were treated additionally by BCP flash chemical treatment, according to retreatment pass RP2. The usable gradients in MV/m of the cavities in the vertical test before accelerating module assembly (UGV1), in the module test (UGM) and after the retreatment (UGV2) together with the retreatment procedure are given in the tables below. The constraint which limits the usable gradient of the cavities is given in brackets. UGV2 for the cavities CAV00831 and CAV00869 were measured after the BCP treatment.
