# Charge Lifetime, Emittance, and Surface Analysis Studies of $K_2CsSb$ Photocathode in a JLab DC High Voltage Gun

ERL 11, KEK, Tsukuba, Japan

# Story starts with PAC11 results

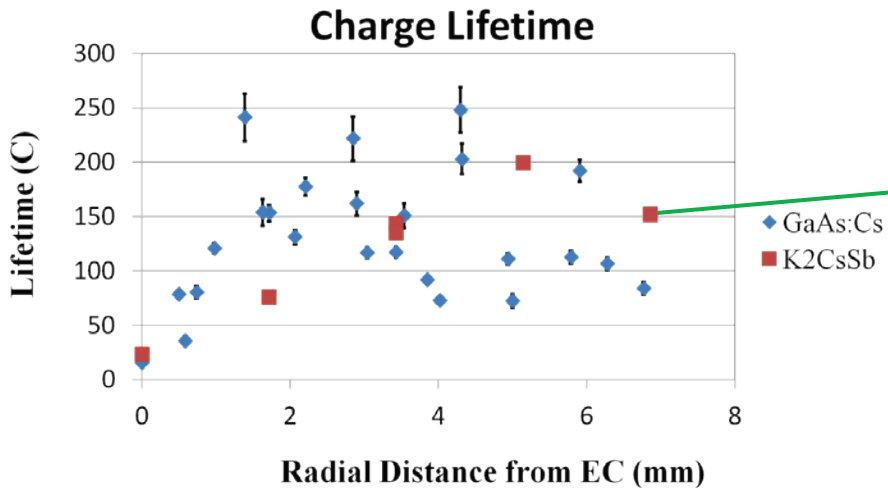
- Lifetime data taken at 100kV, 1mA, 532nm
- Similar performance to GaAs, not exactly what was hoped for...
- However, exact stoichiometry of cathode unknown, as K dispenser depleted during deposition.

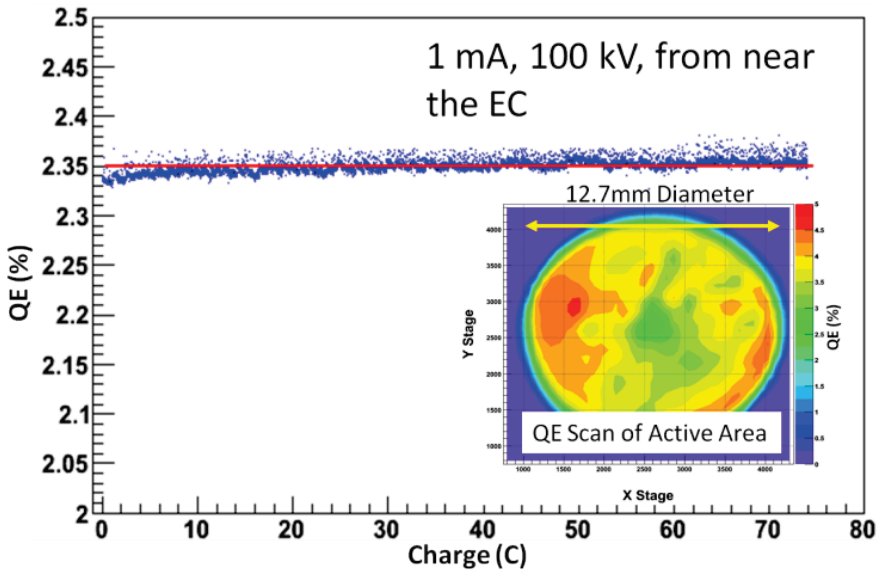
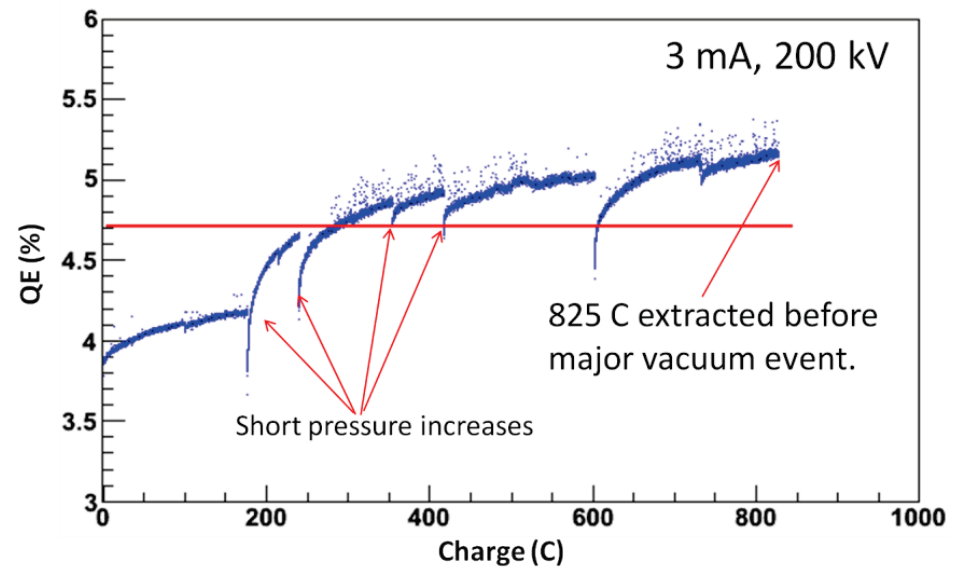
- No QE decay was observed for all 1 mA runs at up to 100 C extracted at 100 and 200 kV bias voltages and every spot tested on the cathode, even from the EC.
- QE actually increases during the 3 mA run despite several short pressure increases (vacuum events) in the beamline and gun chamber that temporarily reduced the QE.
  - Short pressure/vacuum events are due to full active area and poor spatial quality of blue laser beam (halo).

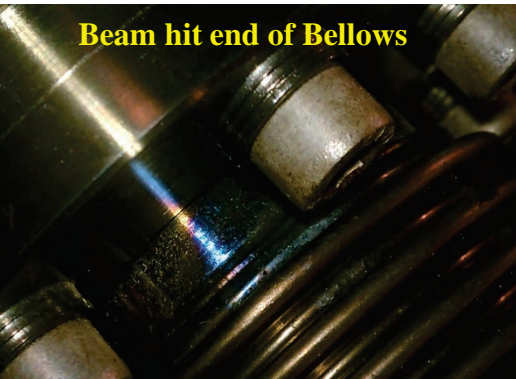
QE scan after event with 440 nm (850

A power glitch caused some beam steering magnets to reset causing the electron beam to scrape a portion of the beam pipe. The high voltage and laser were not affected which resulted in 3 mA beam being extracted from the cathode in  $5 \times 10^{-10}$  Torr environment for ~2 hours

Went back to running at 5 mA at a new spot, and the QE just kept going up.....

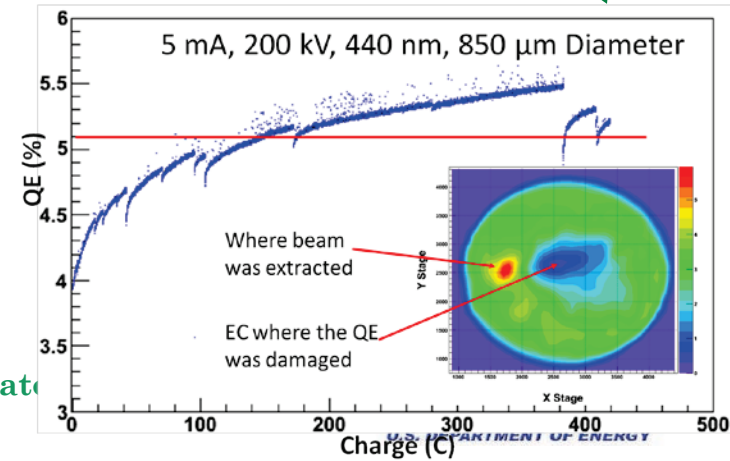
Vacuum rise from beam into bellows around 100x increase in vacuum level

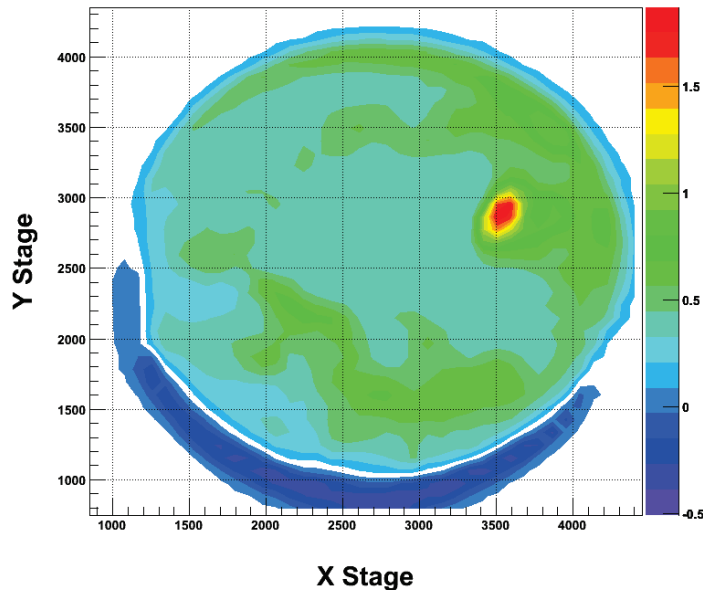
**QE difference after heating  
3500/2800 for 12 hours with 440 nm  
and 211 mW**

- The QE increases without making beam – just illumination with light. Is the stoichiometry of the photocathode improving locally?
- Running the beam into the bellows seems to have improved the cathode , outside of the EC.
  - Unclear if due to sputtering away low K surface layer
  - Or due to surface interactions with gases in the ‘high’ vacuum run

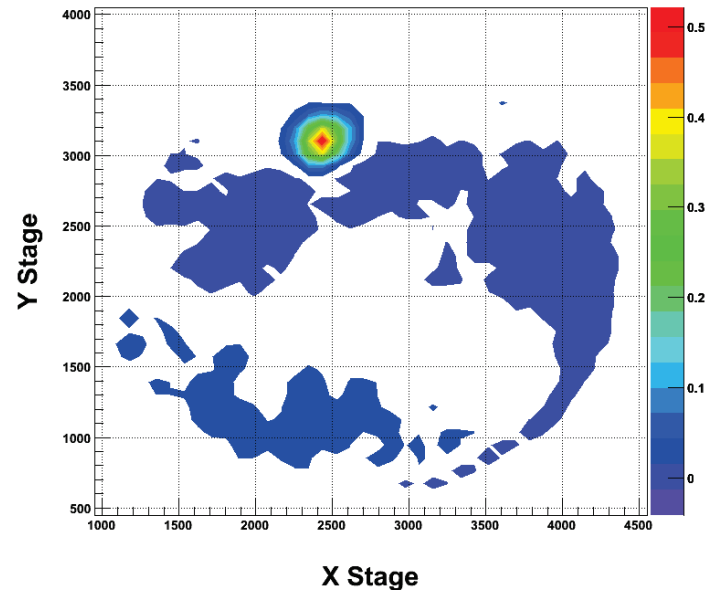
**QE difference after heating  
2450/3100 for 2 hours with 532 nm  
and 672 mW**

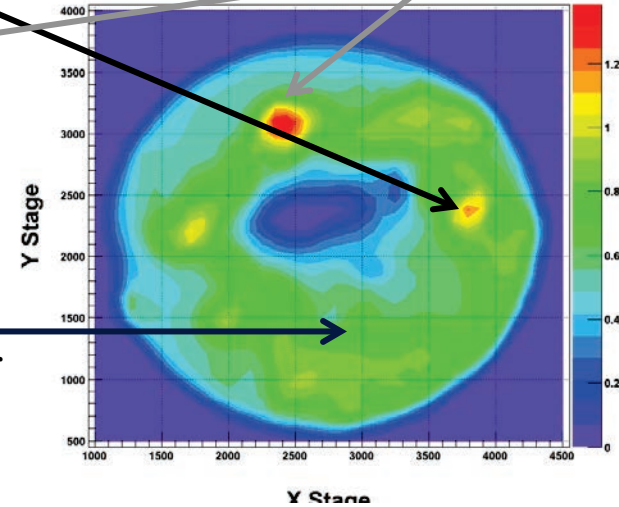
Location of no beam, ever  
Before 0.5%  
After 0.8%

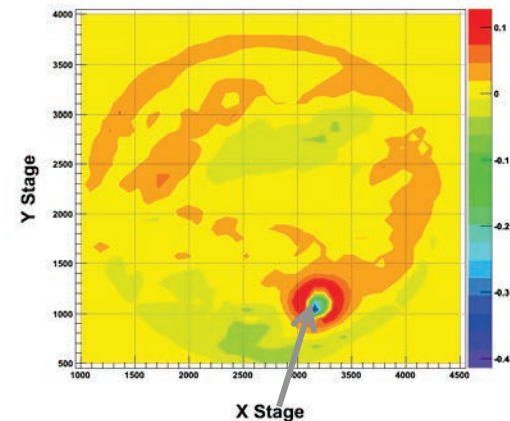
QE Change before and after the run.

Center of run location lost QE, surroundings gained.

Earlier, we saw laser heating seemed to help, but now it seems it only helps up to certain laser levels.

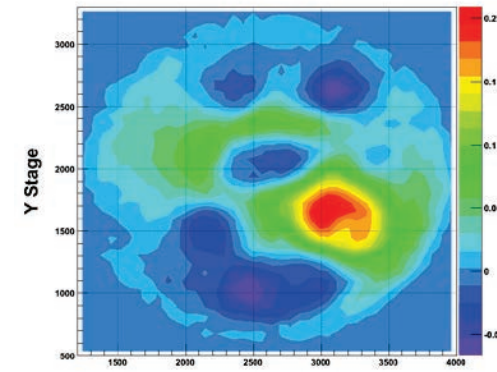
After heating 3200x/1500y  
with ~4 W for 1.5 hr.

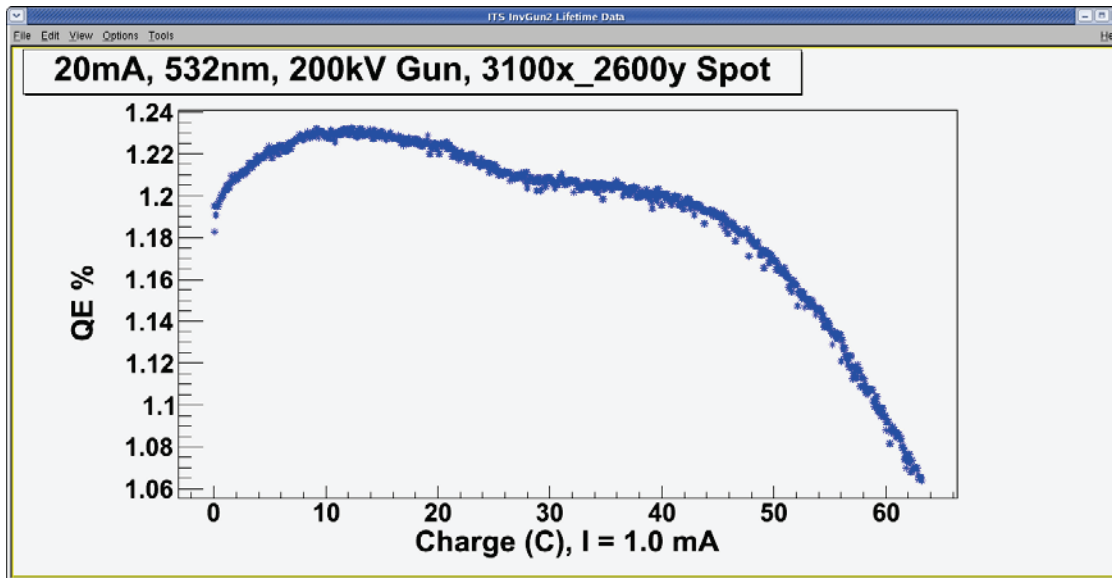
Needed laser power near 4.5W to get beam current up to 20 mA.  
Beam shape was very large and the radiation/vacuum along the beam pipe was larger than expected.

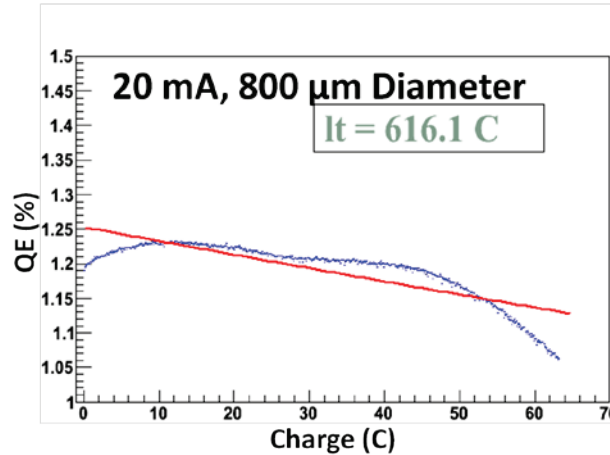
At 100 kV, the spot size increased roughly by a factor of 5, yet the lifetime went up by a factor of 20 or more, indicating that the decreased laser power density on the cathode increased lifetime.

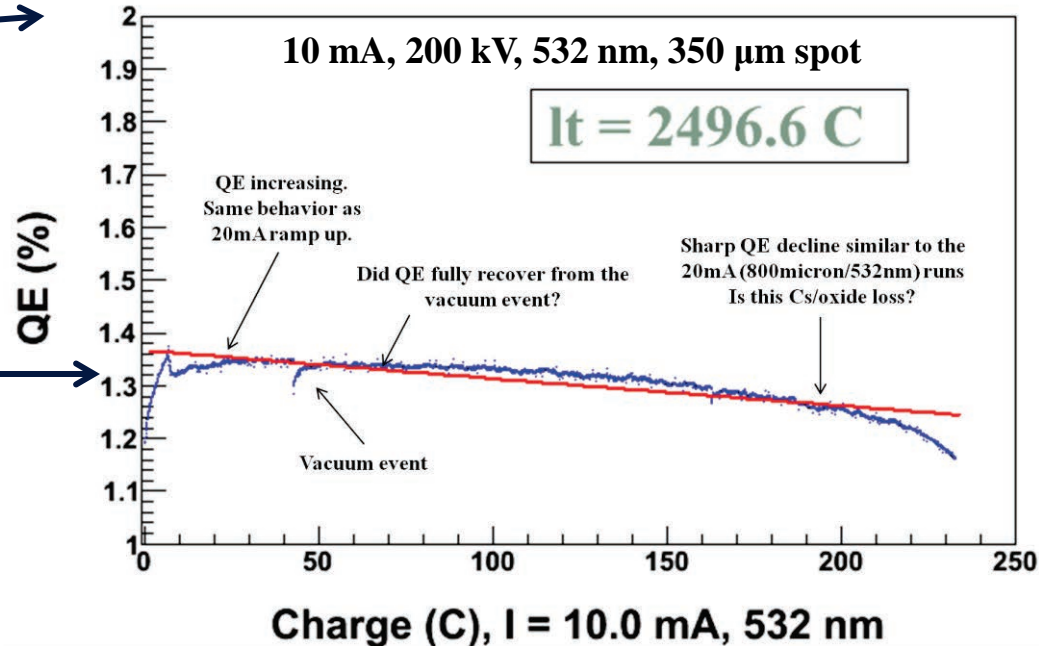
Even at longer runs, the QE decay now (after the major vacuum event) is much slower than GaAs

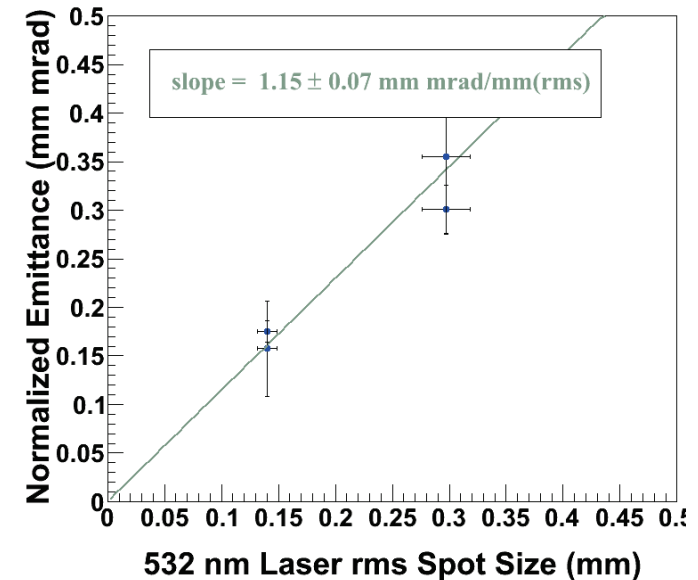
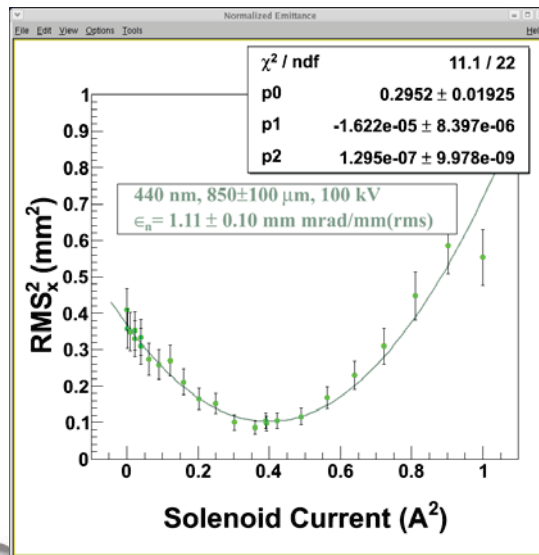
Done via solenoid scan technique at 100 and 200 kV, and 3  $\mu\text{A}$  of beam.

Summary of Emittance Measurements			
Laser Wavelength (nm)	Laser FWHM ( $\mu\text{m}$ )	HV (kV)	Normalized Emittance (mm mrad/mm(rms))
440	850	100	1.11 +/- 0.10
440	850	200	0.97 +/- 0.18
532	330	100	1.25 +/- 0.08
532	330	200	1.12 +/- 0.35
532	700	100	1.01 +/- 0.08
532	700	200	1.19 +/- 0.27

- **Emittance was roughly twice that of previous measurements made at Cornell on a similar cathode .**
- **The increase can partially be attributed to the high surface roughness of the JLab/BNL photocathode (coming up).**

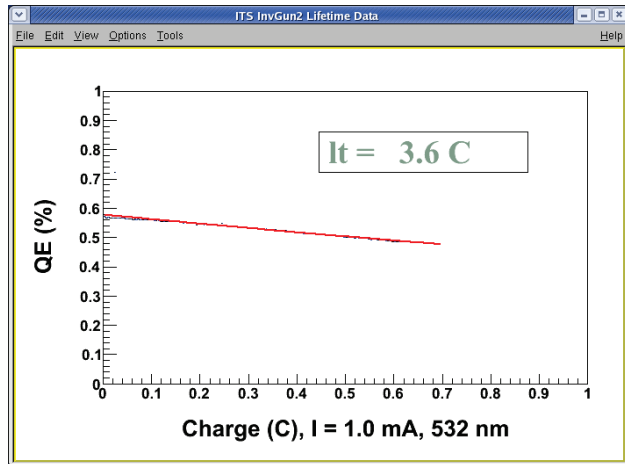
Very bad lifetime, but unknown if due to vacuum or heat. The entire gun chamber became warm to the touch, including the HV cable, indicating that the photocathode heated, though to an unknown amount.

Also, QE of entire cathode dropped by 1/3.

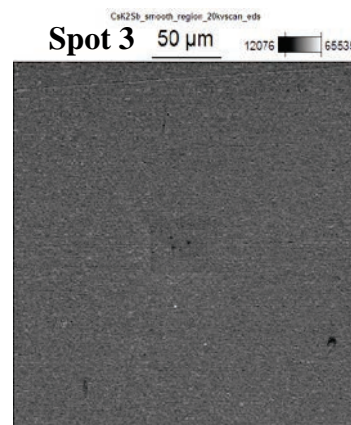
Taken after all measurements in the DC gun.  
Transferred to SEM via argon bag.

Images of the spots at  
400x with 20 keV  
electrons.
