# HIGH FIELD Q-SLOPE PROBLEM IN END GROUP CAVITIES

F. Furuta<sup>#</sup>, K. Saito, T. Konomi

KEK, High Energy Accelerator Research Organization, 1-1 Oho, Tsukuba 305-0801, Japan

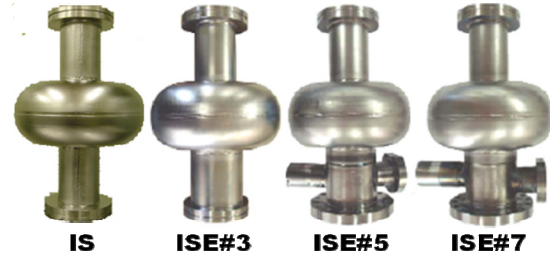
Figure 1: ICHIRO single cell cavities  
IS: centre cell shape, ISE: end cell shape

We have successfully demonstrated the principle proof of 50MV/m with KEK Low Loss (ICHIRO) single cell cavities (IS cavities) [1]. IS cavity has the centre cell shape of ICHIRO 9cell cavity (I9 cavity), but no end group. End group includes HOM coupler, high power RF input coupler port, and transmitted RF power pick up port on beam tube. For the pilot study of I9 cavity, we also made end single cell cavities (ISE cavities) that have end cell shape of I9 cavity. ISE#3 that has end cell shape but no end group successfully achieved 50MV/m using same recipe as IS cavities. It will be described later about the recipe. ISE#5, and #7, those have full end group except transmitted RF power pick up port, have achieved around 48MV/m with modified recipe but limited by Q-slope so far (Figure 2). We confirmed that RF design of ICHIRO cavity has no problem for 50MV/m, but end group has Q-slope problem at more than 40MV/m. In this paper we focused on Q-slope problem of ISE cavities.

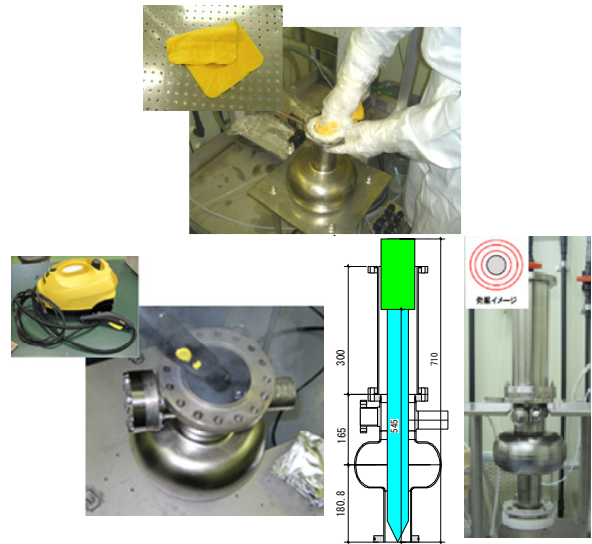
Figure 4: post EP cleaning, Top: Wiping, Bottom left: Steam cleaning, Bottom right: Horn rinsing

Figure 3 shows the results of the yield test of wiping. Figure 4 shows the picture of wiping. The tested recipe consists of light EP, flash EP, ethanol rinsing, wiping with degreaser, HPR, and baking. We repeated this 5times for ISE#5. The average of maximum gradient is  $42.6 \pm 3.7 \text{ MV/m}$ , scatter is 9%. The average of FE onset is  $31.8 \pm 7.1 \text{ MV/m}$ . The average Qo value at 40MV/m is  $(1.12 \pm 0.21) \times 10$ . The Qo value is 15% higher than that of ethanol rinsing.

Figure 4 shows steam cleaner and steam cleaning for end group. This steam cleaner is commercial one. We used pure water for the steam. Hot steam, about  $100^\circ\text{C}$ ,

come out from nozzle of steam cleaner, we sprayed it all around end groups. The recipe for series test of steam cleaning did not include EP. It consists of steam cleaning, degreasing, HPR, short baking for degassing, and VT. We applied this for ISE#5, #7, and #8. We repeated this twice for ISE#7 and #8 to check the reproducibility. Qo vs. Eacc curves are summarized in figure 5. The average of maximum gradient is  $41.6 \pm 3.9 \text{ MV/m}$ , scatter is 9%. The average of FE onset is  $33.3 \pm 5.0 \text{ MV/m}$ . The average Qo value at 40MV/m is  $(0.93 \pm 0.19) \times 10$ .

Figure 3 shows schematic image and photo of horn ultrasonic rinsing. There are several oscillators in the horn. Frequency of oscillator is 28kHz. Power can be changed from 500~1000W. Pulse operation also possible. In this series test we applied duty of 50%. Total horn rinse is done about 10~20min. The condition of horn rinsing, power, time, and duty are still under optimization. Qo vs. Eacc curves are summarized in figure 5. The average of maximum gradient is  $41.6 \pm 2.8$  MV/m, scatter is 6%. The average of FE onset is  $35.8 \pm 2.9$  MV/m. The average Qo value at 40MV/m is  $(0.75 \pm 0.39)e10$ .
