IMPROVEMENT OF THE RUN-TIME OF 35 MBAR HELIUM GAS PUMPING UNITS FOR THE SUPERCONDUCTING LINEAR ACCELERATOR S-DALINAC*

J. Conrad[#], F.Hug, T. Kürzeder, N. Pietralla, TU Darmstadt, Darmstadt, Germany

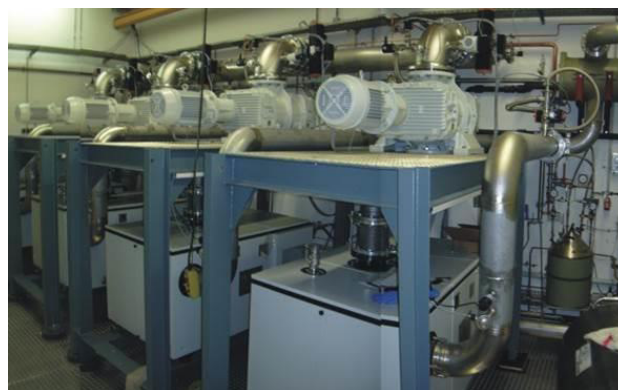
speed from 8.4 Hz to 33 Hz. The rotation speed control is effected by a Siemens SIMATIC S7 PLC according to the pressure set value of 35 mbar. The lubrication is done by dehumidified BREOX LUBRICANT B35[®] synthetic oil. The reliable work of these devices is essential for a successful operation of the accelerator.

Figure 2: Four parallel switched Pumping Units.

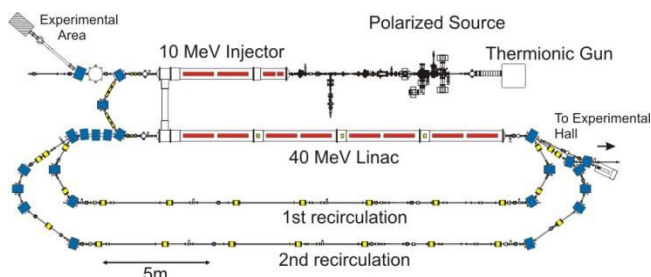
The superconducting Darmstadt linear accelerator S-DALINAC (see Fig. 1) has been designed to provide electron beams of up to 130 MeV for nuclear and astrophysical experiments [1]. The accelerating cavities are operated in a liquid helium bath at 2 K. To achieve this temperature the cryostat has to be pumped down to a pressure of 35 mbar which was done by a system of pumping units connected in series, when the accelerator started its operation in 1991. In 2005 this system was replaced by four parallel switched pumping stations. In the first three years of their operation, the reliability of the accelerator was very poor due to repeated breakdowns of the pumping stations caused by overheating. In addition the high temperatures lead to an early decay of the gaskets used. The problem was solved by installing oil cooling systems and more appropriate shaft sleeves at the pumping stations. We will report on the technical efforts we made and thereby further increased the availability of the accelerator significantly.

Figure 1: The Superconducting Darmstadt Linear Accelerator S-DALINAC.

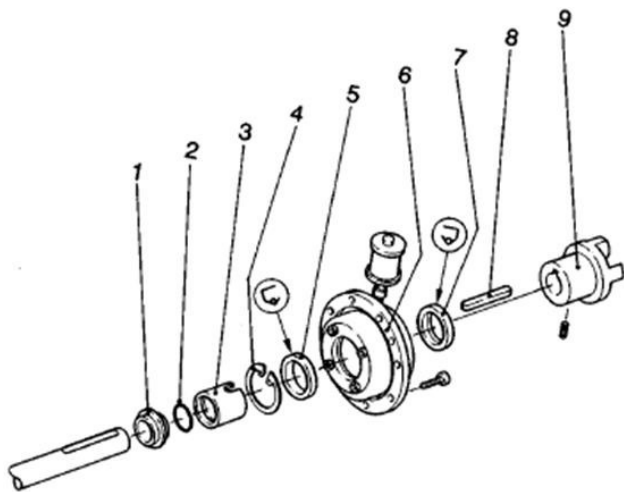
Roots pumps contain in their pump casing two symmetrical impellers rotating in opposite directions. The impellers are synchronised by a toothed gearing so that they move past each other and the casing without contact but with a small clearance. The motor of the pump is directly flanged to the coupling housing. The pump shaft and the motor shaft are linked by means of an elastic coupling. The shaft of the other impeller is driven via a synchronmesh gear. The feed through of the shaft (Fig. 3) of the impeller between the evacuated bearing chamber and the ambient is sealed by two shaft seals. In order to reduce wear on the shaft, these shaft seals run on a stainless steel shaft sleeve and are lubricated with oil. They are located in a shaft seal housing having a separate oil reservoir. The housing is air-cooled. The air flow is produced by a motor fan [2].

Figure 3: Scheme of shaft feed through [2]: spacing ring (1), O-Ring (2), bushing (3), securing ring (4), shaft seal (5), shaft seal housing (6), shaft seal (7), key (8) and coupling half (9).

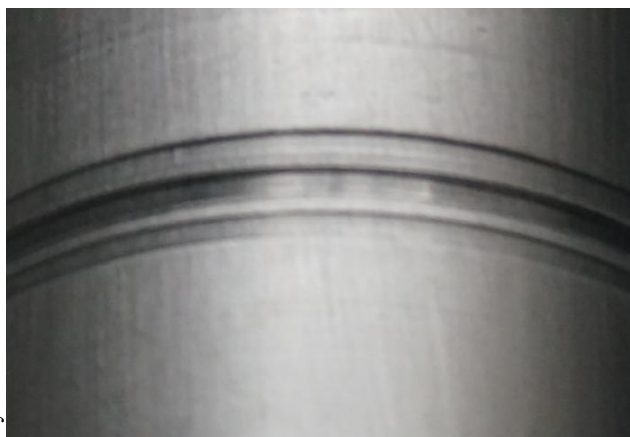
The increase of the shaft seal housing temperature leads to a change of the physical and chemical properties of the oil used for lubrication. The viscosity decreases significantly from 33 cSt at 40 °C to 4.2 cSt at 130 °C and with a localised heating from above 150 °C the oil decomposes slowly [3]. The lubrication between the

Figure 4: Roping at the shaft sleeve. The picture shows a close-up of a notch (1.5 mm width, 0.5 mm depth) on a stainless steel shaft sleeve (50 mm diameter).

shaft seal and the sleeve gets inadequate. The temperature at the seal edge can increase by up to 50 °C, in extreme cases by up to 80 °C above the environmental temperature as a result of the increasing shear forces in the lubricant and the low thermal conductivity of the elastomer [4]. Wear and heat cracks may occur at the shaft seal and roping begins at the surface of the sleeve (see Fig. 4).

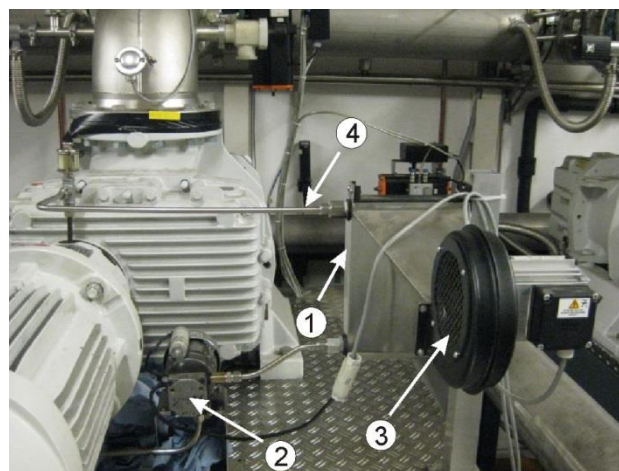
Figure 5: Oil cooling system: oil radiator (1), oil feed pump (2), centrifugal fan (3) and piping (4).

To avoid overheating it is compulsory to cool down the oil in the shaft seal housing to an appropriate temperature. The idea was to bring the oil out of the chamber, dissipate the heat and increase the total amount of liquid. In 2008 a piping and a commercial oil radiator were installed; also an oil feed pump was employed to force the oil to circulate. For a better heat exchange a centrifugal fan directly flanged to the radiator produces a cased airflow (see Fig. 5). With these modifications the oil volume was increased from 1 liter up to 4.5 liters as well.

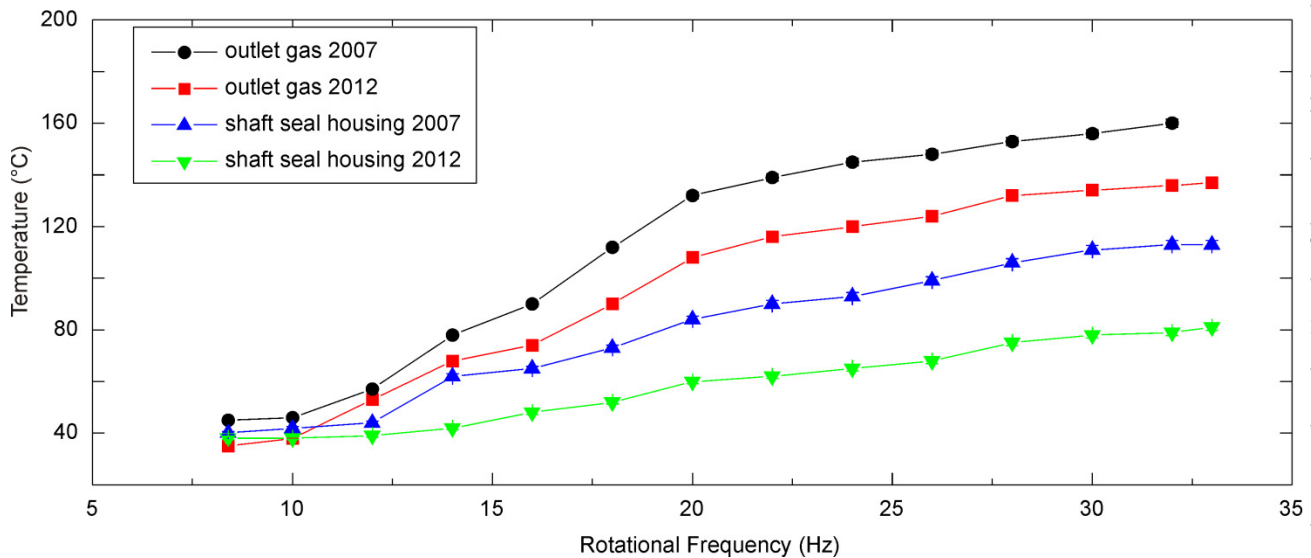
The temperatures were measured in the outlet gas flow with a PT 100 instrument shunt and with an infrared temperature measuring device and an emission-foil placed on the outer surface of the shaft seal housing. The new oil cooling system allows us to run the pumping units at a temperature level which is in average 25 to 30 °C below the level of 2007 (see Fig. 6). Until now neither the shutdown temperature nor the critical range for oil and seals were reached. The pumping station rarely affects the reliability of the accelerator any more.

Figure 6: Temperature depending on the Rotational Frequency of the pump before (2007) and after (2012) installing the circulating oil cooling system.

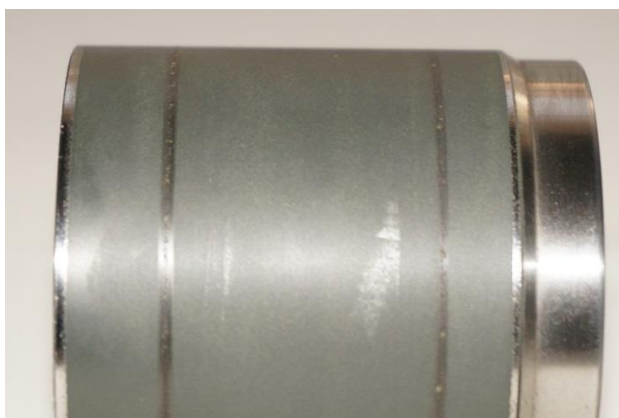
Figure 7: Ceramic Coated Sleeve (52 mm length, 50 mm diameter, 0.5 mm ceramic coating) shows oil residues but no signs of roping after 9000 operating hours.

The ceramic was coated in a flame spraying process with a thickness of 0.3 to 0.5 mm. After a run-time of about 9000 hours there was no sign of roping on the tread (see Fig. 7).

High temperatures lead to a hardening of the elastomer of the shaft seals. The result is a slowly roping at the surface of the shaft sleeve that impairs the seal integrity. If a seal fails, a leak occurs. The oil loss can be outwards or into the suction chamber, it depends on which of the two gaskets is affected. In both cases we are forced to switch off the engine and replace the broken parts. The average lifetime of bushing and gasket in 2007 was about 600 hours, which means once a month a maintenance work for one week and during this time no accelerator operation. On the one hand the temperature issue was solved by installing the oil cooling system; on the other hand we want to be sure to avoid the notch on the sleeve. Therefore we applied a ceramic coated bushing to maximise the skin hardness of the bearing surface.
