# THE EXPERIENCES OF OPERATION AND PERFORMANCE OF THE 500 MHz CW KLYSTRONS AT THE PLS STORAGE RING

J.S. Yang, M.H. Chun, I.H. Yu, Y.J. Han and S.H. Nam  
 Pohang Accelerator Laboratory, POSTECH  
 Pohang 790-784, Korea

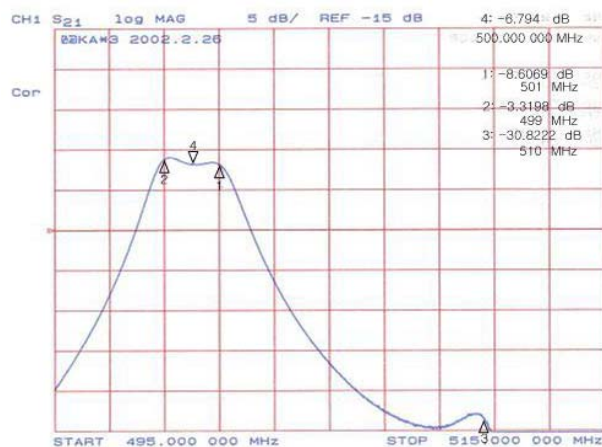
Figure 1. Klystron tuning characteristic curve

Both 60 kW and 75 kW klystrons have four cavities. Each cavity is tuned respectively.

Fig 1. shows the klystron tuning characteristic curve.

In every summer shutdown, we checked klystron tuning status. Sometimes we found the tuning curve is distorted like as Fig 4. We assume that this reason is affected by a heat during long operation. We retuned to get the correct tuning characteristic like as Fig 1.

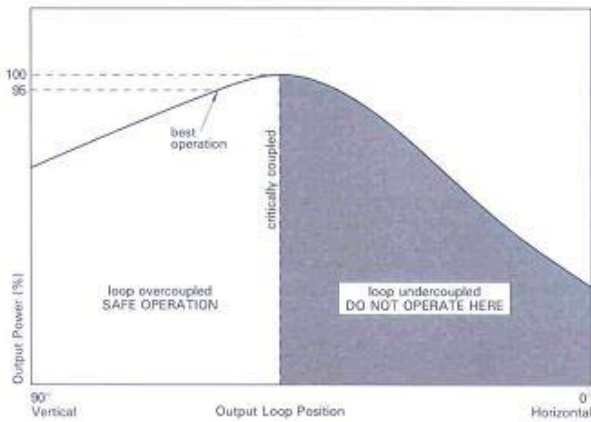
Figure 2. Adjustment of output coupling loop

Adjusting of the output coupling loop is as shown in Fig 2.[2] The output coupling loop should be operated in overcoupled region. If this is operated in the undercoupled region, RF arcing in the cavities may be occurred. In addition, body current will increase. Therefore, klystron tube may be dangerous.

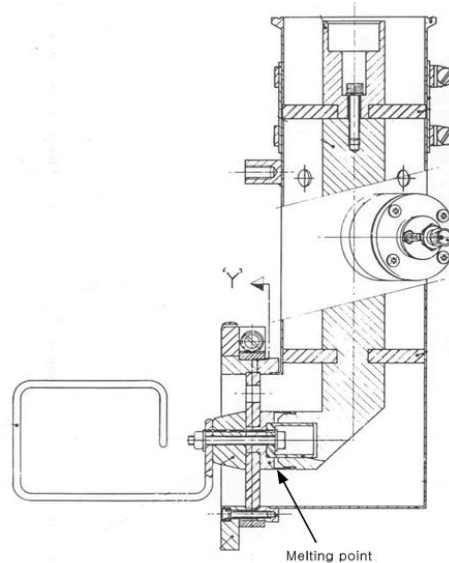
Figure 3. The structure of output coupler

We had the two experiences of tube problems in 2001. Tube maker Philips stopped to produce a klystron. Therefore, we purchased two K3672 as same electrical and physical specification of YK1265 for spare tube. When first K3672 tube installed, beam voltage test was successful. However, during RF adjusting, the second ceramic window of first klystron was cracked. In case of second klystron, the output ceramic window of second tube was cracked after about 1000 hours operation. They were in warranty. The reason of tube fault was not cleared. During operation, excess heat was generated inside of output cavity. The rotating joint of output coupler was melted and we couldn't adjust the loop of output coupler. The melting part was manufactured to have better RF contact and replaced. Fig 3. shows the structure of output coupler.

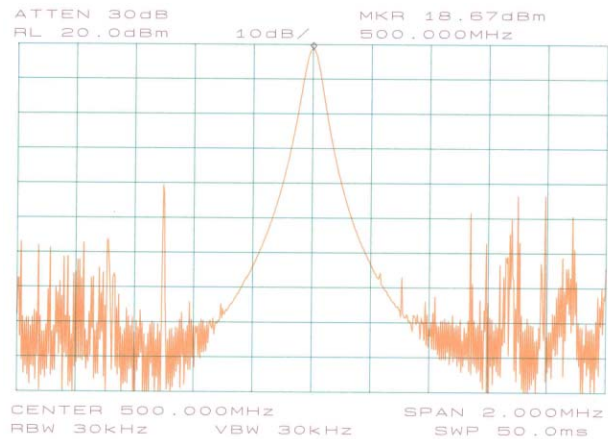
Figure 5. RF spectrum with sideband

According to high power RF system upgrade schedule, we are undertaking replacement 60 kW klystron with 75 kW.[1] Already we replaced two 60 kW klystrons with 75 kW klystrons. 75kW klystron has X-ray shielding in the first and second cavity for health. For installation 75 kW klystron we modified such as additional cooling, coaxial lines, and adjusting of the electrical specification. First 75 kW klystron was installed at homemade amplifier KA#1 successfully in 2002. Through same procedure for installation, second K3773 was installed at KA#2. But we found the sideband near center frequency. After examining several operating factor we found the sideband frequency generation was depend on the angle of the output coupler. The loop angle is  $41^\circ$  in safe region that the sideband frequency is not occurred and as the loop angle goes toward zero direction the more sideband frequency is occurred. This means that the loop of output coupler should be in overcoupled region. Fig 5. and Fig 6. show the RF spectrum with sideband and without sideband.
