HIGH-CURRENT EFFECTS IN THE PEP-II STORAGE RINGS*

Abstract

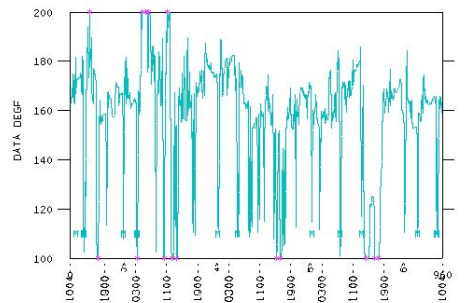
The high synchrotron radiation heat load on the HER dipole chambers[5] causes their extending by several mm as the stored beam current increases during a filling cycle and also a small but noticeable bowing due to the one-sided heat load. In order to reduce stress in the vacuum system, “flex flanges”—i.e. very short bellows—are integrated in the flange connection to the next chamber, thus allowing a certain movement of the chamber. The gap between the chamber is bridged by a flexible, “ Ω ”-type rf seal which was originally made of GlidCop for stability under heat. As the beam current in the HER approached 2 A, more and more discharges in the vacuum system were observed. Thermal monitoring deployed during Run 6 (after having observed some failures of these rf seals) indicated

widespread thermal spikes at these flex flanges, at increasing frequency as the beam current was raised. Fig. 1 shows an example.

Figure 1: Measured temperature of flange with a damaged rf seal.

Based on these measurements, it was decided to replace the seals at *all* of the 192 flex flanges in the ring. The final tally showed that all but 10 of the seals were damaged to at least some degree. Fig. 2 shows an example of a damaged GlidCop rf seal. The damage stems most likely from the

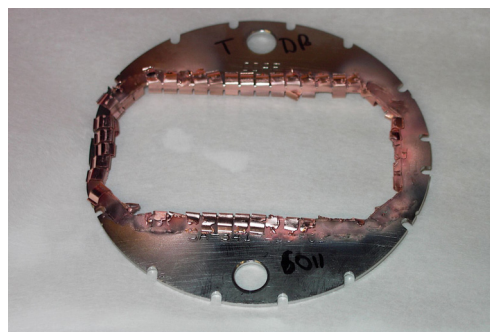
Figure 2: Rf seal damaged by beam-induced heating.

flexing of the two chambers against each other across the seal, which appears to not have sufficient spring-back to avoid lift-off of some fingers. When that occurs, rf power can couple into the cavity behind the seal, causing significant voltage to build up across the narrow gap which in turn can lead to discharge. In addition, rf power is dissipated on the steel plate of the seal causing it to heat up, this may explain some of the observed damage to the mounting screws[4].

In order to avoid repeat of these failures, the replacement seals used spring fingers made of Inconel 718, with silver plating to maintain conductivity. Inconel (a high-resistivity

stainless steel) has a melting point near 1330°C, compared to 1080°C for GlidCop, in addition, Inconel maintains better springiness. Fig 3 shows the same flange temperature as above, after replacing the seal. One of the Inconel seals was

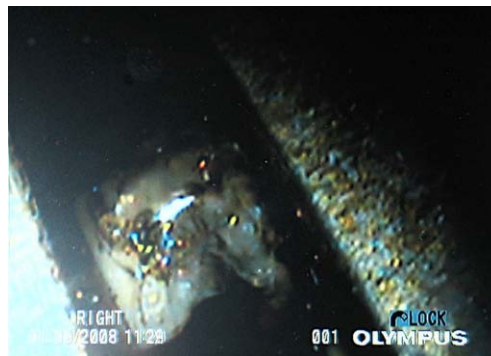
The PEP-II transverse bunch-by-bunch feedbacks stabilizing the beams against multibunch instabilities use stripline kickers to act on the beam. The LER kickers use molybdenum electrodes for heat tolerance and were expected to easily support the highest possible beam currents[6]. However, on inspection it was found that the electrode of the horizontal kicker had sagged down by a few mm, due to the increased weight of the Mo electrode compared to the original Al electrode and the cantilevered support of the electrodes by the feedthroughs. The remedy of this sagging effect was to add Macor pins to the “paddle” structure holding the electrode; these pins engage into openings in the end caps of the kicker housing. Careful rounding of the holes was done to avoid local field emission and discharge. This modification was done to the horizontal kicker only.

Figure 4: Borescope of the kicker end showing damaged pin.

The immediate repair for this problem was to reinstall the old kicker without the Macor pins. For any future redesign of this kicker concept, one would have to consider carefully how to increase the withstanding strength against electric fields, possibly by introducing rings around the surface, thus increasing the pathlength any discharge would have to span.

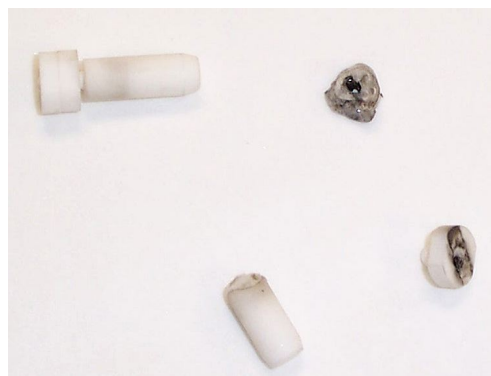
Initially, the modified kicker performed well with measurements confirming that the match at the ends had not deteriorated in any measurable way. However, as beam currents were increased, and during a period of relatively high bunch current, vacuum spikes were observed in the pumps near the kicker and the bunch current became limited to close to 1.1 mA before a clear discharge phenomenon near the kicker set in. Eventually the vacuum system was opened up and one of the pins was observed to be badly damaged with signs of melting and discharge, see Fig. 5.

Figure 5: The molten and the intact Macor pins removed from the kicker.

This can then give rise to voltage drops of many kV of potential, and arcing—esp. along the pins—becomes a distinct possibility. The situation may have been aggravated by a possible deterioration of the electrical properties of Macor at high temperature.

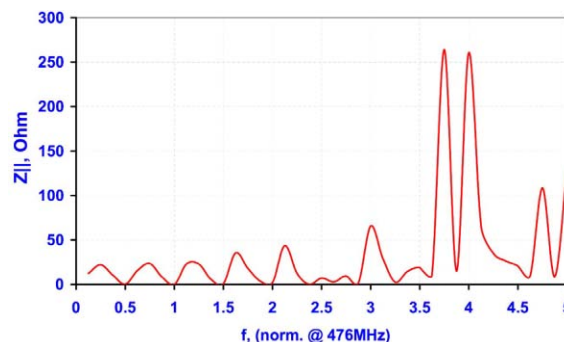
Reanalysis of the kicker structure revealed the most likely scenario of failure. The impedance spectrum of the kicker is shown in Fig. 6. When evaluated at low frequencies using the average beam current, the expected voltage to ground in the region of the mounting paddles is on the order of 100 V and no danger of arcing exists. However, with bunch length of about 12 mm the peak beam current in fact approaches 100 A (for 3 A average beam current) and in addition the impedance spectrum shows impedance peaks of near 250 Ω at frequencies ranging from 1.5 to 2 GHz, where the beam current still has significant spectral power.

Figure 6: Impedance spectrum of the feedback kicker.

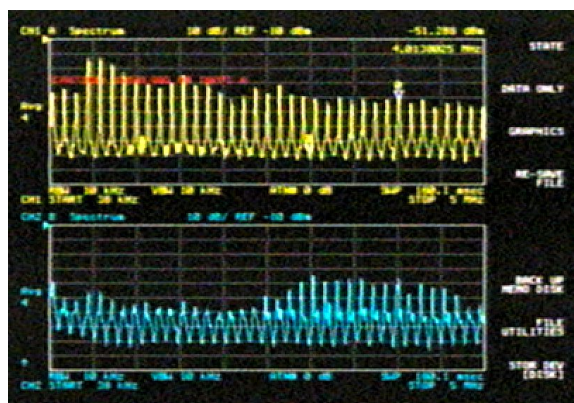
While initially a concern, ion effects in the HER have not been a significant limitation to operation of PEP-II. In fact, the machine had been run with the abort-kicker gap reduced to about 1.4% (18 buckets or about 100 ns), down from the originally envisaged 10%. Since the gap in the beam leads to significant phase transients—which cause difficulties for the rf system—an experiment was conducted to explore reducing the gap to its minimum size and, potentially, omitting the gap completely. The experiment had the surprising outcome that in fact we could not reduce the gap by any significant amount without causing trouble. By the time the gap was reduced to near 1% clear signs of beam motion were observed and luminosity had in fact not increased. Further reduction in the gap lead to outright beam instability and reduction of luminosity. The motion occurred in both planes and the vertical motion exhibited enhanced spectral content around 2...4 MHz, see Fig. 7. This sig-

Figure 7: Transverse spectra of the HER with 16-bucket gap (34 ns). Top trace (yellow) is horizontal; bottom trace (blue), vertical motion. The frequency range is from 20 kHz to 5 MHz and the vertical scale is 10 dB/div in both spectra.

nature is characteristic of ion effects in the HER, in fact, it has been seen with the normal gap when bad vacuum conditions exist. Note that the observed frequency bump does not correspond to the frequency of the prevalent ion species (CO and CO₂) presumably as it is shifted due to the combined action of the transverse bunch-by-bunch feedback and the Landau damping from the beam-beam interaction. There is some indication in the time-domain data that the phenomenon is likely a fast-ion type of instability[7]: After the gap near the left side of Fig. 8 the motion is small, it then grows along the bunch train, however, later in the train the amplitude appears to be reduced again. Also, there is strong motion in the horizontal plane which is not fully explained although it does appear that with the reduced gap the beam tended to lock onto the half-integer resonance (with a mode 6 or 7 oscillation) but not get lost.

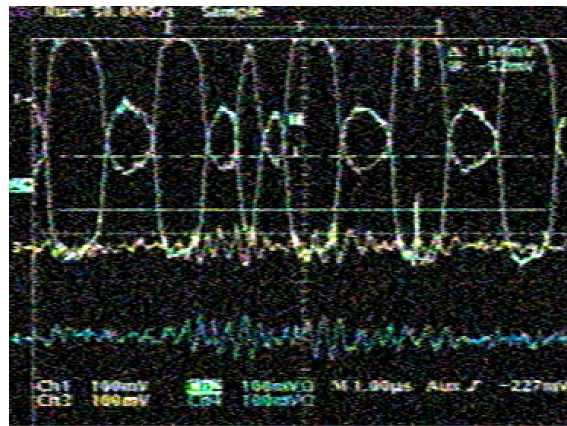
Figure 8: Transverse motion of the HER with 16-bucket gap (34 ns). Traces 1 and 2 with the large mode-6 oscillation are horizontal, traces 3 and 4 with the much smaller amplitude, the vertical plane. Horizontal time scale is 1 μs/div (10 μs total), the vertical scale is 100 mV/div for all traces.
