DEVELOPMENT OF A HIGH RESOLUTION CAMERA AND OBSERVATIONS OF SUPERCONDUCTING CAVITIES

Y. Iwashita, Kyoto University, Uji, Kyoto, JAPAN

H. Hayano, KEK, Ibaraki, JAPAN

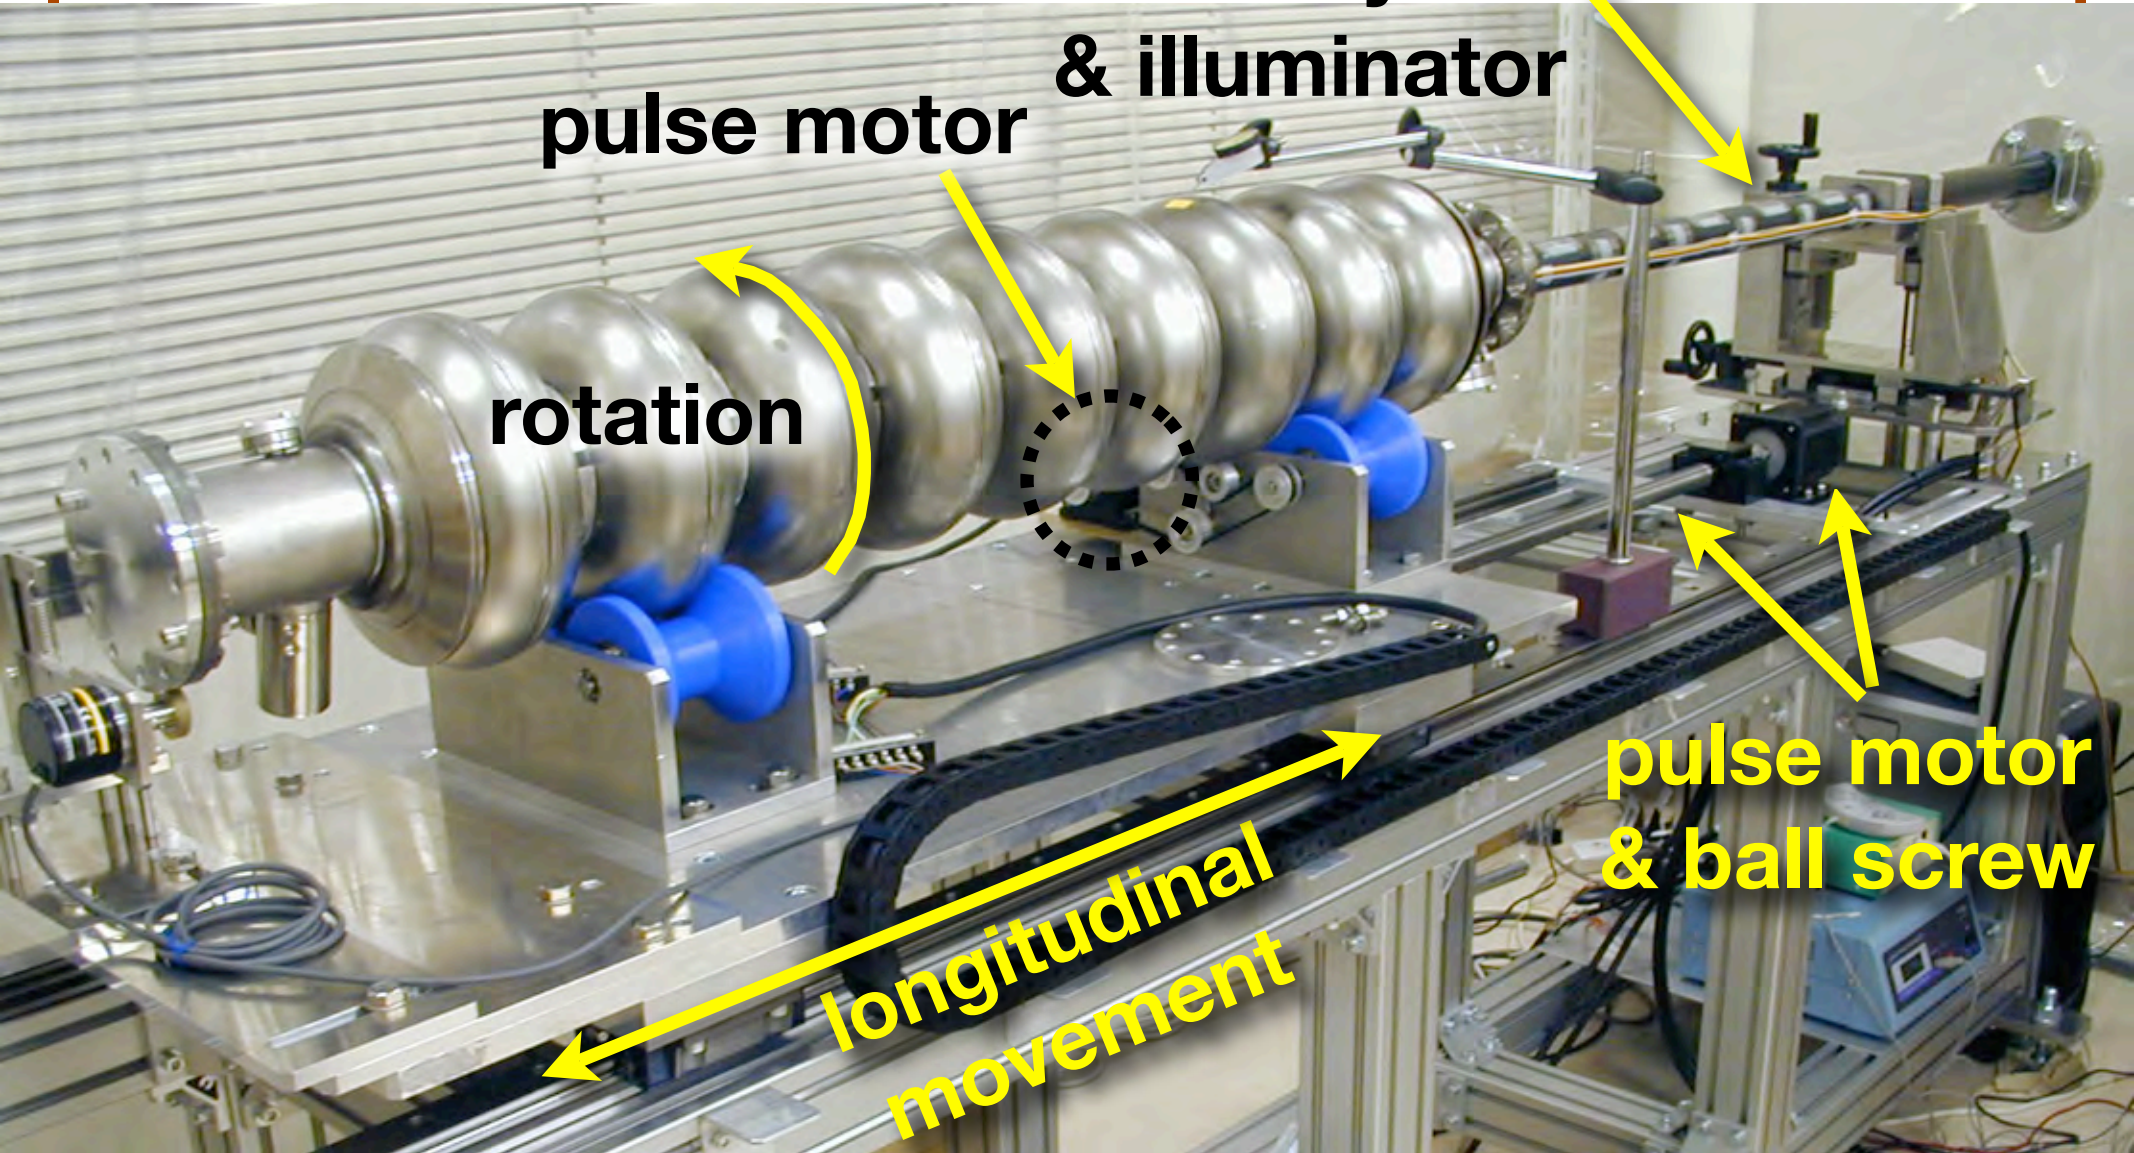
Inspection System

camera cylinder

& illuminator

pulse motor

rotation

pulse motor
& ball screw

longitudinal
movement

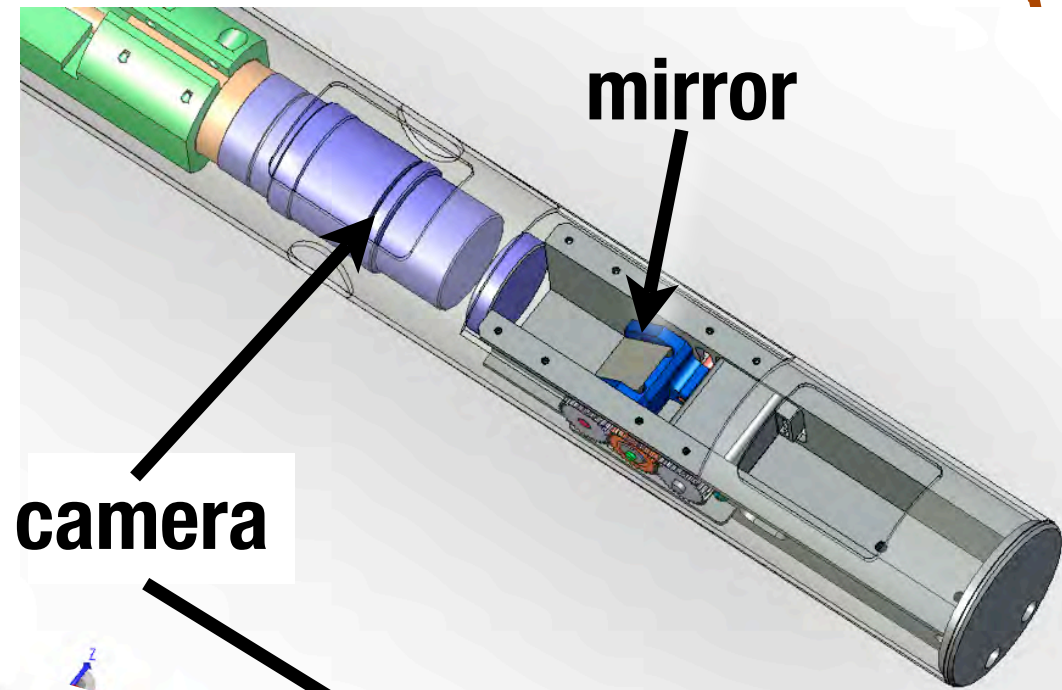
Camera Head

resolution: $7.4\mu\text{m} / \text{pixel}$

camera

mirror

- I. The resolution of $7.4\mu\text{m}$ is achieved.
- II. AES1 spot locations agree with the results from passband mode and thermometry.
- III. The wall height/depth can be estimated by integrating the measured gradient.
- IV. It may improve the yield of the cavity fabrication.
- V. It is ready to be delivered to worldwide; the first product was just delivered to KEK.

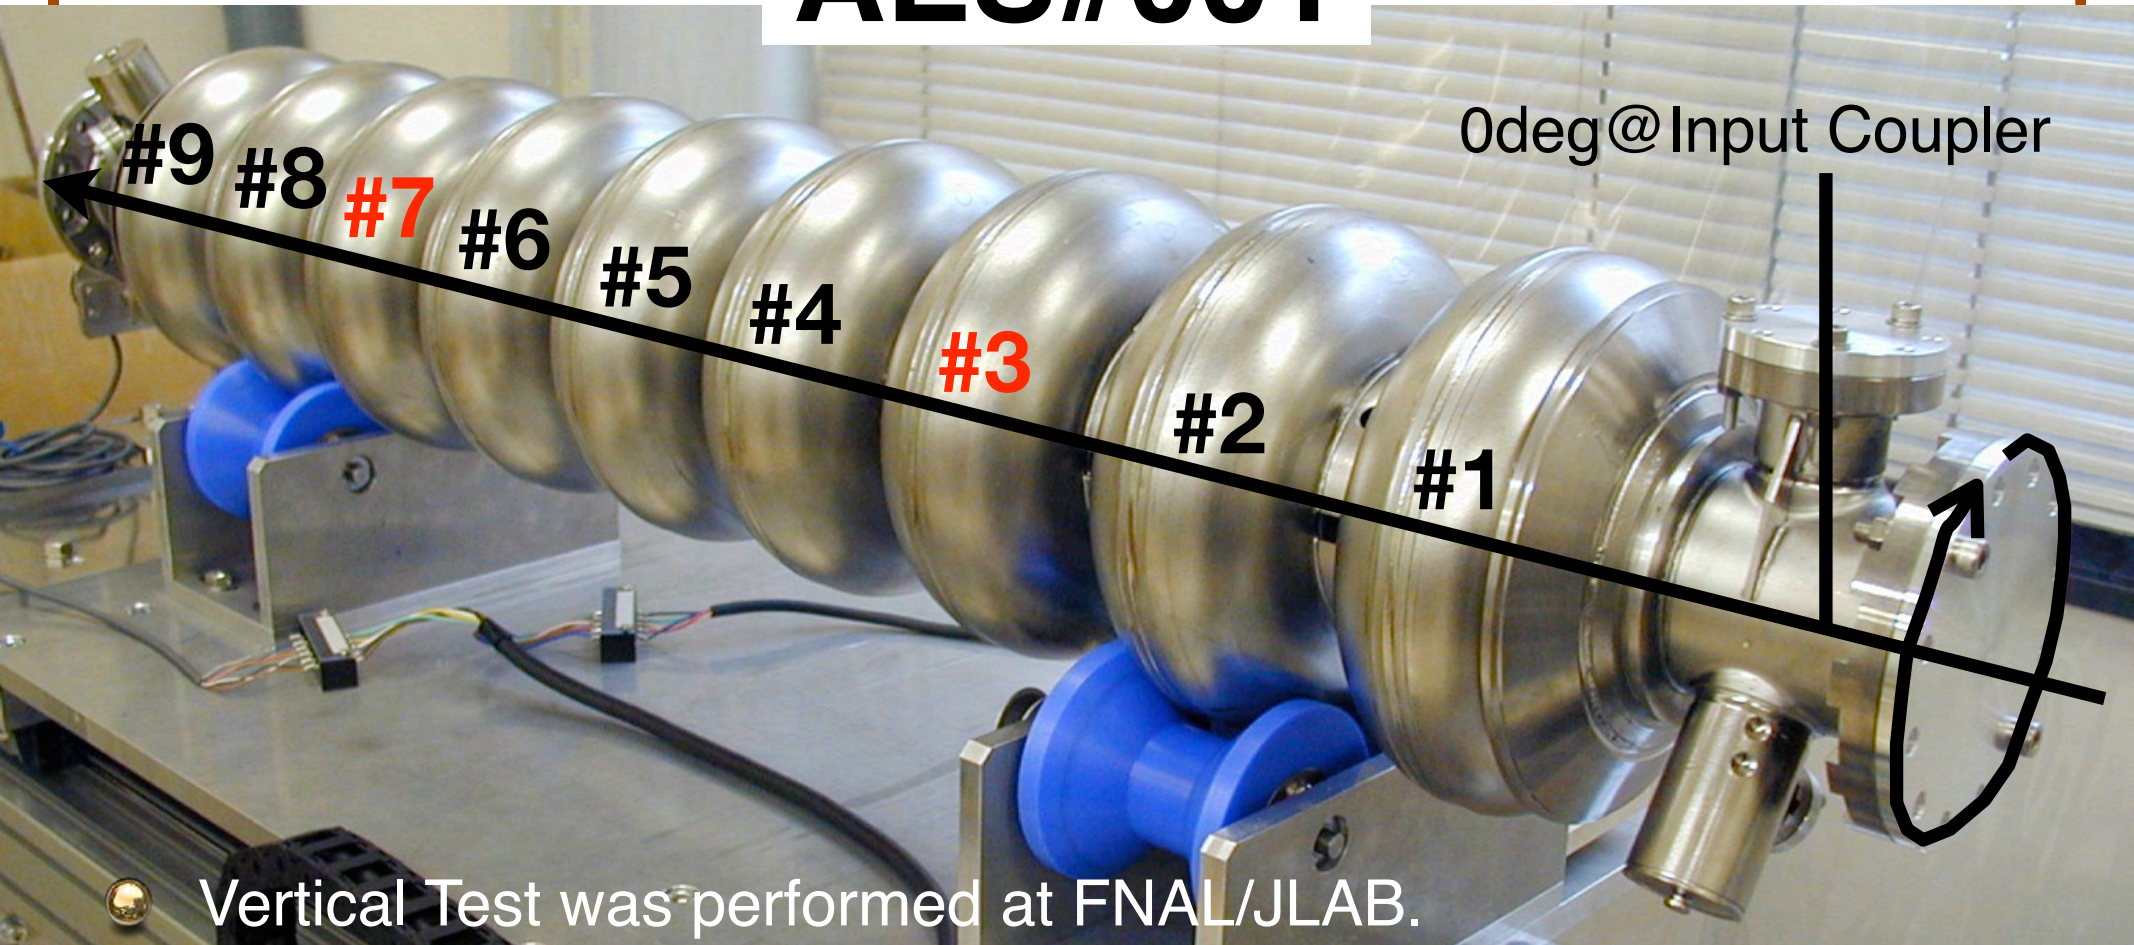
AES#001

0deg@Input Coupler

- Vertical Test was performed at FNAL/JLAB.
- Quenched at $E_{acc} \sim 15 \text{ MV/m}$ without field emission (no Xray).
- Passband mode measurements shows that #3 and #7 cell are suspicious.
- In thermometry measurements two hot spots were found at the equator region of #3 cell.

AES001 has hard quench at 15MV/m, where its location was identified by Cernox at FNAL.

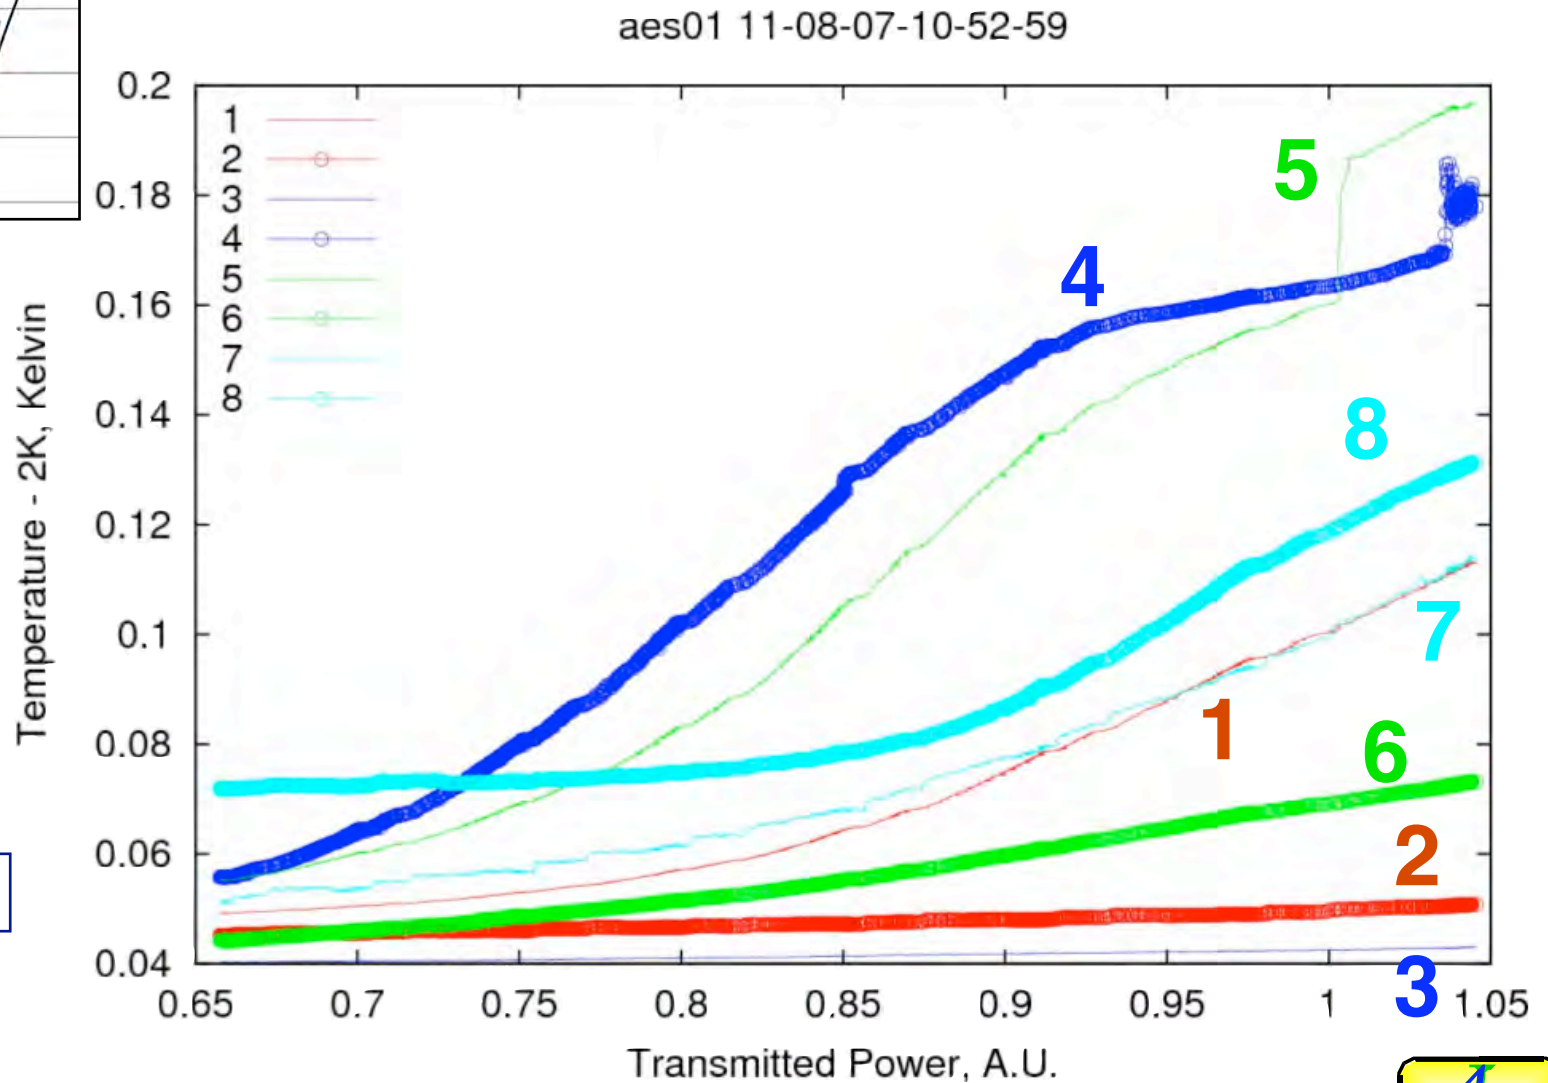
Cernox thermometry

Dmitri A. Sergatskov: Thermometry on AES01 cavity at Fermilab @webex20071204

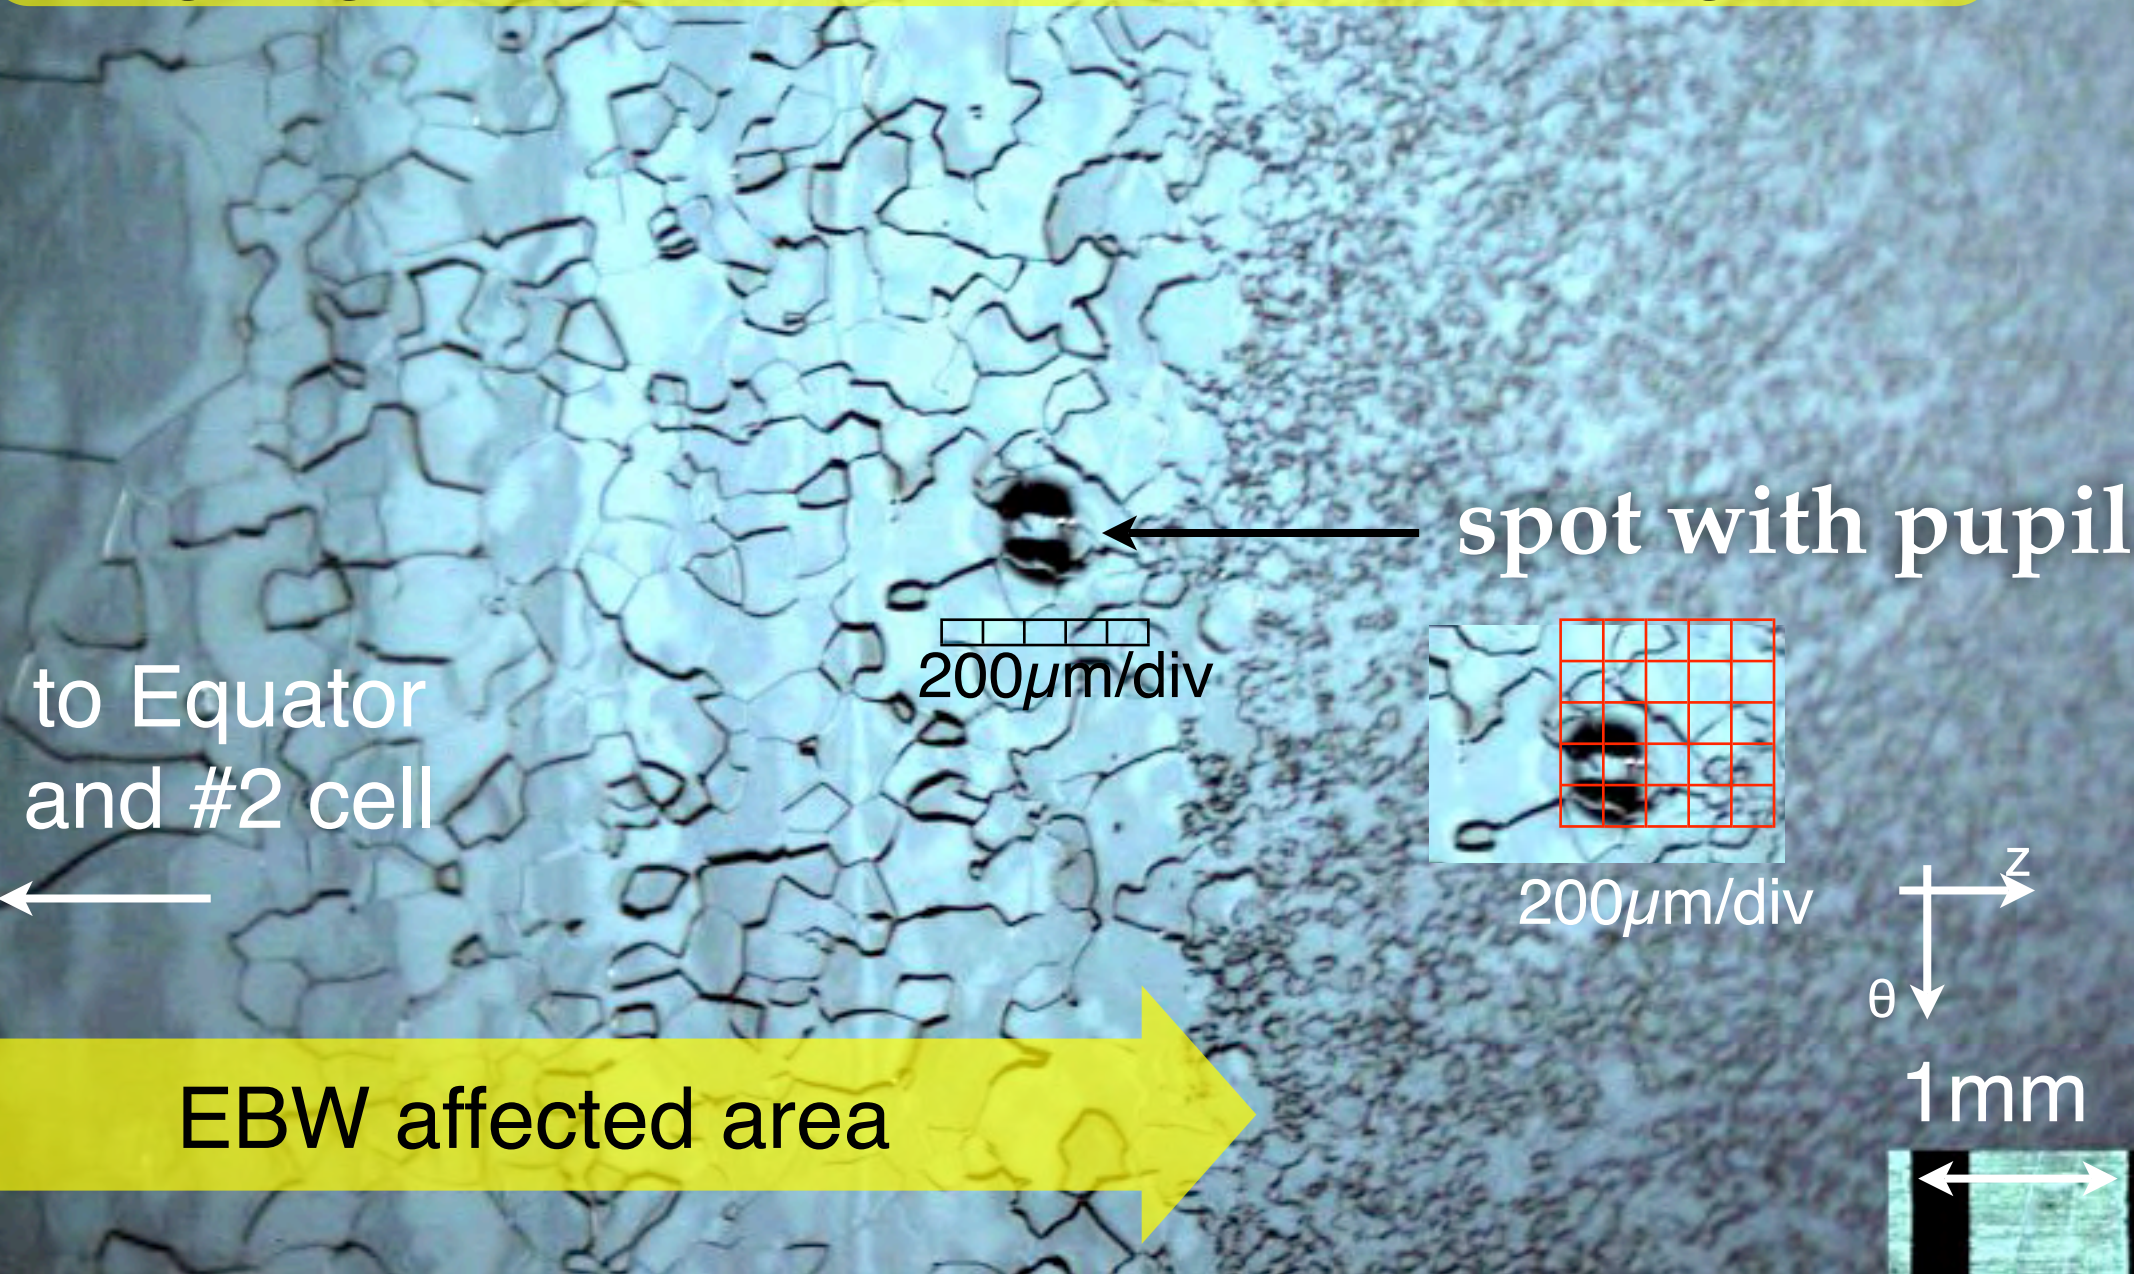
AES001 #3 cell 181°

Larger grains Transition? Fine grains

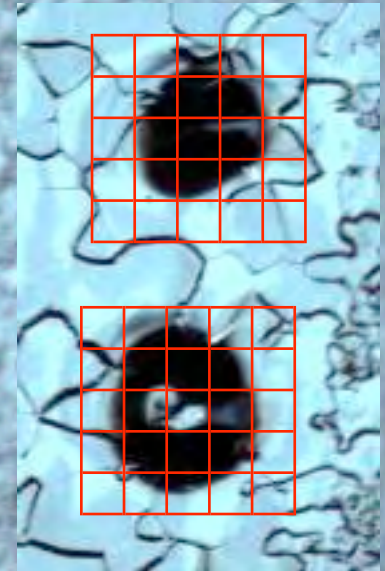
AES001 #3 cell 169°

Larger grains Transition? Fine grains

Twins

← spot(a) @ 168°

← spot(b) @ 169°

200μm/div

to Equator
and #2 cell

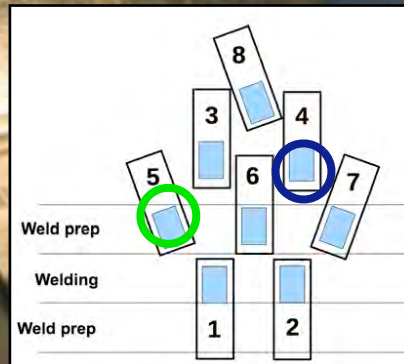
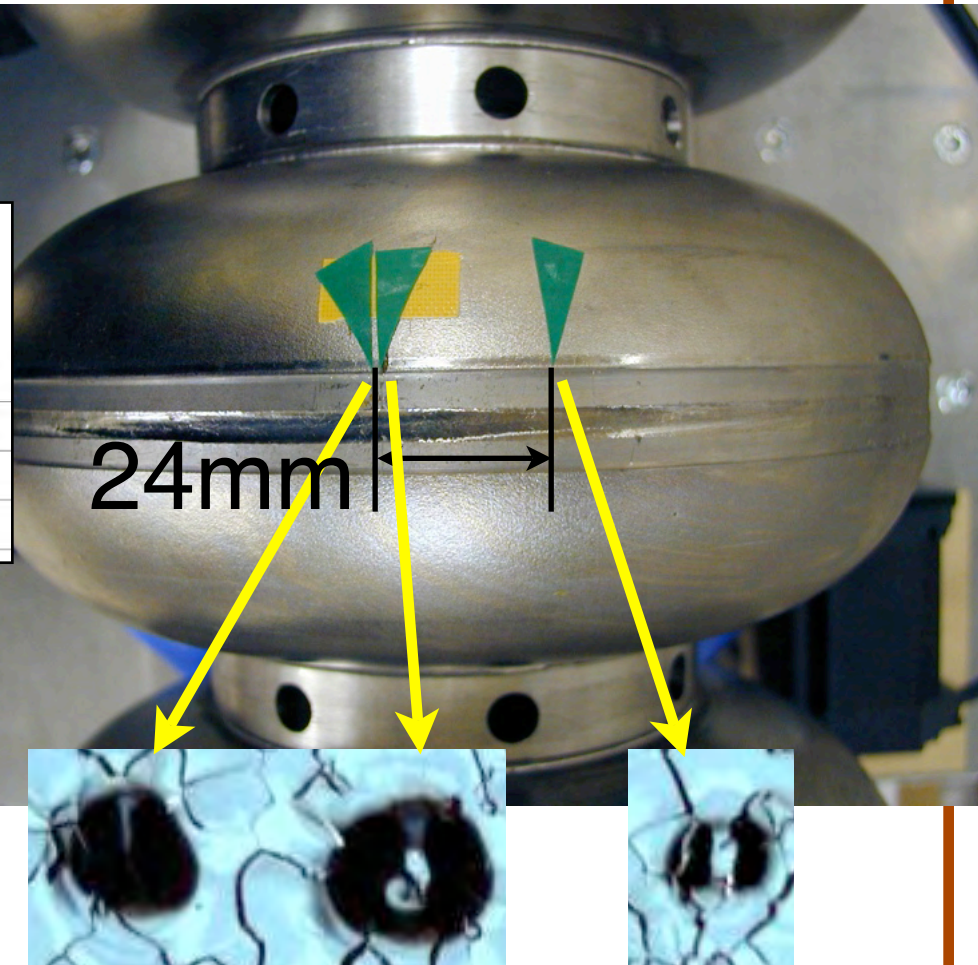
Correlation with Thermometry

Two thermometers shows the temperature rise.

24mm?
The width of the themometers are about 5mm.

Two hot spots@FNAL/JLAB

Three spots found@Kyoto

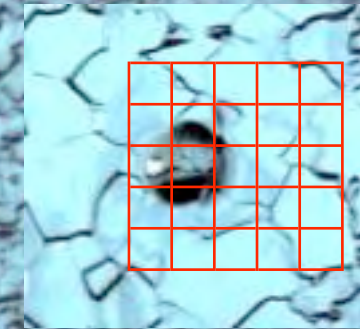
AES001 #7 cell 325°

Larger grains Transition? Fine grains

to Equator
and #6 cell

200 $\mu\text{m}/\text{div}$

spot with pupil

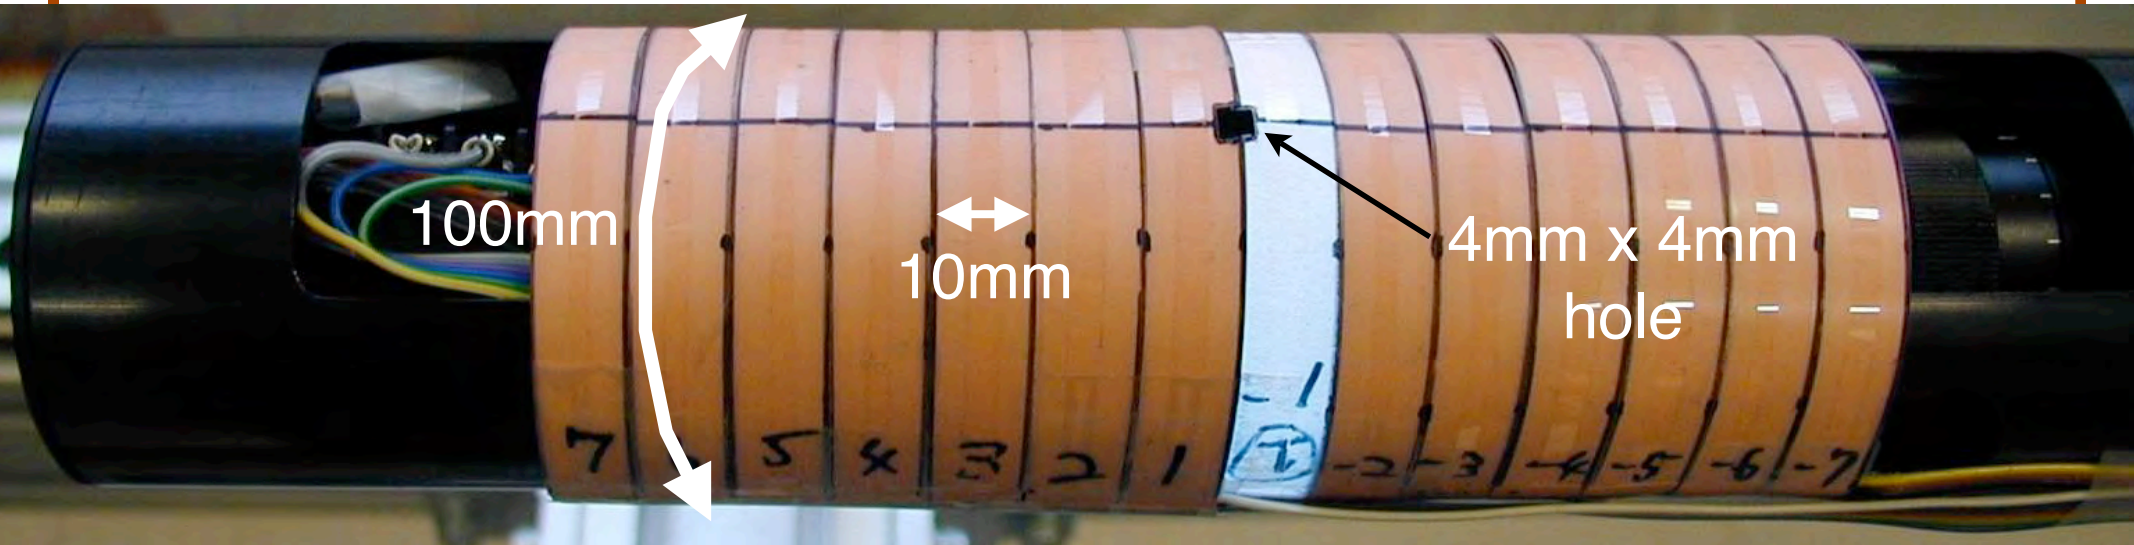
Stripe Illumination(SI)

- Fourteen Electro-Luminescence(EL) stripe sheets are 10mm in axial direction and cover 100mm in azimuthal direction.
- These fourteen stripes can be turned **ON/OFF one by one**.
- Assuming that **cavity's interior surface is a complete mirror**, we can measure **wall gradients** of the cavity's interior surface with these ELs.

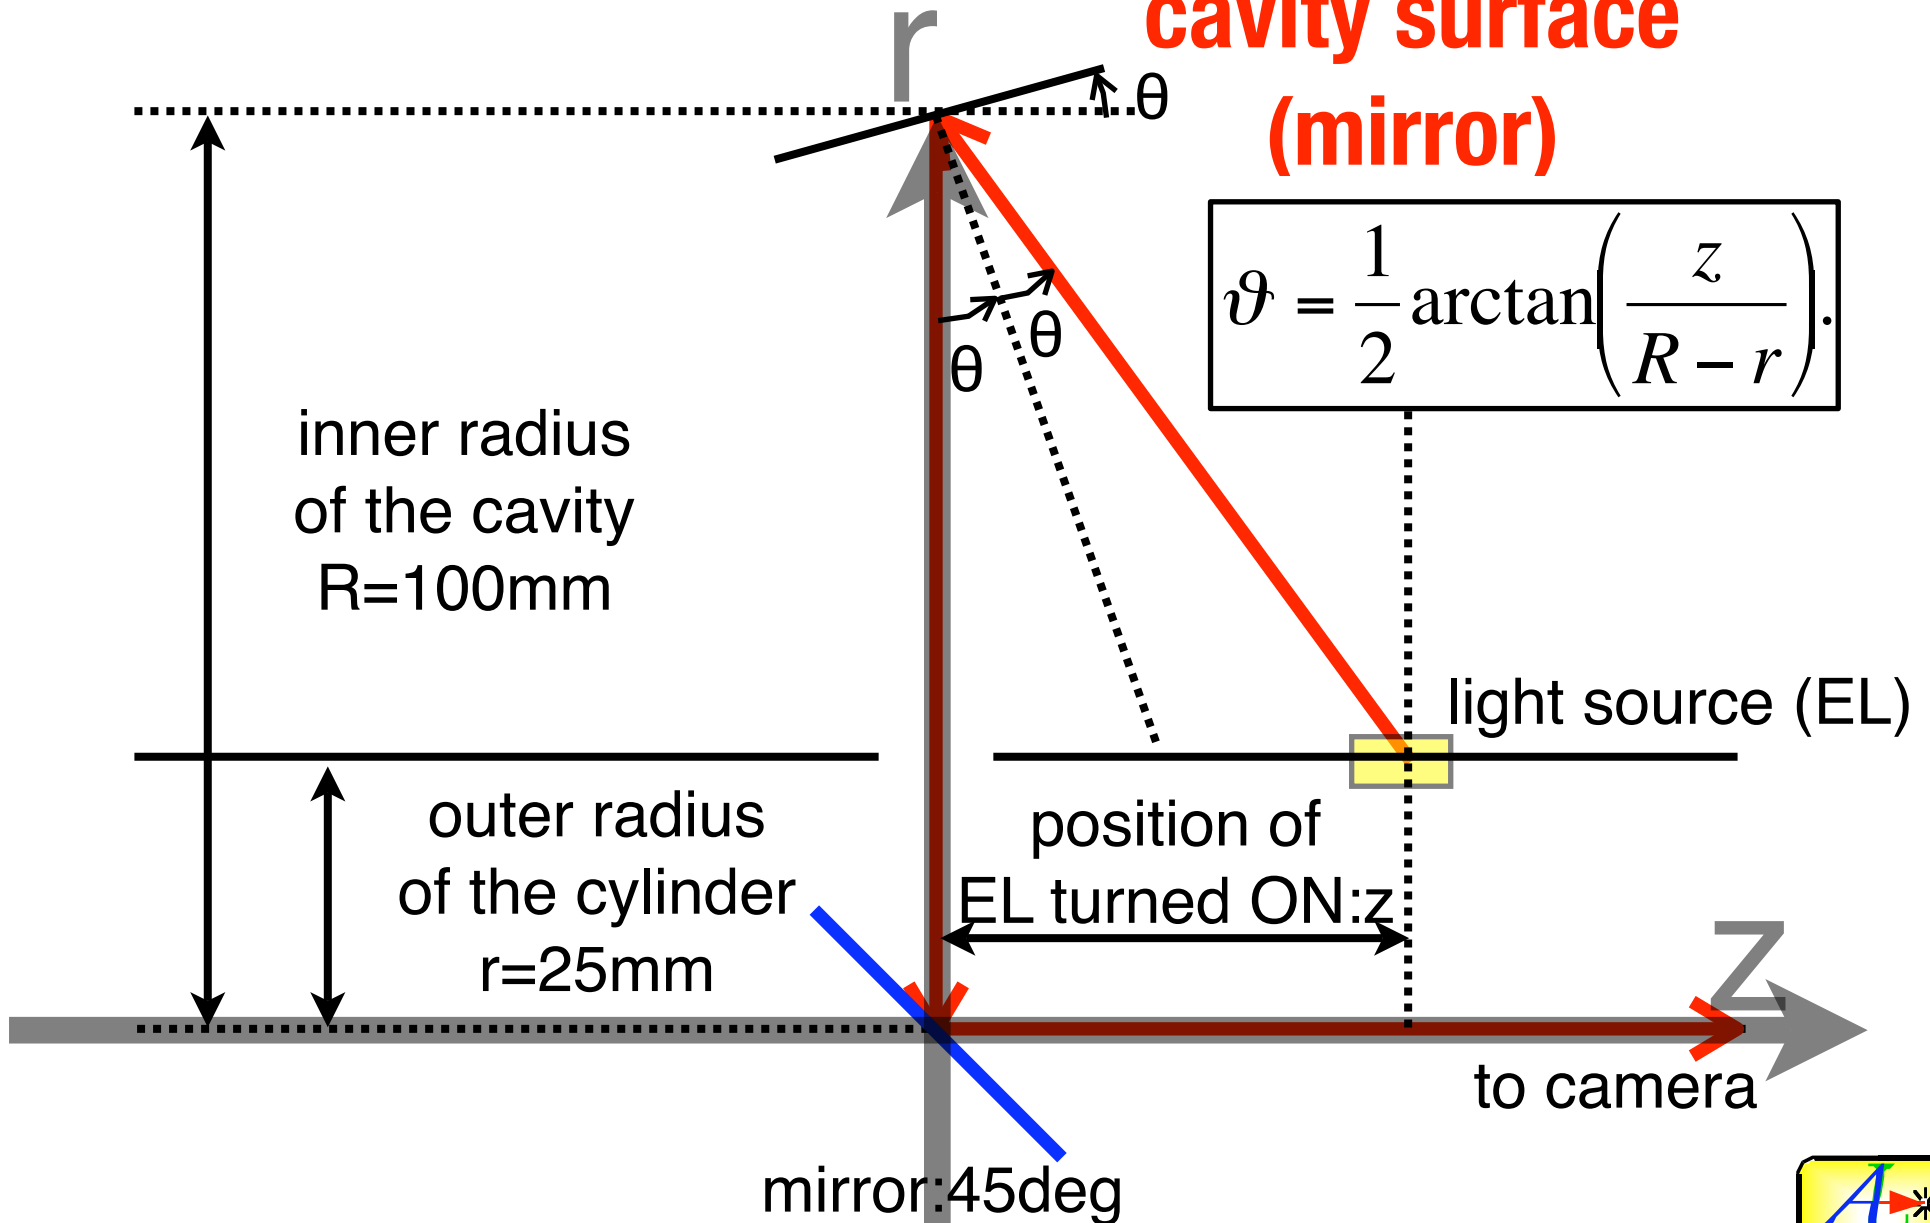
Wall Gradient Measurement

**cavity surface
(mirror)**

$$\vartheta = \frac{1}{2} \arctan\left(\frac{z}{R-r}\right).$$

inner radius
of the cavity
 $R=100\text{mm}$

outer radius
of the cylinder
 $r=25\text{mm}$

light source (EL)

position of
EL turned ON: z

to camera

mirror: 45deg

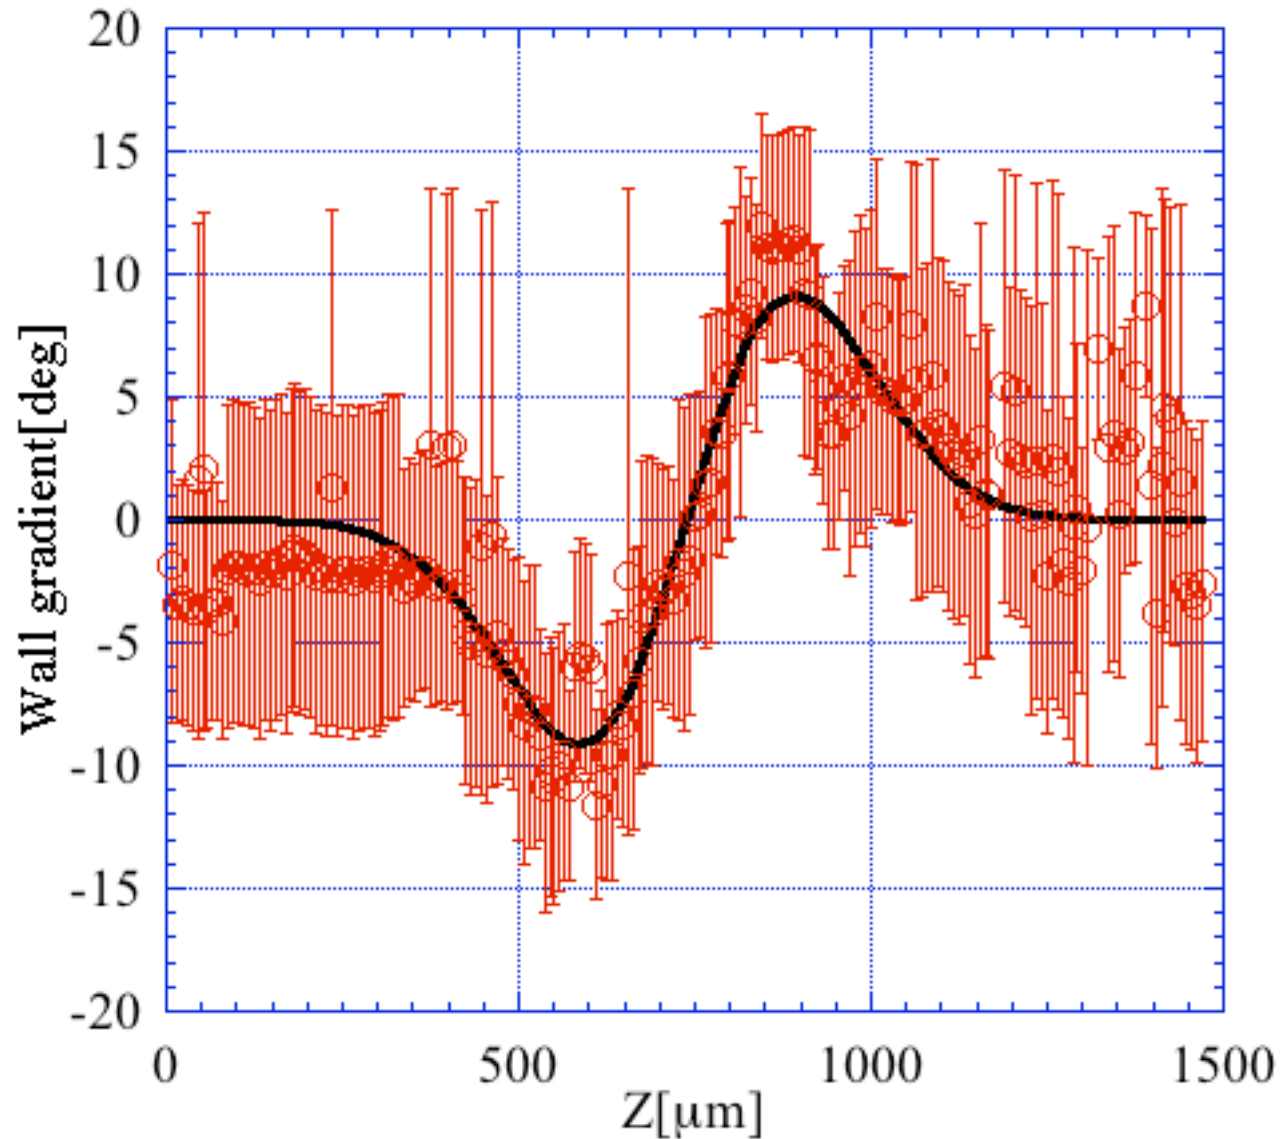
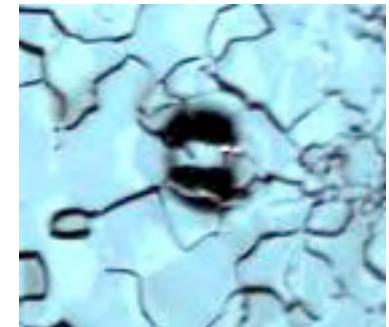
Wall Gradient of spot at #3 cell 181°

200 $\mu\text{m}/\text{div}$

- This data shows that the spot is a convex(ball).
- Because of the continuity of the measured gradient, we can integrate the gradient to estimate the height of the spot.

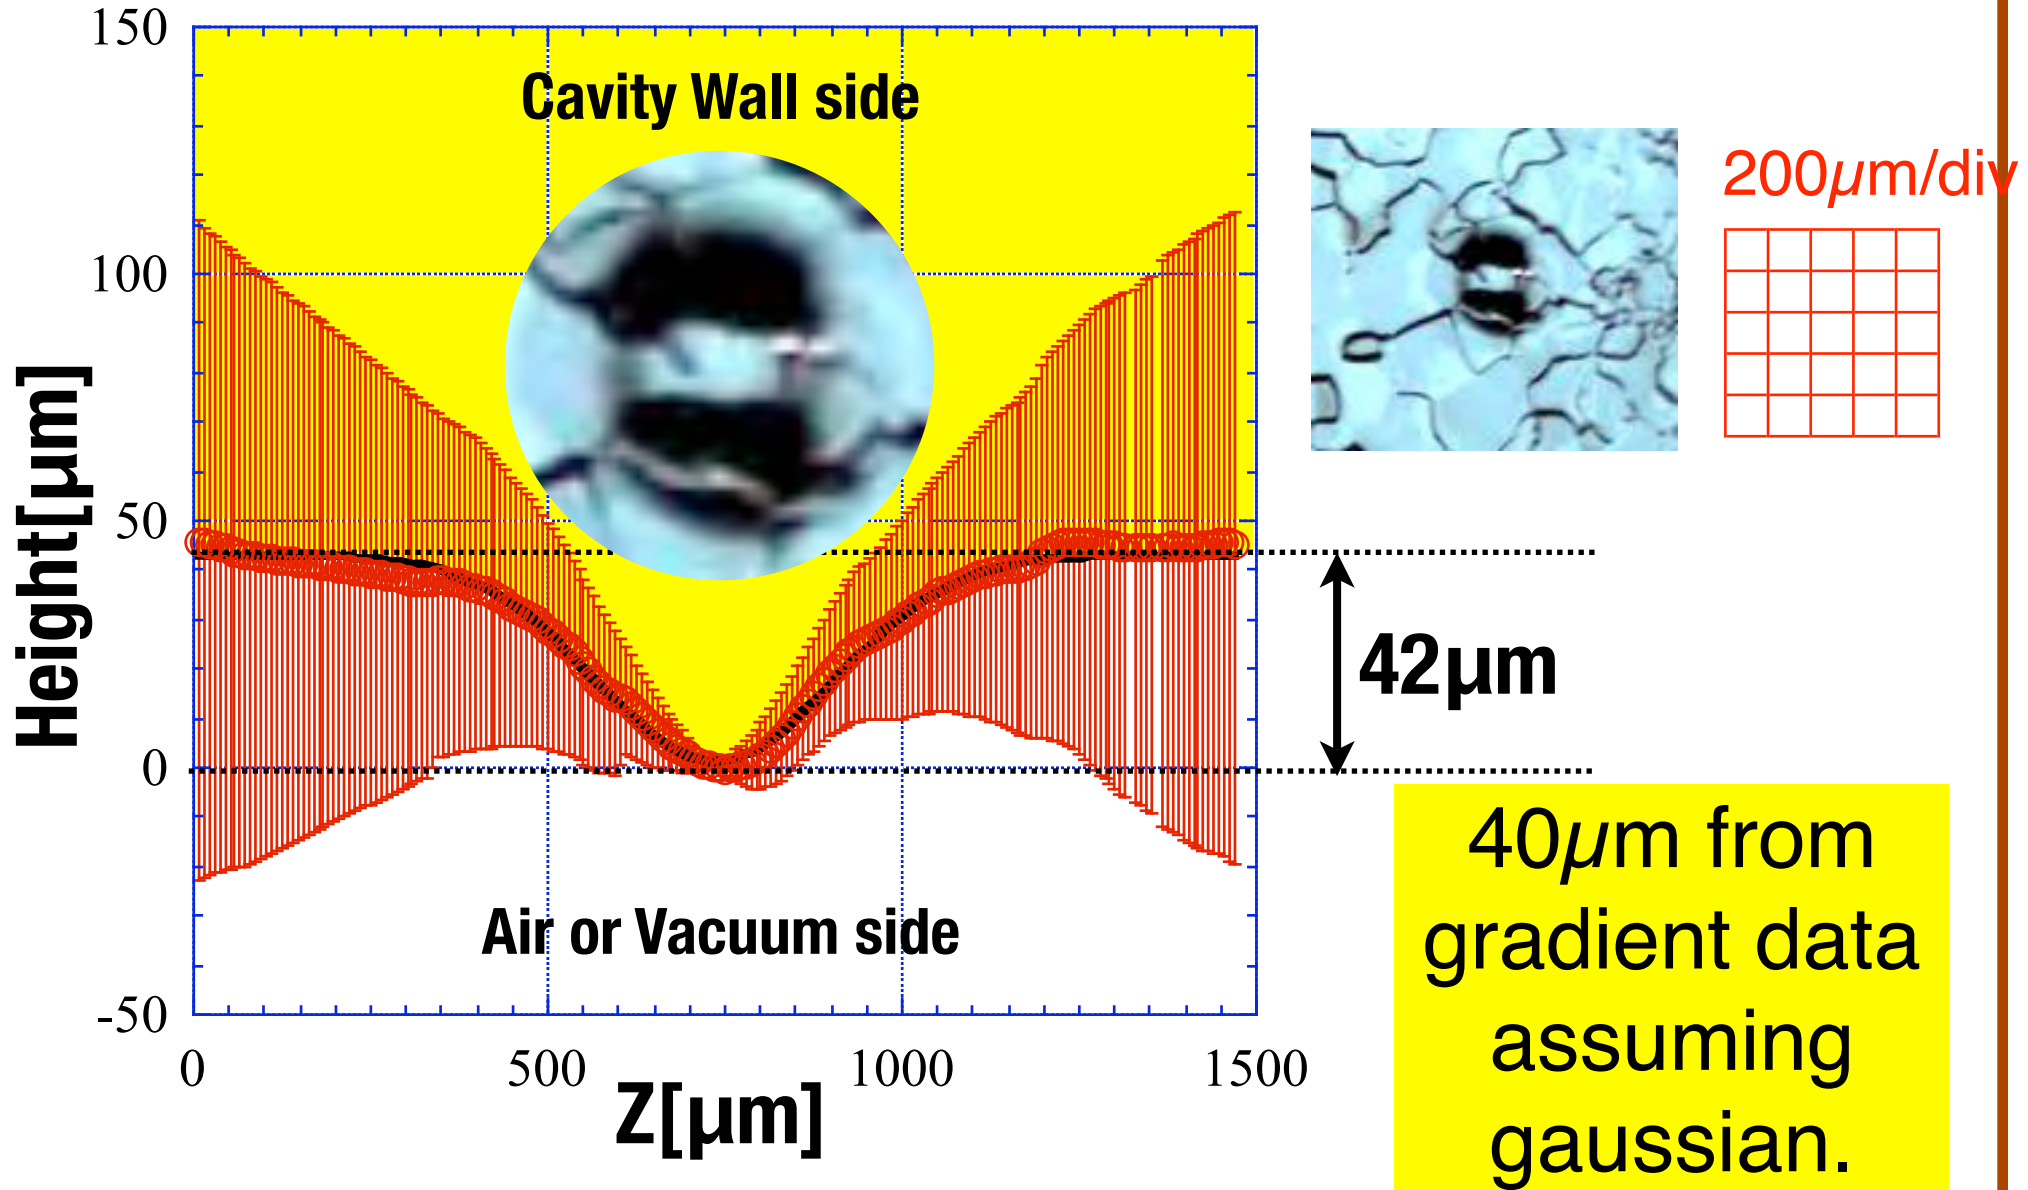
Height of spot at #3 cell 181°

Black curve is a fitted gaussian.

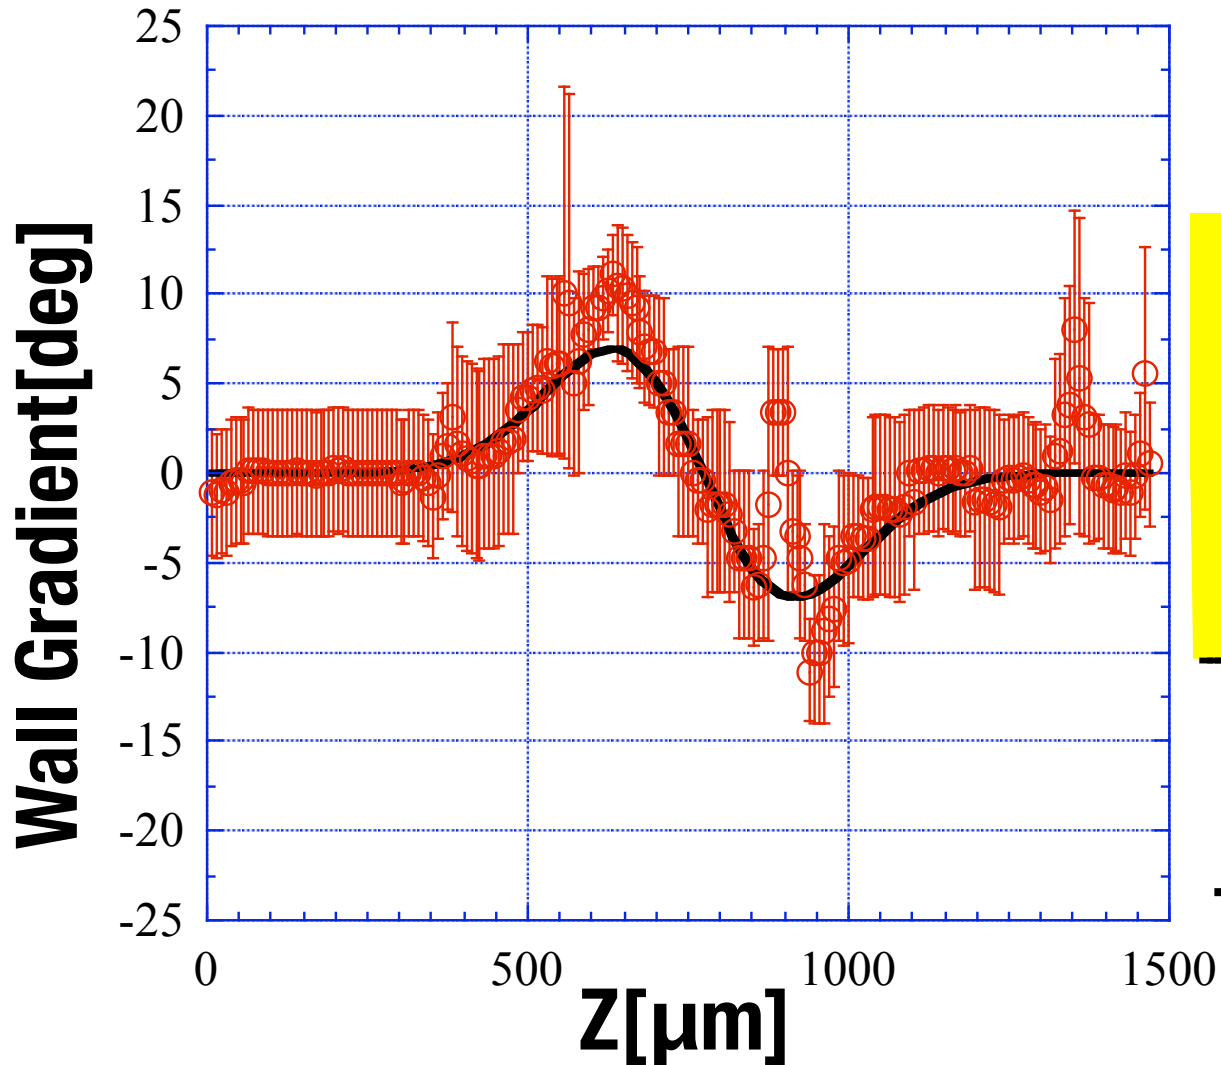
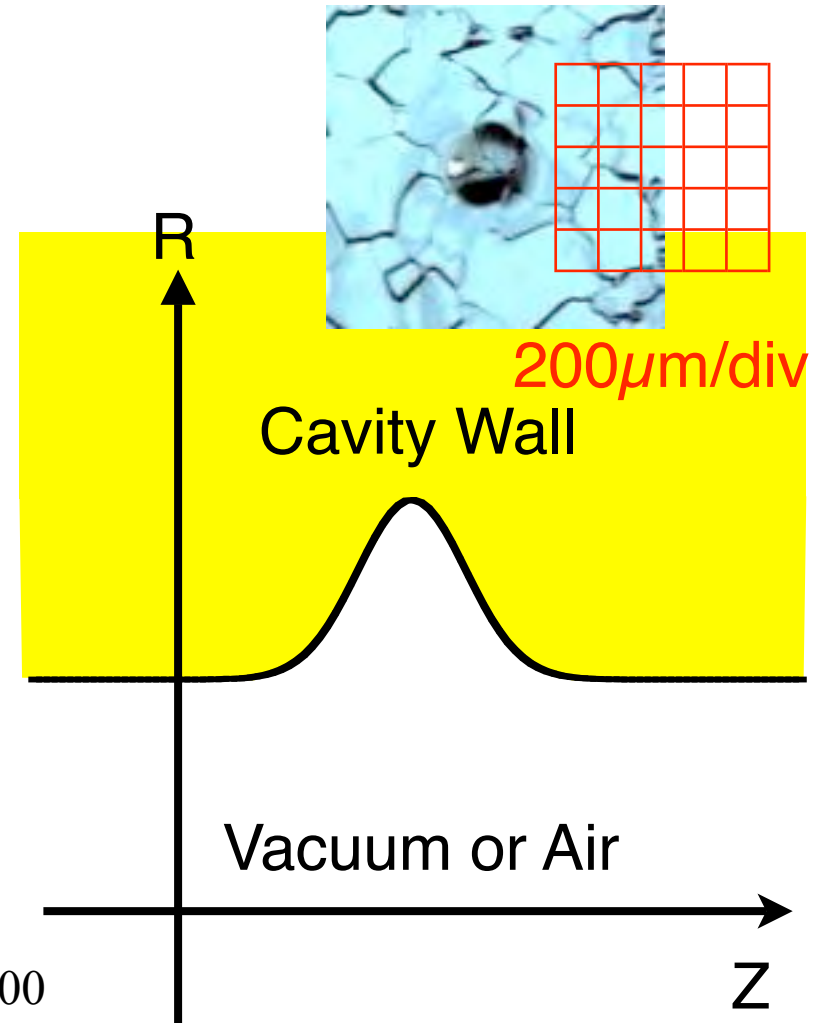
Wall Gradient of spot at #7 cell 325°

This data shows that the spot is a concave(pit).
