DEVELOPMENT OF A HIGH RESOLUTION CAMERA AND OBSERVATIONS OF SUPERCONDUCTING CAVITIES

Y. Iwashita, Kyoto University, Uji, Kyoto, JAPAN

H. Hayano, KEK, Ibaraki, JAPAN

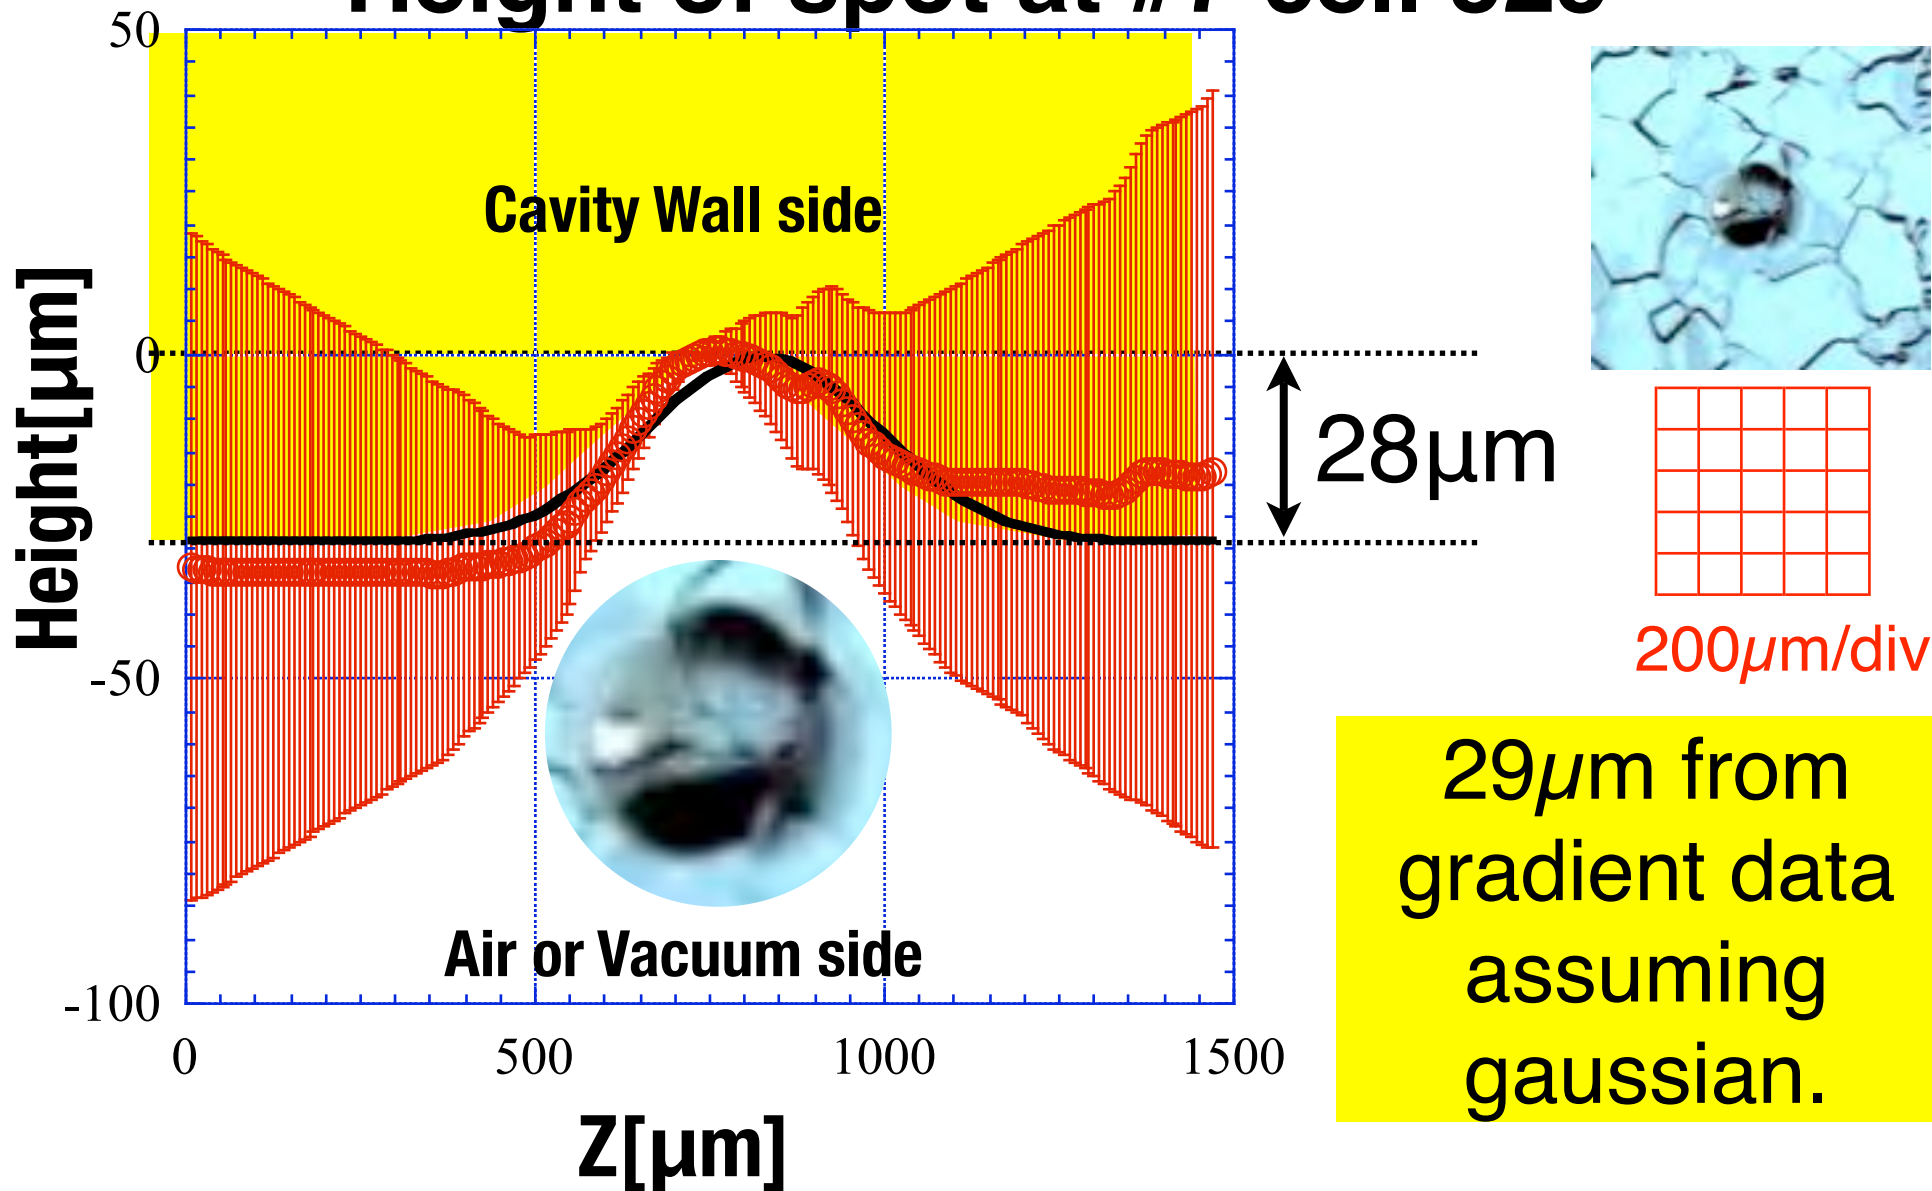
Height of spot at #7 cell 325°

Black curve is a fitted gaussian.

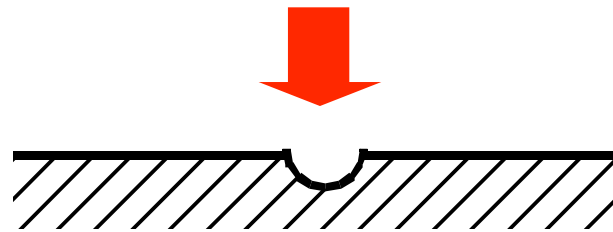
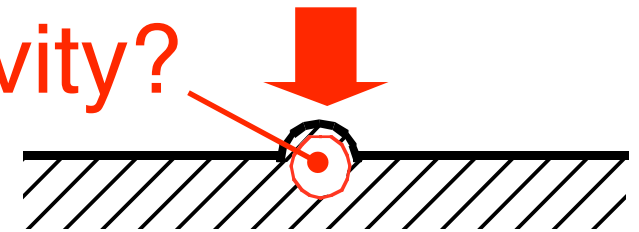
A Speculation

Impurity inside?

Eruption!

Bulge

Transition region?

cavity?

Seam center?

Hot enough to melt over

Nothing left if temperature is high enough

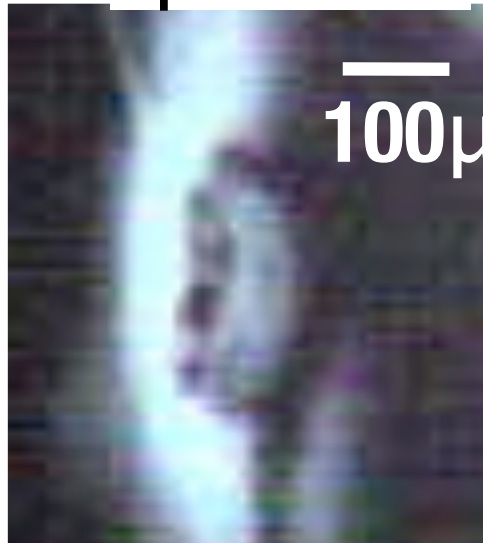
AC74:
spot1 95°

Stiffener out side? 95°, 141°

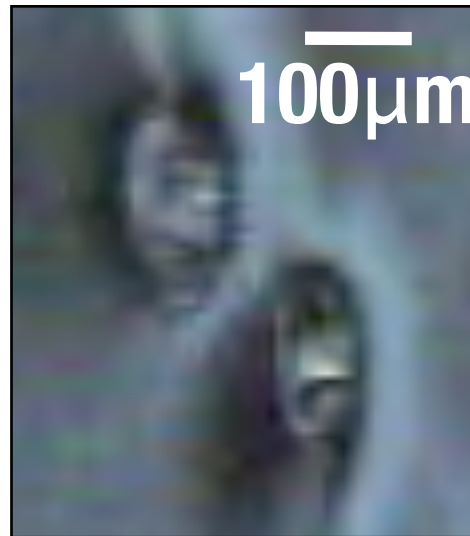
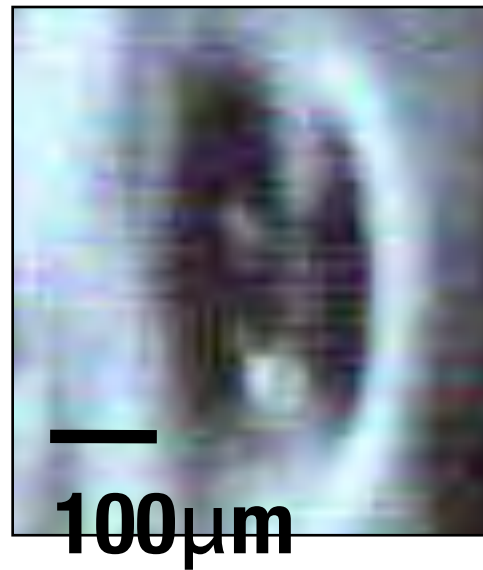
AC80

Spot location

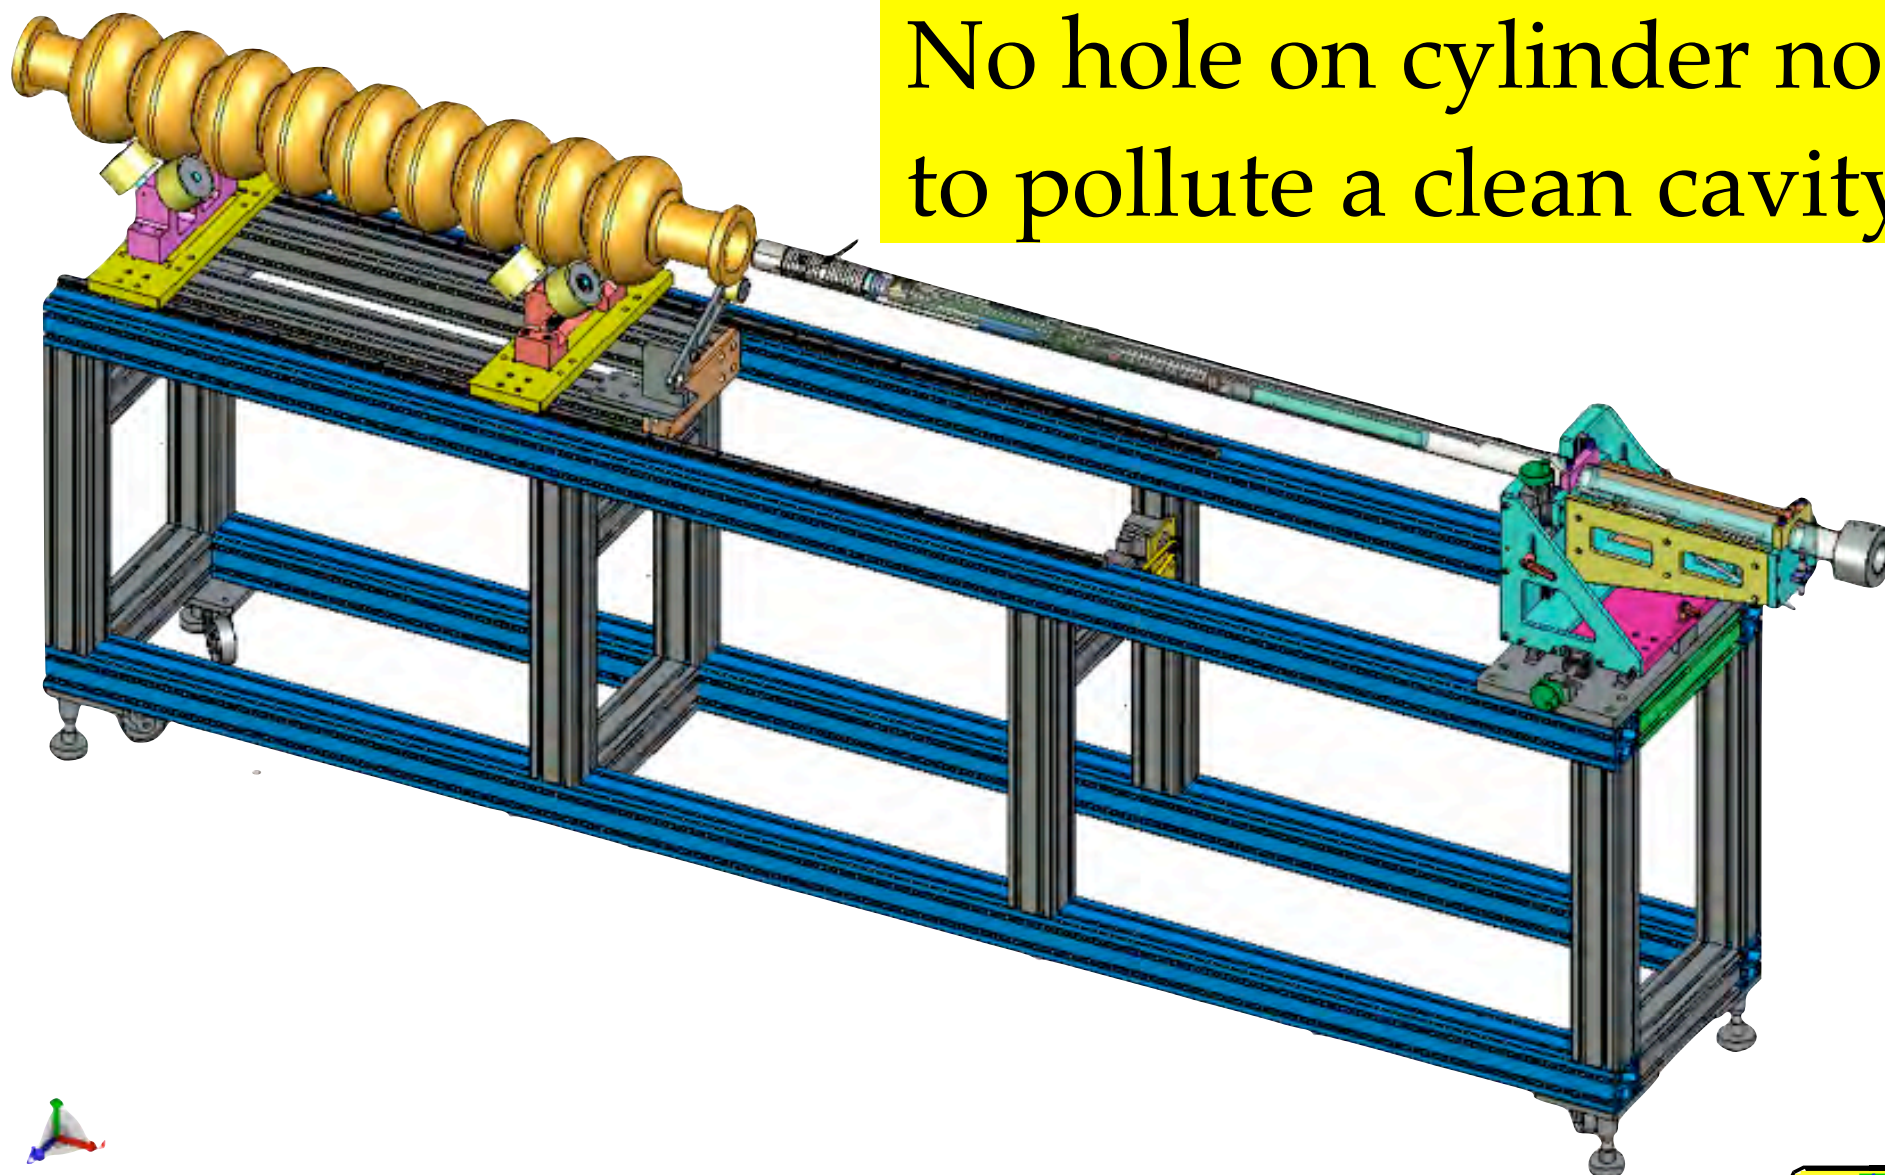
Prototype design for production series

No hole on cylinder not to pollute a clean cavity

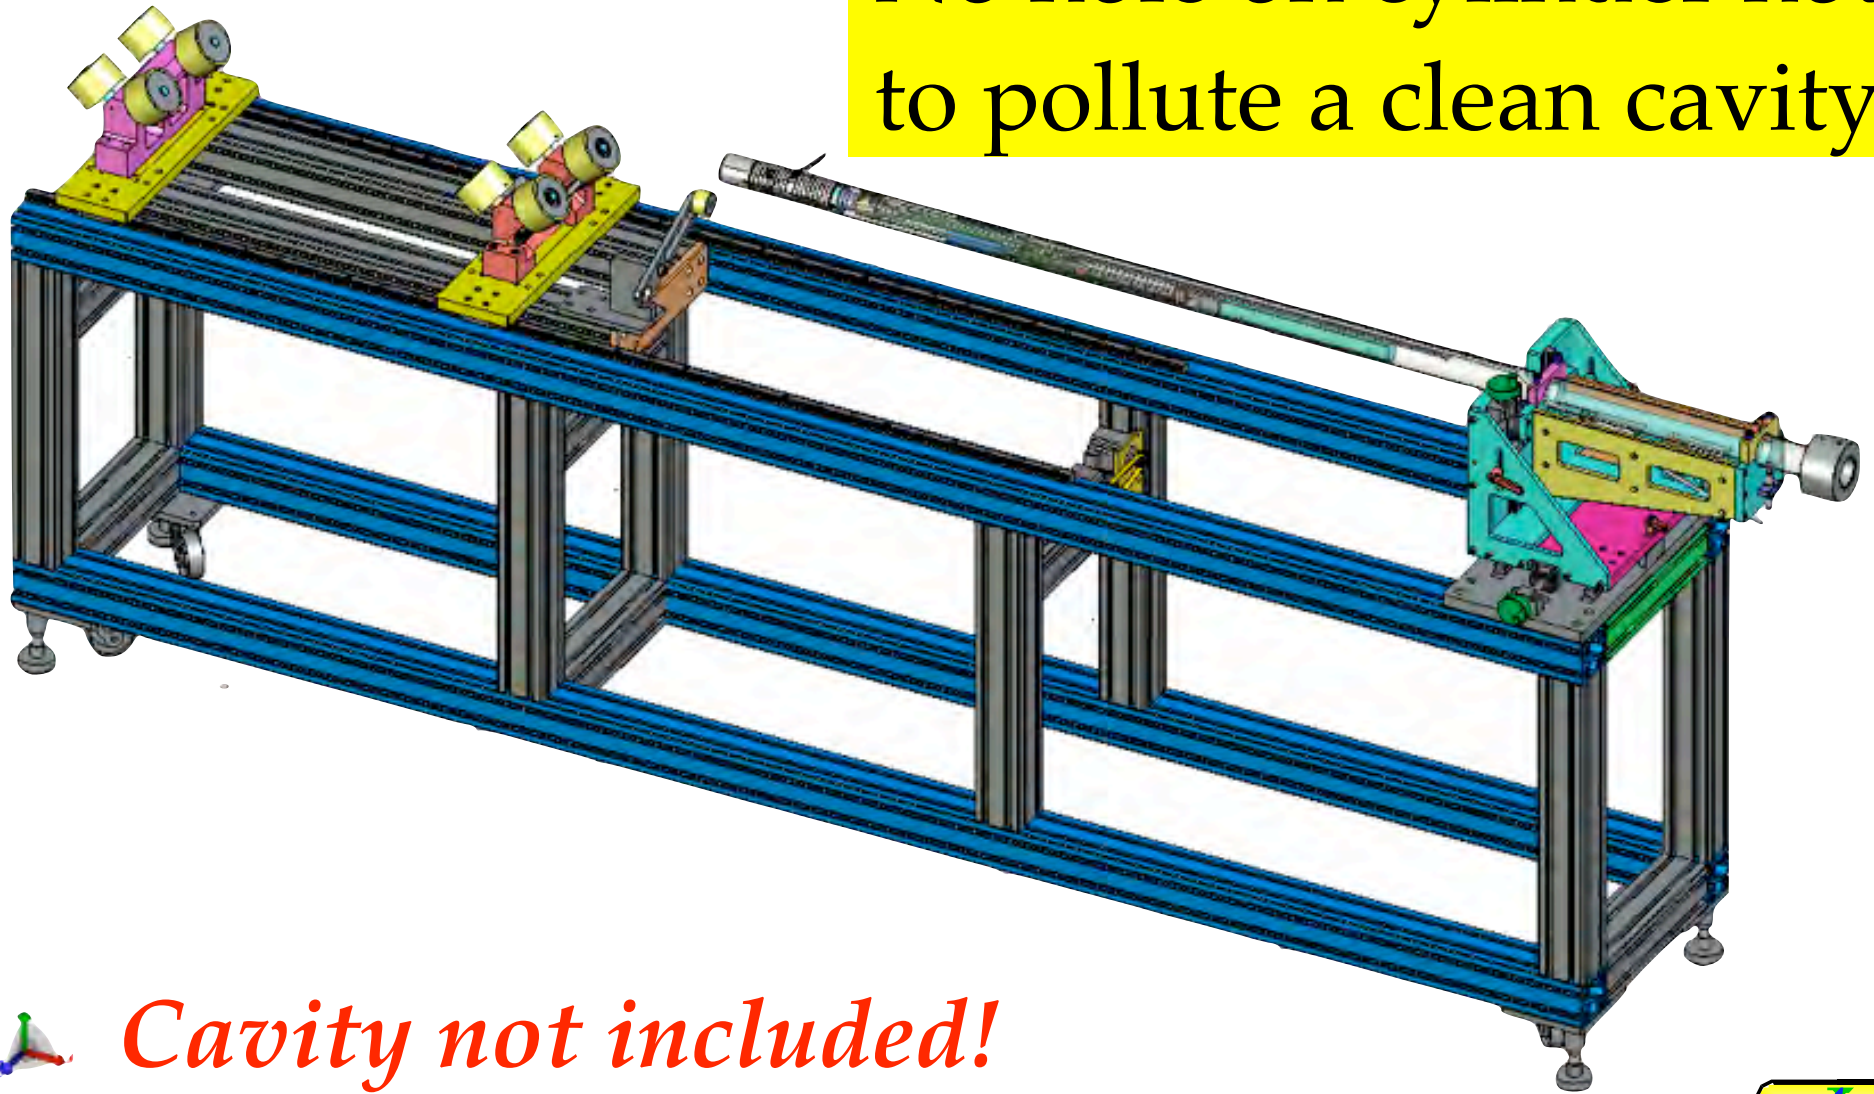
Prototype design for production series

No hole on cylinder not to pollute a clean cavity

*Cavity not included!*
