# RELIABILITY AND MAINTENANCE OF PLS LINAC MECHANICAL SYSTEMS\*

K. R. Kim<sup>†</sup>, S. J. Kwon, S. H. Kim, Y. J. Park, H. G. Kim, K. W. Suh,  
S. H. Nam, C. W. Chung and W. Namkung.  
Pohang Accelerator Laboratory, POSTECH  
Pohang, 790-784, Republic of Korea

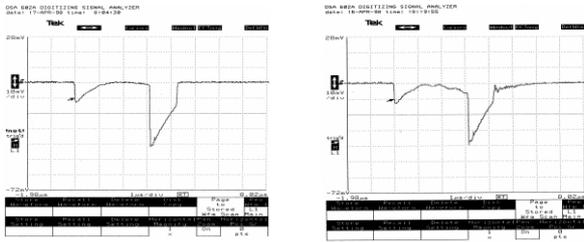
Figure 1: The RF waveform of pulse compressor output power; within temperature control of  $45\pm 0.1$  °C (left) and beyond temperature control of  $45\pm 0.5$  °C (right)[2]

There are total twelve SLED-type pulse compressors to amplify the RF power from the klystron into accelerating columns. PLS SLED consists of two TE015 mode resonant cavities, 3dB power divider, and water cooling tubes for temperature control. The cavity temperature must be held constant to within 0.3 °C to maintain the difference between the driving frequency and the cavity resonant frequency less than 16 kHz[4]. The PLS temperature control system holds the temperature fluctuations to better than  $\pm 0.1$  °C, by using independently dedicated temperature controller of SLED cavities. An example of the output power waveform of pulse compressor according to cavity temperature variation is shown in Fig. 1. Through the periodic tuning test, the system is identified so that the RF phase of the pulse compressors is sustained very stable by optimising temperature control variation of the structures.

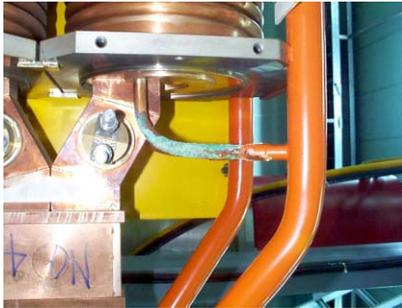
Figure 2: Water leaks in tube joint of SLED system

As the operation time increases, the cooling tubes for supplying the temperature-controlled water appeared the water leaks at the dissimilar metal joints such as stainless steel manifold and OFHC copper tubes. It is estimated due to the corrosive products activated by a chemical reaction under air exposure condition[5]. Figure 2 shows an example of the water leaks in joint area for the SLED

water supply. The more analysis of causes of corrosion will be performed in near future.

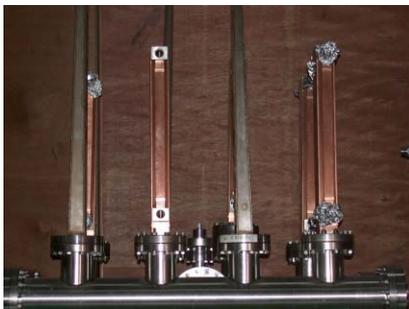
Figure 3: SiC loads and water-cooled RF loads under vacuum processing

RF output load has a function of absorption of residual travelling wave around the exit of accelerating column without reflection. The direct water-cooled RF output loads produced by IHEP were initially installed in the accelerating columns. At commissioning stages, some RF loads appeared water leaks in welded joint due to the fabrication errors. Recently, new indirect RF output load using SiC ceramic developed by H. Matsumoto[6] was adopted to prevent the water leaks. SiC loads was successfully operated with up to 50-MW of RF power at a  $1 \mu\text{s}$  pulse width and 50 Hz repetition rate in the 2856 MHz. The input VSWR obtained was less than 1:1.1 at the maximum RF power. In order to prevent the water leaks by micro-cracks on the welding point of the water-cooled output loads, the newly designed SiC loads were prepared and replaced. Six modules including preinjector in PLS linac have been replaced with SiC output loads. The fabricated SiC loads and water loads under vacuum processing are shown Fig. 3.
