# IMPROVED SR EXTRACTION CHAMBER FOR KEKB LER SR MONITOR

J.W. Flanagan, S. Hiramatsu, H. Ikeda, K. Kanazawa and T. Mitsuhashi  
 KEK, Oho 1-1, Tsukuba, Ibaraki 305-0801 Japan

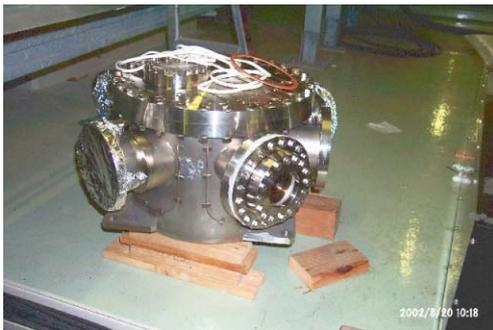
Figure 1: Original chamber, exterior view.

The original LER synchrotron radiation extraction chamber was installed in the ring in 1998 prior to the initial commissioning. The design employs a cylindrical vacuum chamber through which runs a segment of beam pipe.[1] Both chamber and beam pipe are made of stainless steel. The water-cooled beryllium extraction mirror is mounted in a notch in one side of the beam pipe at a 45-degree angle. RF contact fingers are used to mate the mirror to the edges of the notch.

Opposite from the extraction mirror are two titanium-coated windows mounted in the wall of the beampipe. One window is directly across the pipe from the extraction mirror in the synchrotron light path. The other window is located next to the first one and is used for observation of the mirror surface and to check the proper seating of the RF fingers around the mirror. The interior windows are coated with a thin layer of titanium (0.5 microns) to minimize disturbance to surface currents in the wall, however the windows are not vacuum sealed. Sealed windows are located on the outer chamber on axes extending from the mirror and through the inner windows.

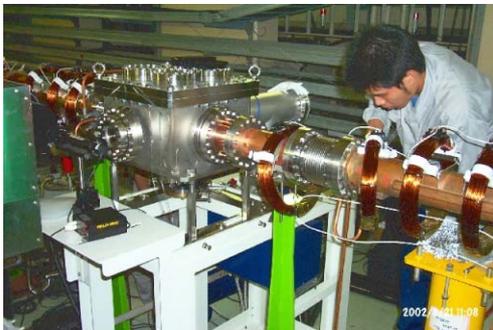
Figure 6: Installation of new LER synchrotron radiation extraction chamber.

The new chamber is shown in Figures 6, 7 and 8. The most significant change was to make the beampipe out of copper, except for a section of beampipe outside the containment chamber connecting to a flange which was made of copper-plated stainless steel. The greater conductivity
