FIRST BEAM ACCELERATION IN KOLKATA SUPERCONDUCTING CYCLOTRON AND ITS PRESENT STATUS

C MALLIK

Variable Energy Cyclotron Centre Kolkata, India

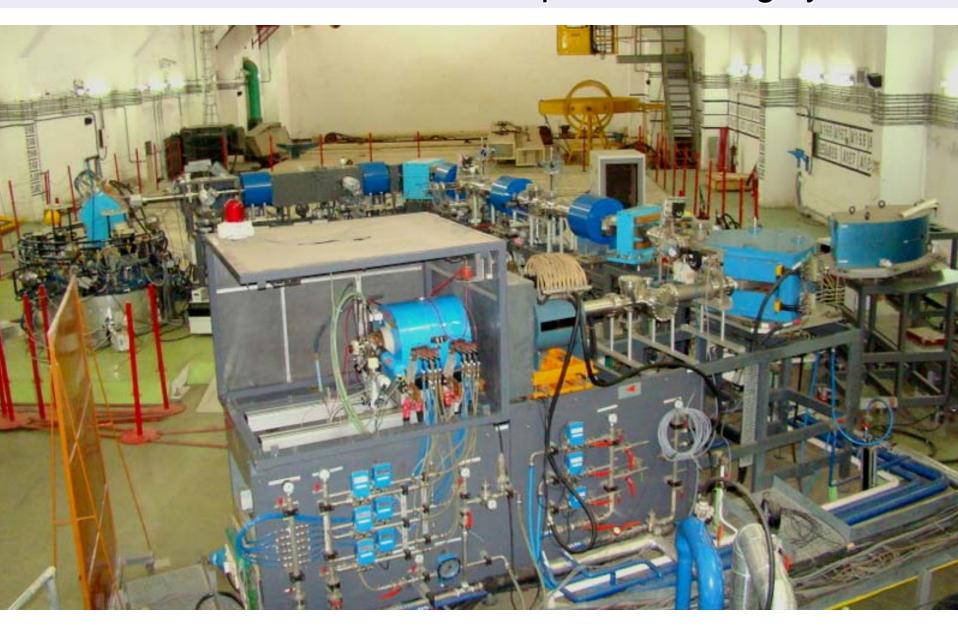
14 GHz ECR Ion source for Superconducting cyclotron

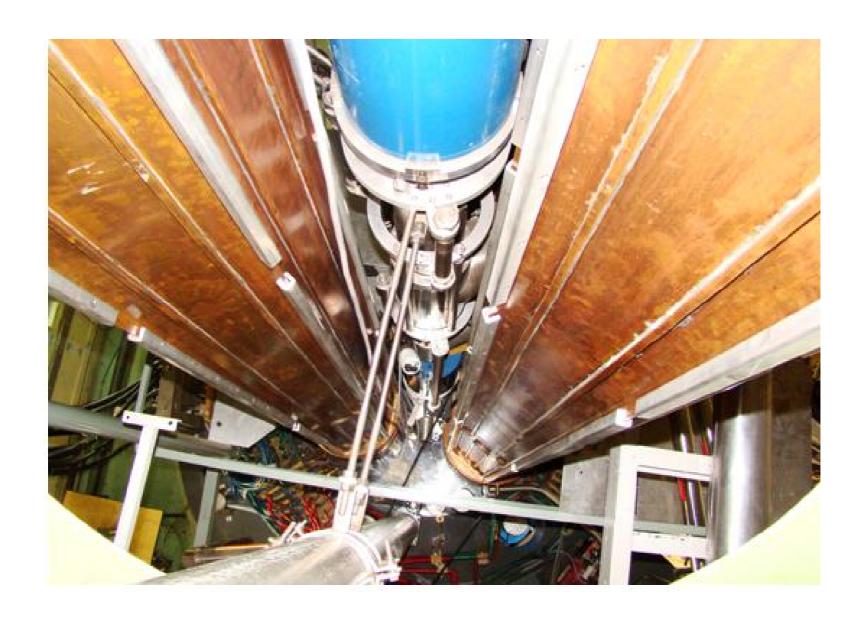
BEAM INJECTION FROM TOP OF THE CYCLOTRON

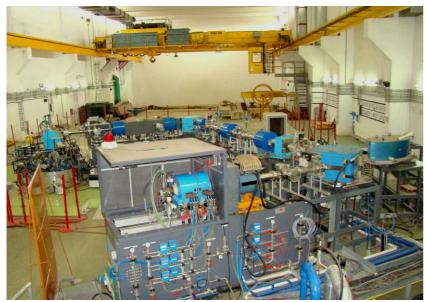
ECR and Injection beam line

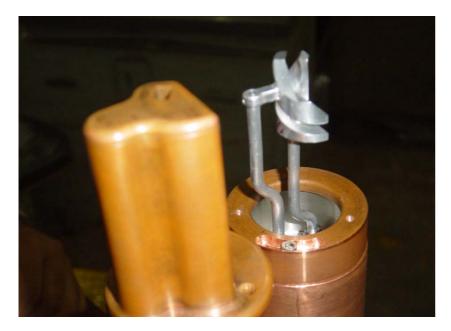
Spiral Inflector and its housing

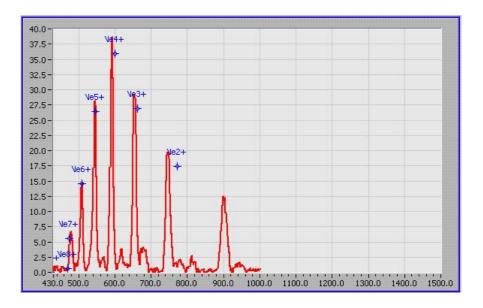
Various charge states of Neon from ECR

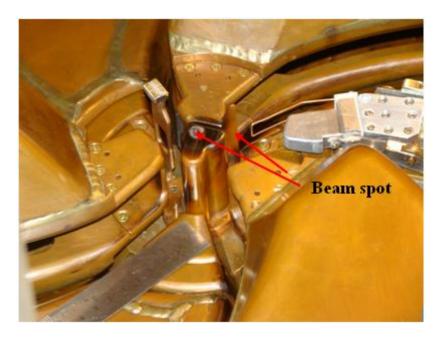
Beam mark on inflector cover

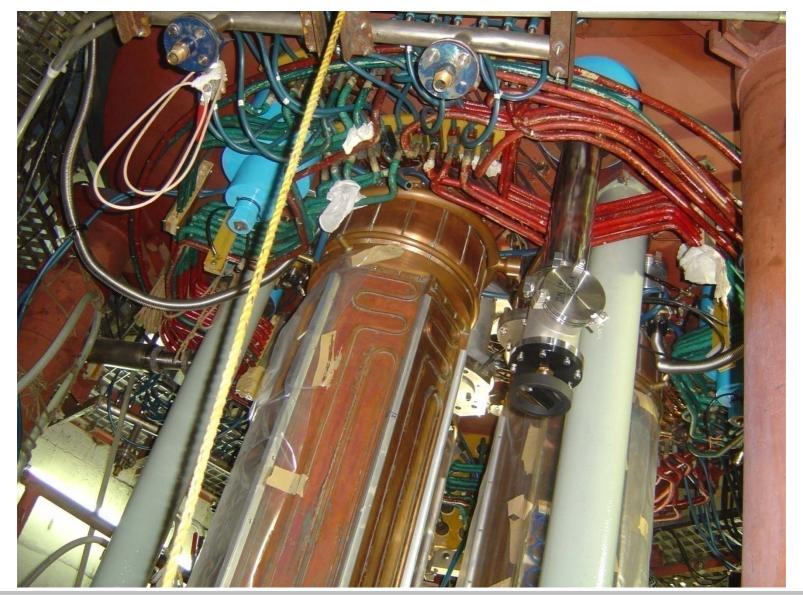
Lower RF cavity assembly showing the outer conductor spinning, hexagonal panels, trim coil leads, etc.

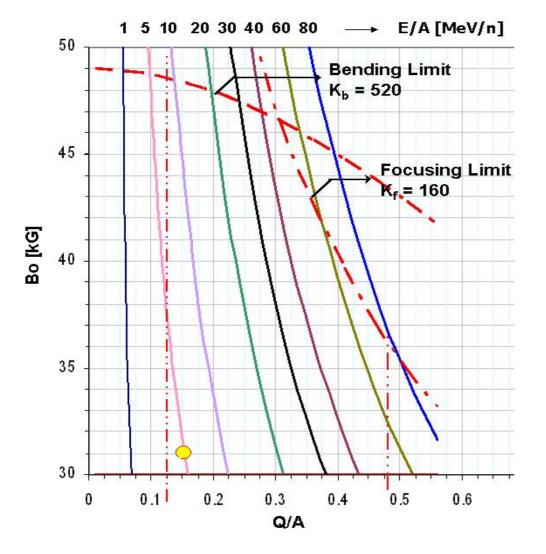
Ion Ne 3+, Q/A = 0.1487 V_{ECR} =4.408 kV, T=4.44 MeV/u, harmonic mode h=2, v_{RF} =14.001 MHz, $B_0 = 30.9 \text{ kG},$ $V_{Dee} = 41 \text{ kV},$ **R=26.24** inches

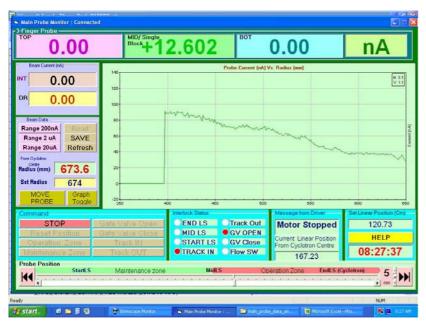
Beam current profile along radius

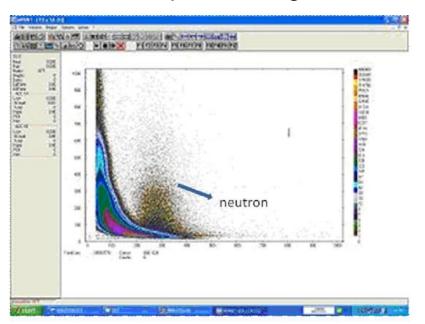
Neutron and gamma spectrum

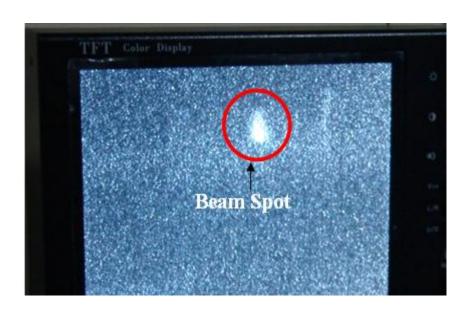
Accelerated Ne3+ Beam on viewer probe

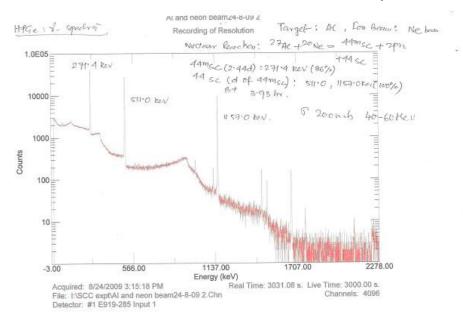
Gamma spectrum of activity of Al target irradiated by Ne beam

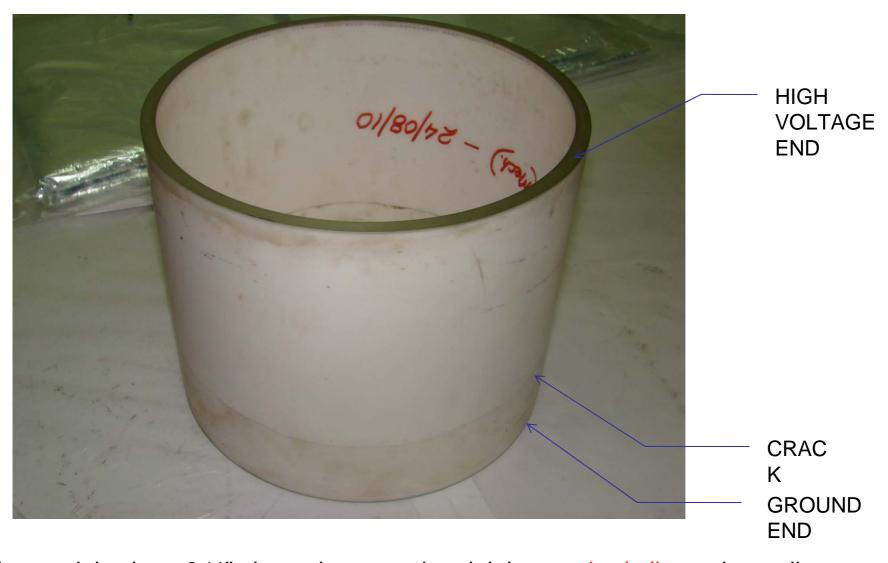
CERAMIC FOR UPPER 'B' CAVITY

The crack is about 2 ½" above the ground end. It is exactly similar to the earlier ceramic failures. This is fourth time happening. The previous ones were ceramics for lower 'A' cavity once and upper 'C' cavity twice.

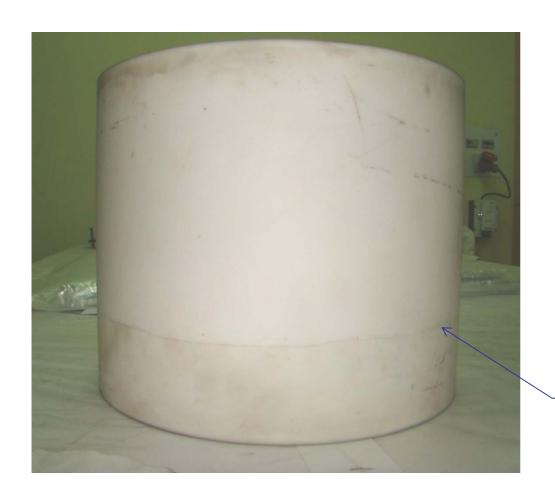
CREAMIC FOR UPPER 'B' CAVITY

- The ceramic inside surface is clean. Outside surface has a few black styrration marks, these marks are much less compared to the last failure.
- The vacuum rise was extremely fast at the time of failure. It went from 10⁻⁷ mbar to 35 mbar within a second.

CRACK
PENETRATED
THOUGH FULL
THICKNESS

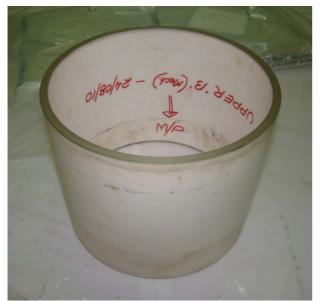
UPPER 'B' CAVITY CERAMIC

This time the o-rings have shown no damage, no burning, no heating evidence, no deformations also. The o-rings look like the new ones.

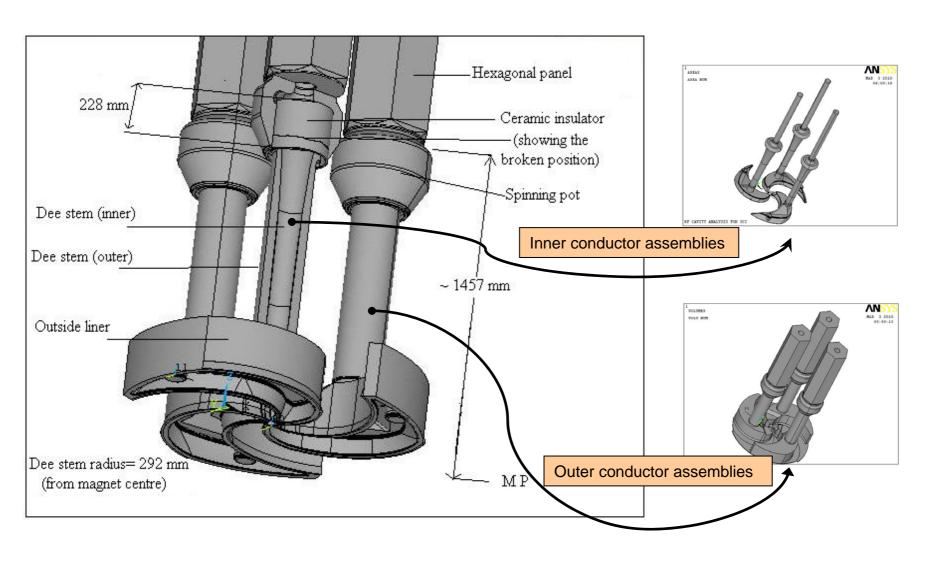
Electrical field distribution in the ceramic insulator

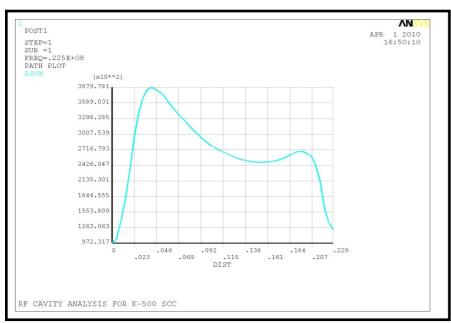
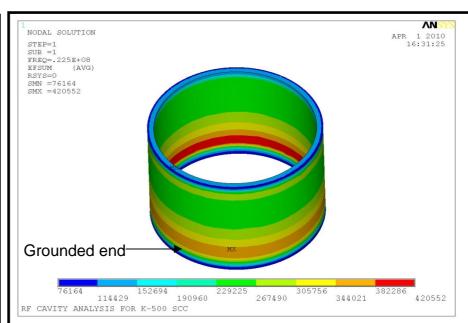
Electric field (0 end is grounded) along the length of ceramic

Electric field contour (Volt/mts)

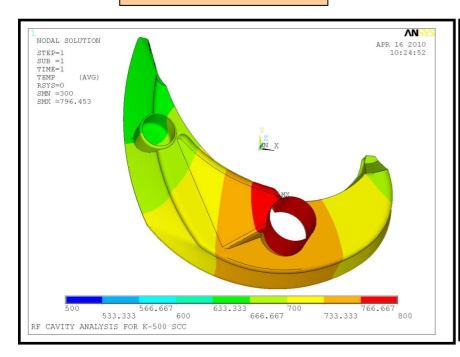
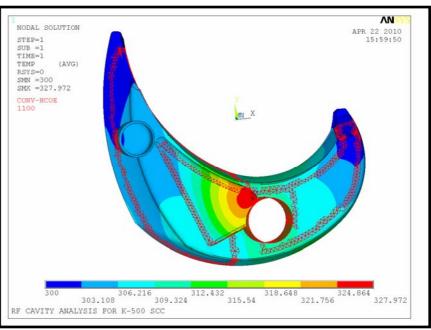
Temperature distribution inside Dee (with and without cooling)

Without cooling

With cooling water (3 lpm)

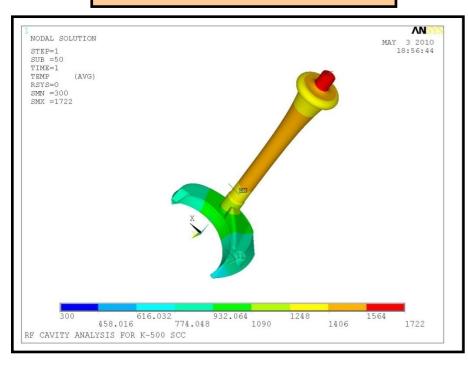
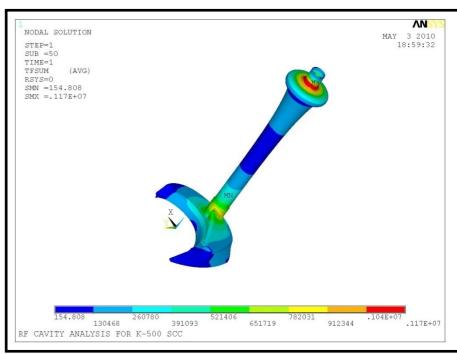
Surface loss distribution (Inner conductor, without cooling)

Temperature distribution

Heat flux distribution
