# ***J-PARC RECOVERY STATUS***

HB2012

**Kazami Yamamoto**

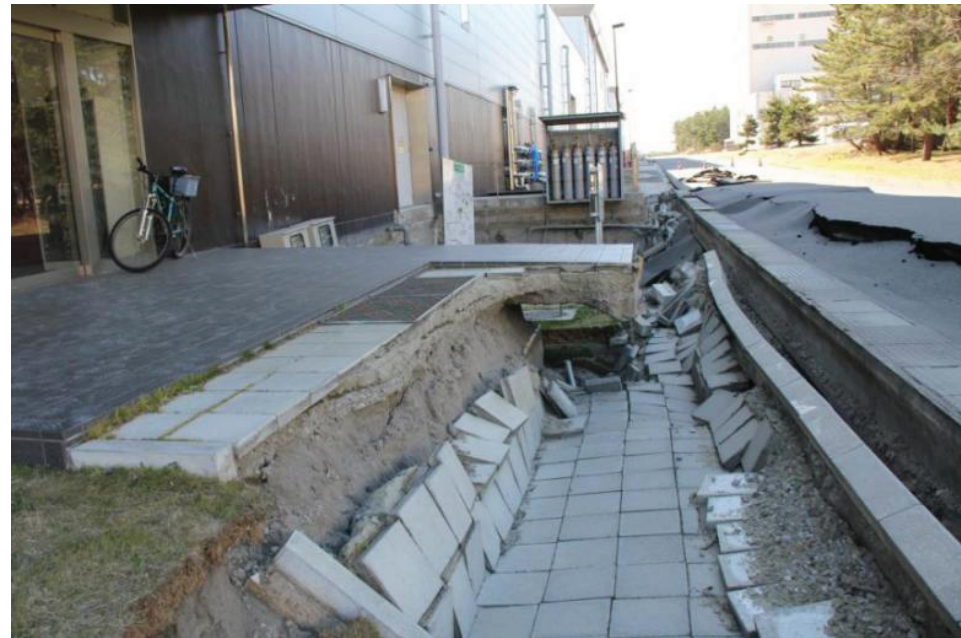
## **Entrance of the Linac**

**About 1.5 m drop over a wide area.  
Underground electric wires and  
water pipes were all damaged.**

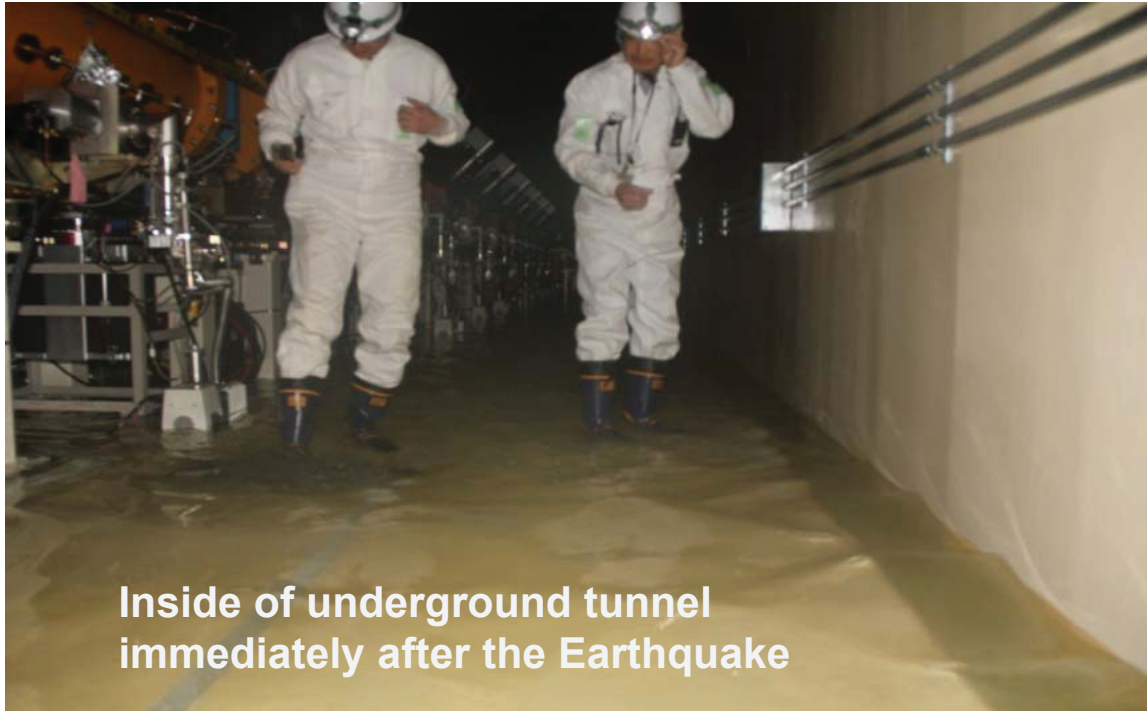
Inside of underground tunnel immediately after the Earthquake

**Linac tunnel has many piles that reached to a basement rock. These piles minimized a direct damage to the tunnel. However, groundwater leaked into the tunnel and the water depth increased to 10 cm (100 tons) within two weeks after the earthquake.**

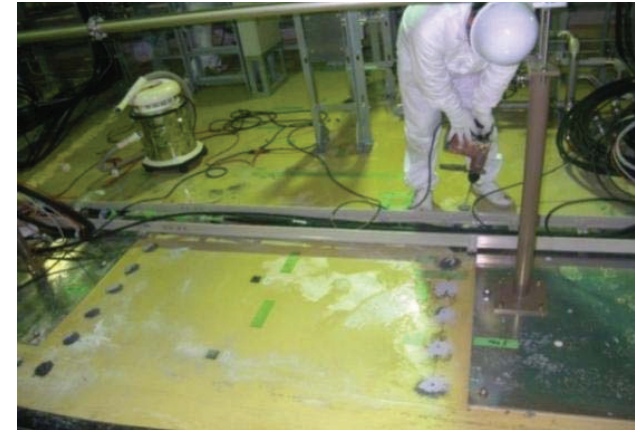
**Repairing water leaks in the tunnel is almost completed.**

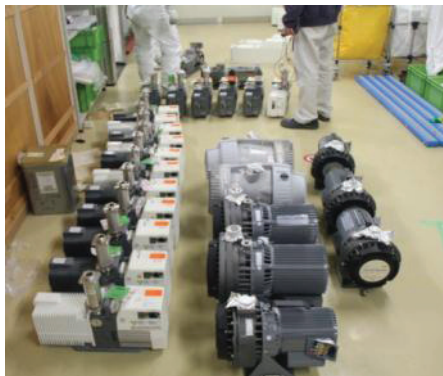
↑ Pumps with waters inside.

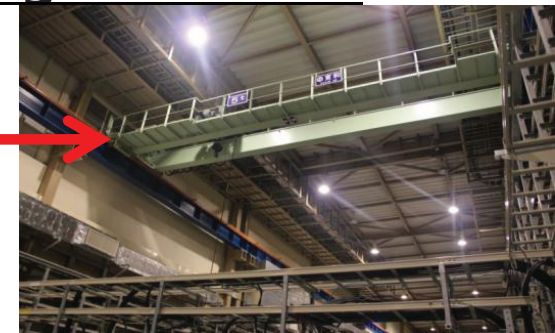
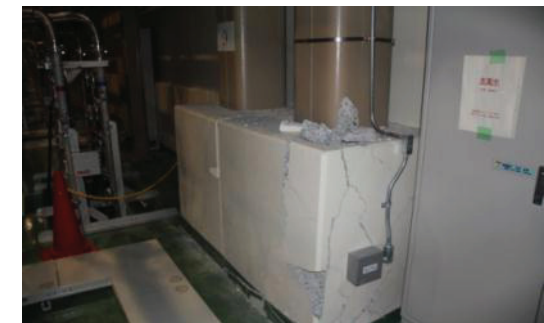
### Damage of Crane

- Many bolts were dropped from the crane.

bolts that were dropped.

Cracks seen on the pillar for the crane →

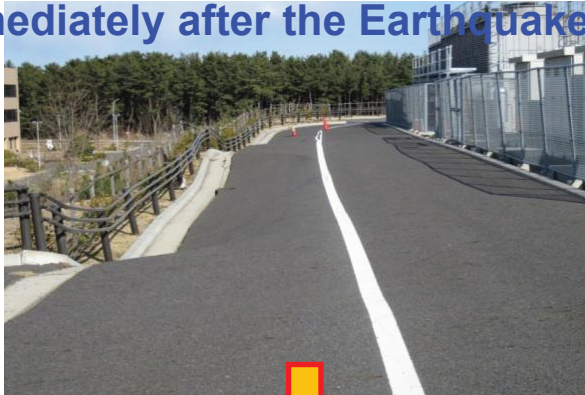
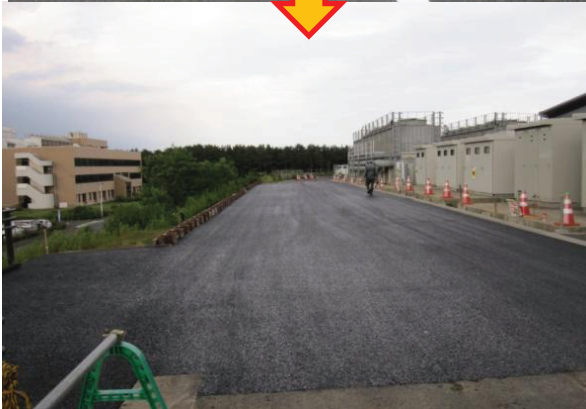
Immediately after the Earthquake

**The road was repaved.**

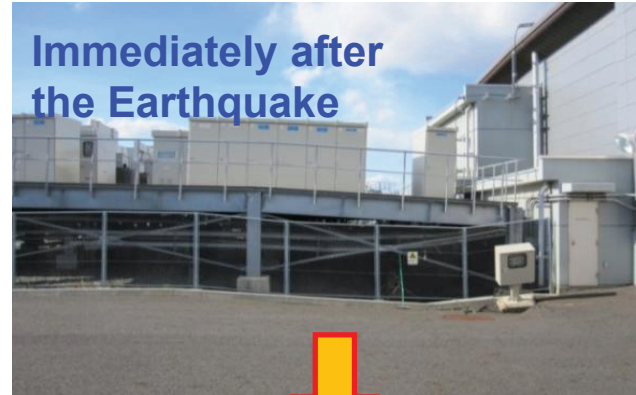
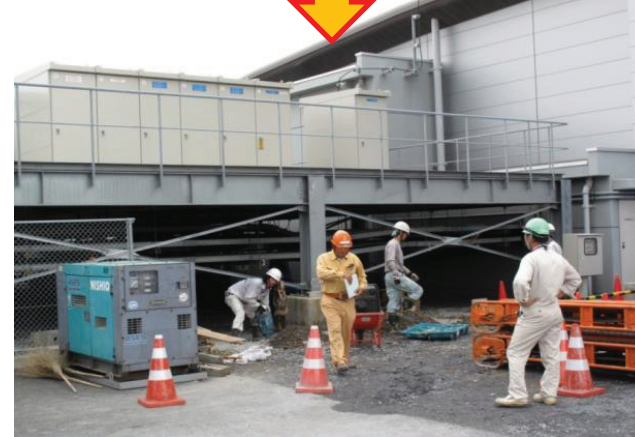
Immediately after the Earthquake

**The bent stage was repaired. Power was supplied to the RCS building after 5 month.**

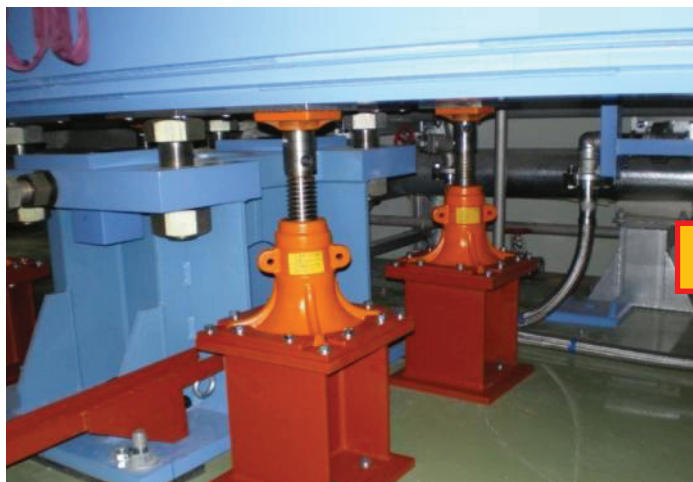
Jacking up an electromagnet to make a space between the magnet and the stage

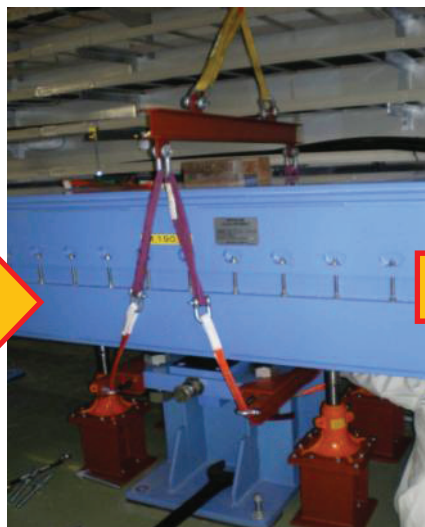
Hanging up the magnet

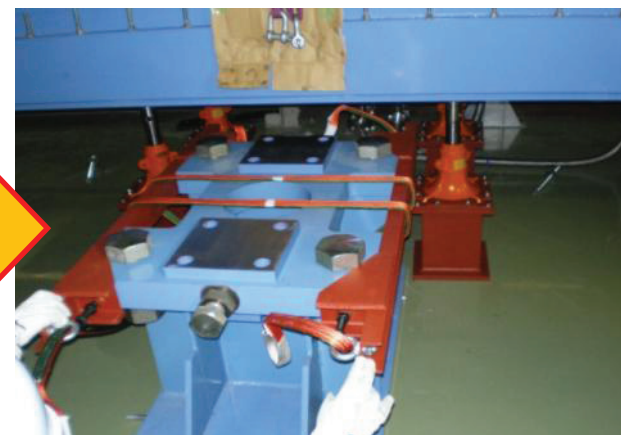
Pulling out the stage to put new longer height-adjust screws

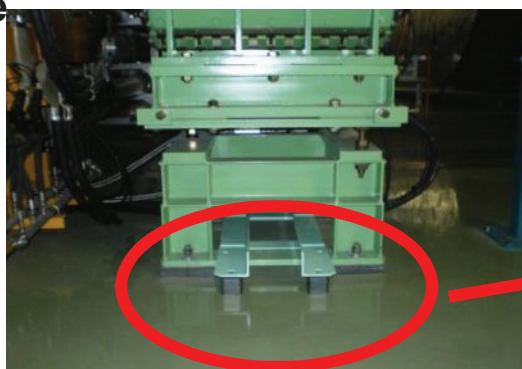
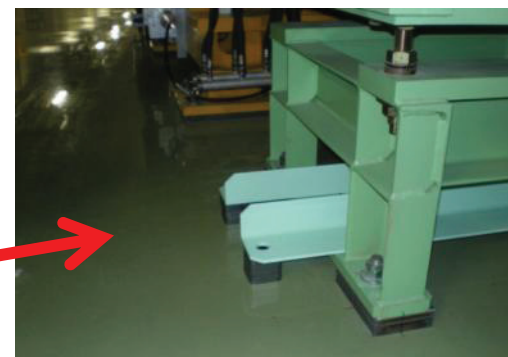
Sometimes we need to place an adapter to put a new longer anchor bolt.

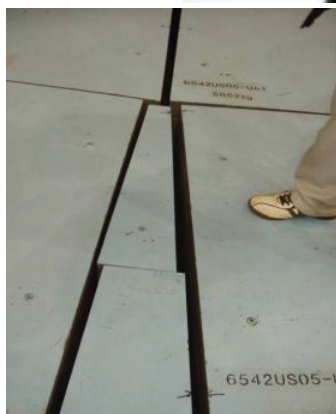
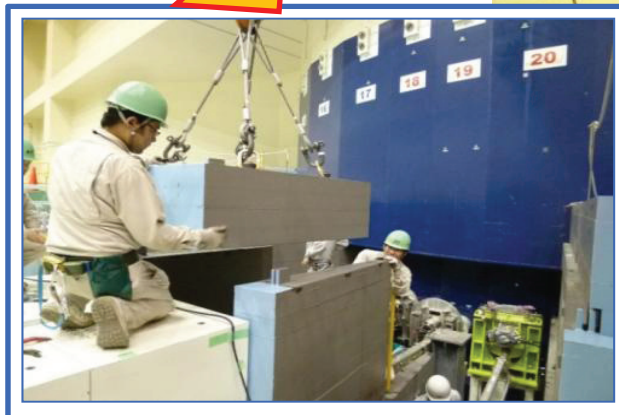
Immediately after the Earthquake

Reassembling work of shielding blocks for neutron beams in the 2<sup>nd</sup> experimental hall

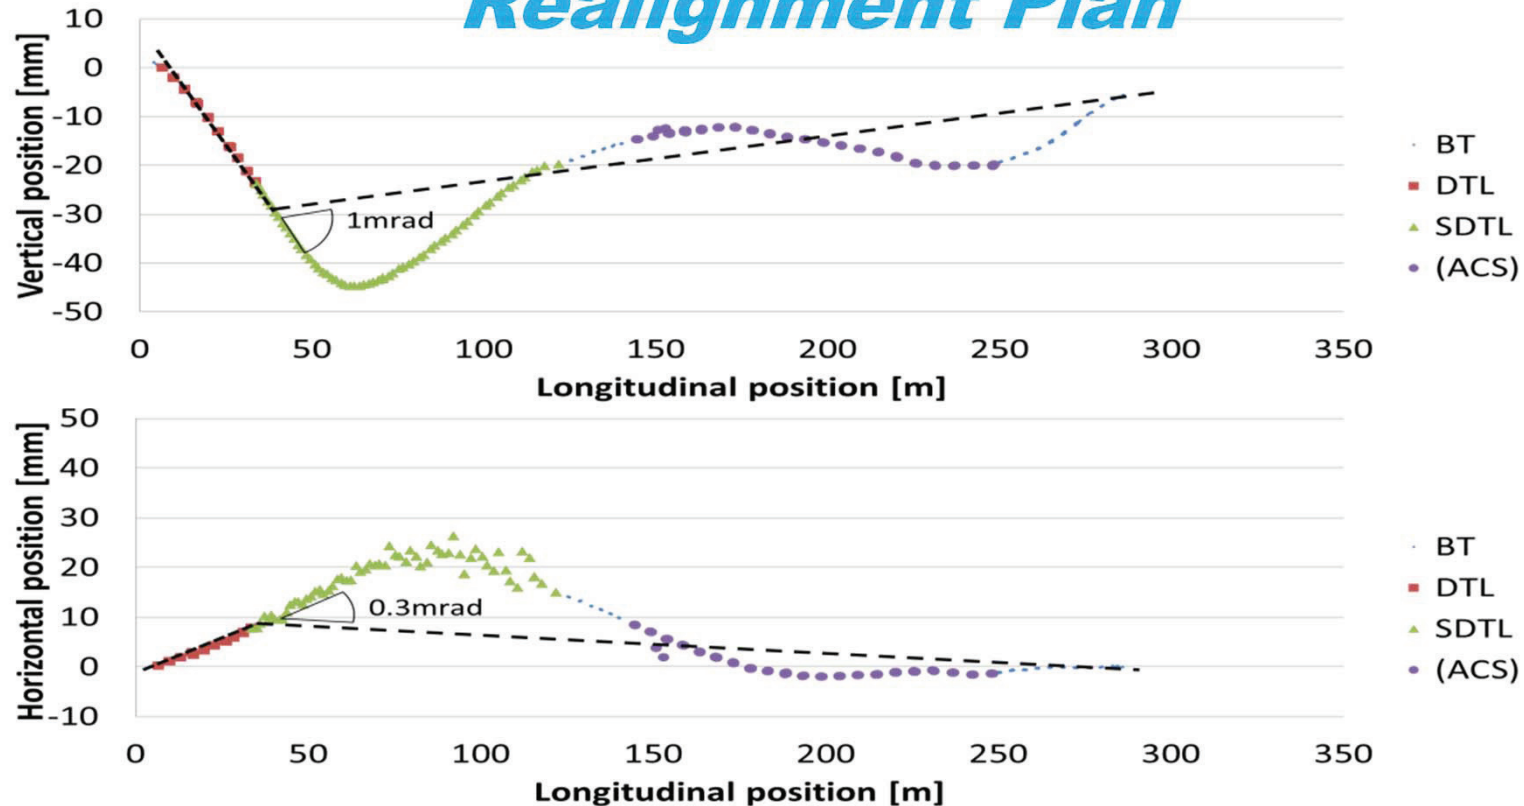
# Measured Displacement of the Linac and Realignment Plan

- The maximum subsidence and horizontal deformation are about 43 mm and about 25 mm, respectively.
- To aim at an early restart of the beam operation, we decided to steer the beam at the steering magnets downstream of the DTL section horizontally and vertically.
- The dashed line shows the target realignment line in the straight section.

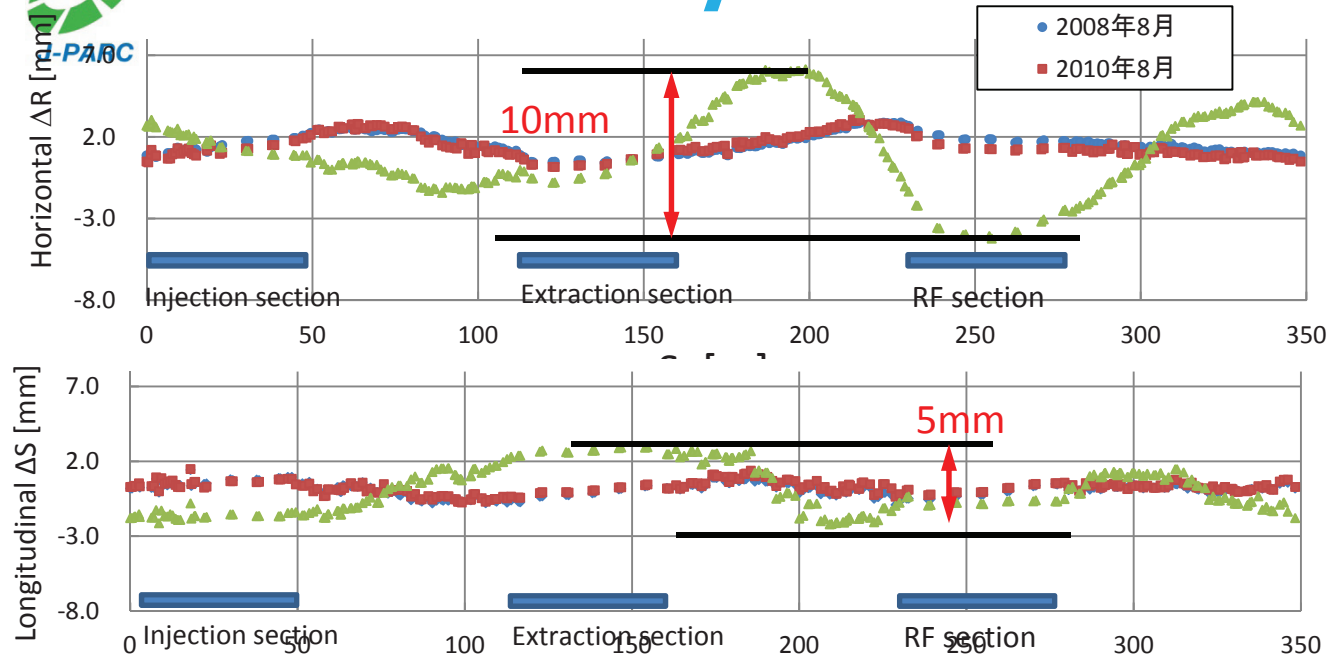
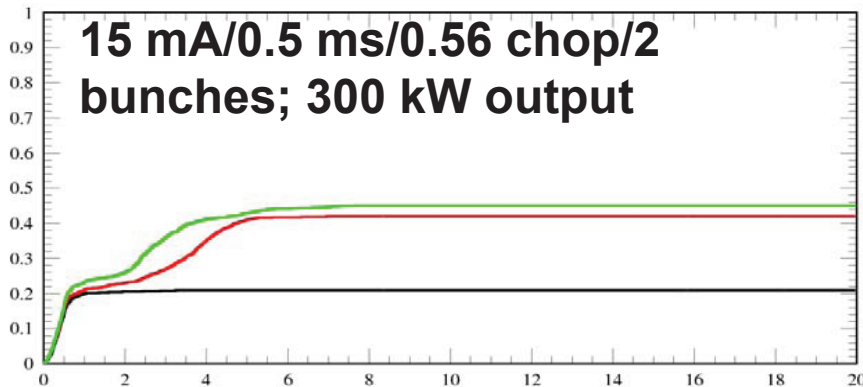
# Measured Displacement of the RCS magnets

**Black:** Before the earthquake

**Red:** After the earthquake

**Green:** After the earthquake with tune manipulation

-> Twice larger, but enough acceptable

The simulation shows that the RCS could operate at 300 kW without re-alignment, thus we decided that the re-alignment of RCS will perform in the summer shutdown of 2013.

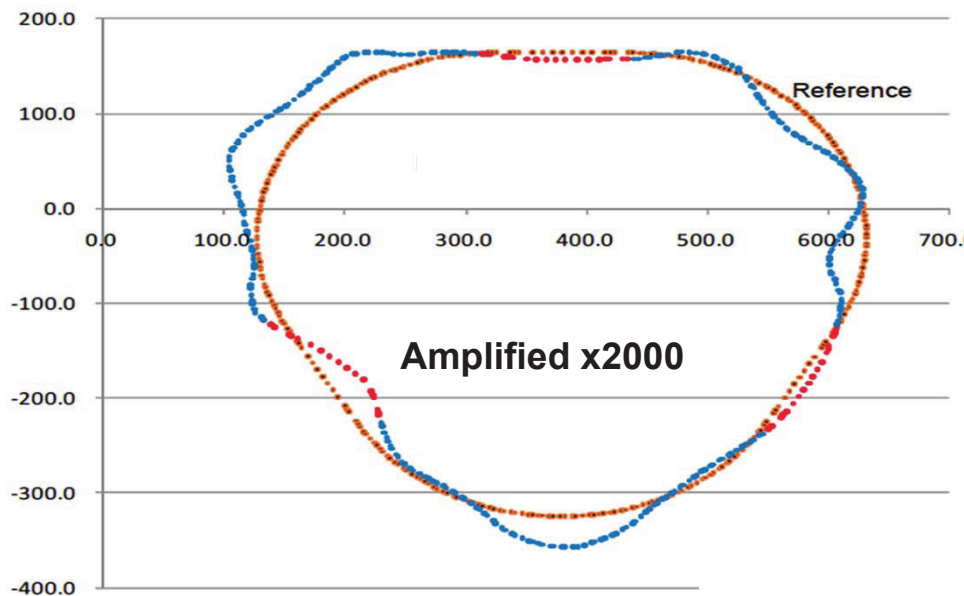
Red: Reference positions of electromagnets  
Blue: Actual positions after the earthquake  
(Please note the magnitude of displacement is amplified x2000.)

- All the magnets were realigned and set to zero position by the end of November 2011.

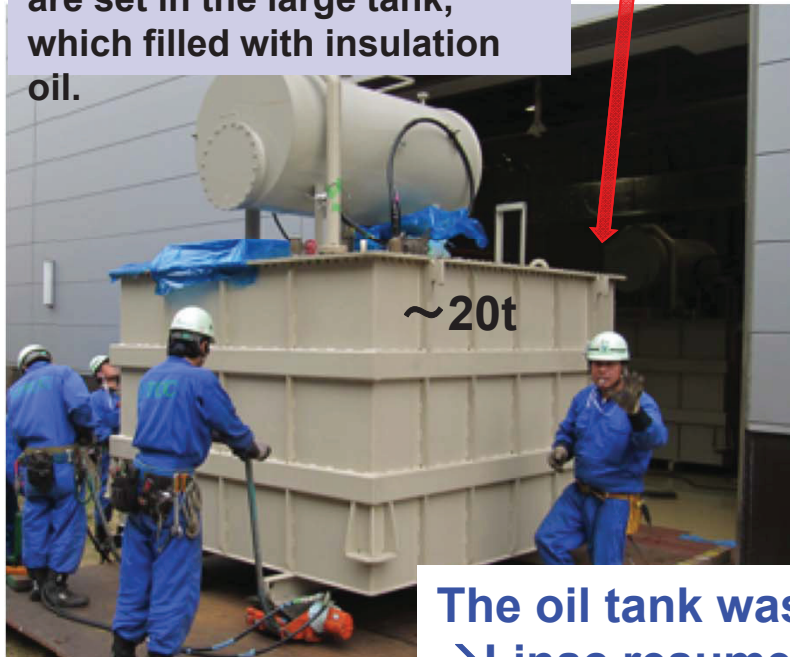
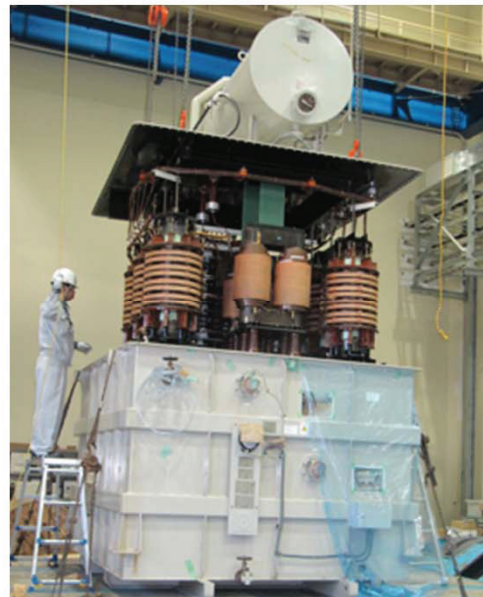
The oil tank was replaced with a spare ( used in rf test bench)  
→ Linac resumed the beam acceleration from April 5, 2012.

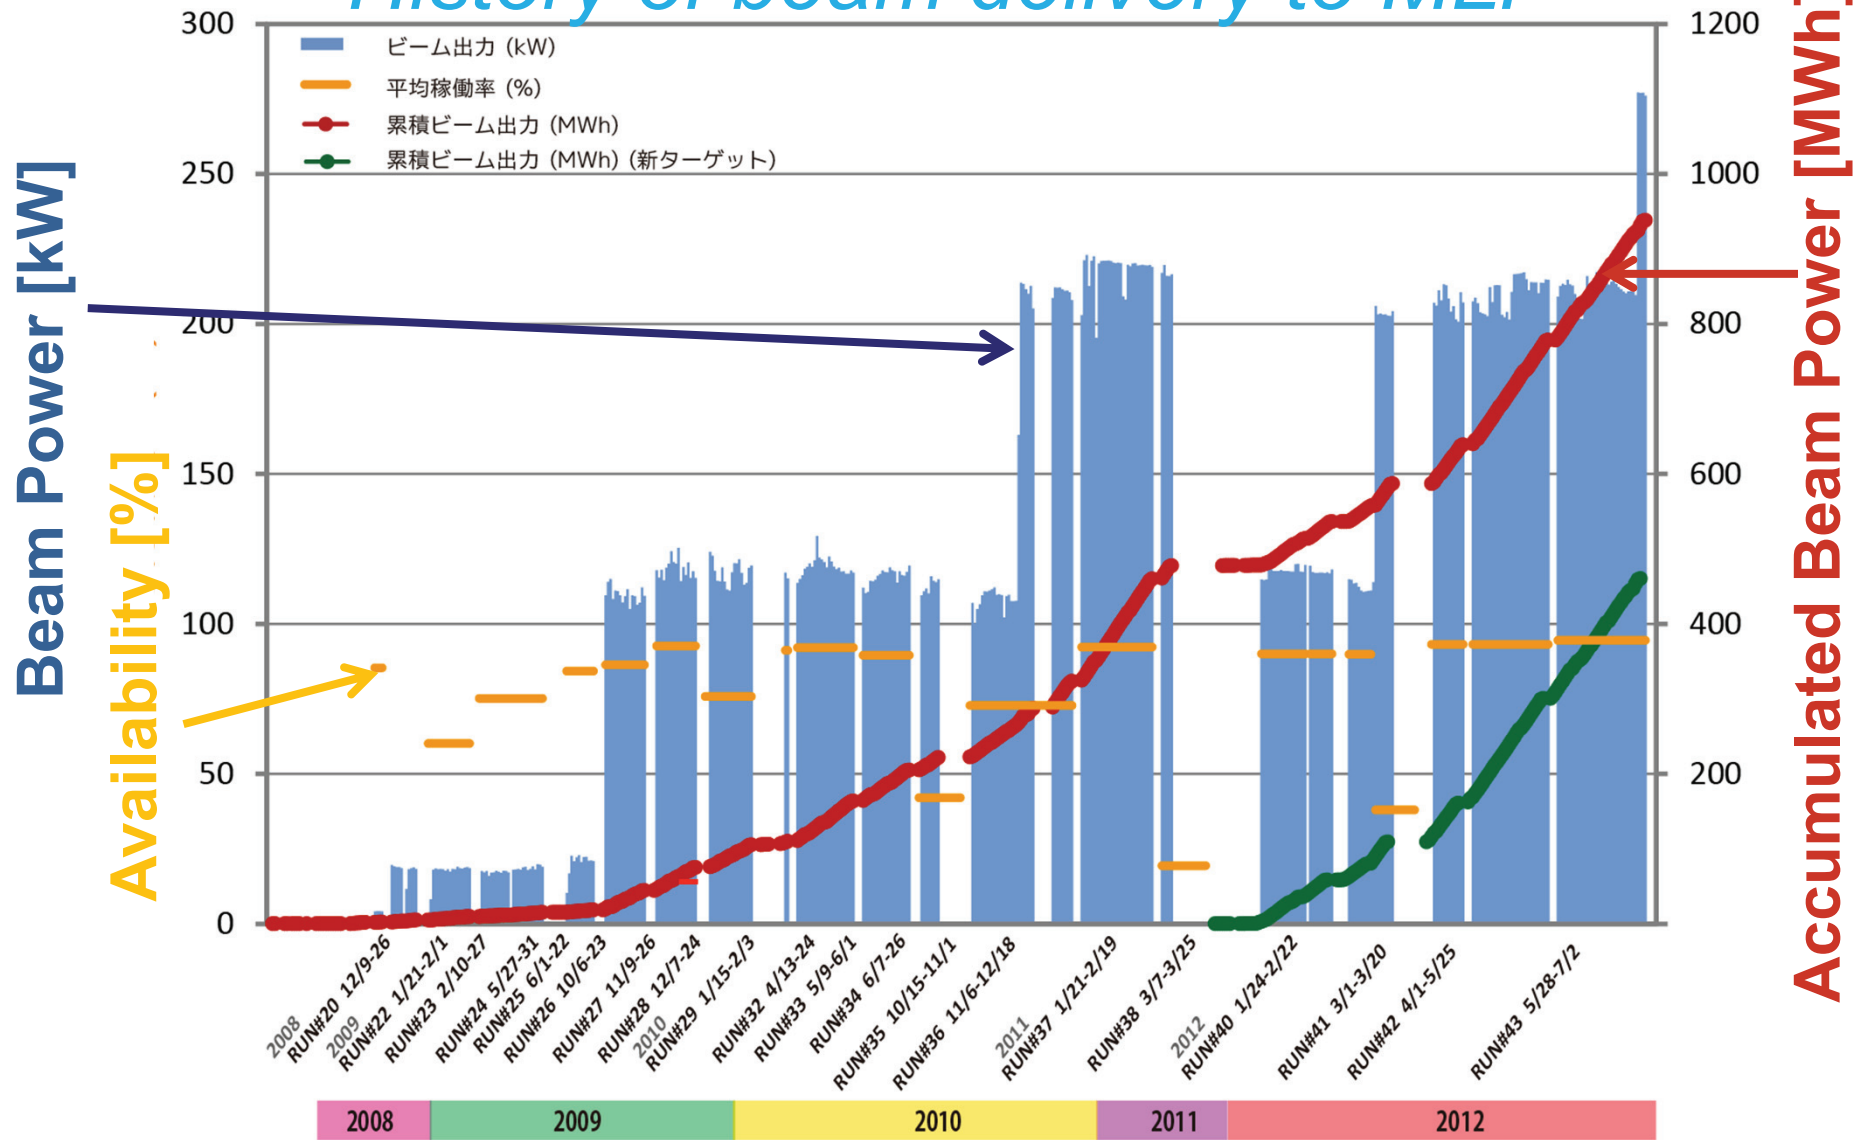
## History of beam delivery to MLF

In the last three days, 275 kW beam was delivered from the RCS to the MLF. 24  
Stable operation of 275 kW was successfully demonstrated.
