Evolution of the Defects on the Niobium Surface During BCP and EP Treatments

Paolo Michelato, Laura Monaco INFN Milano – LASA, Segrate (MI), Italy

In the cavity production process some defects may appear on the niobium surface, after the chemical and/or electrochemical processes, mainly in the region close to the equatorial weld and in the HAZ (Heat Affected Zone). We have produced defects on the Nb surface, with geometrical characteristics similar to the defects that may be produced during the mechanical machining of the cavity cells. We have investigated the evolution of these defects, during the usual chemical and electrochemical surface preparation stages.

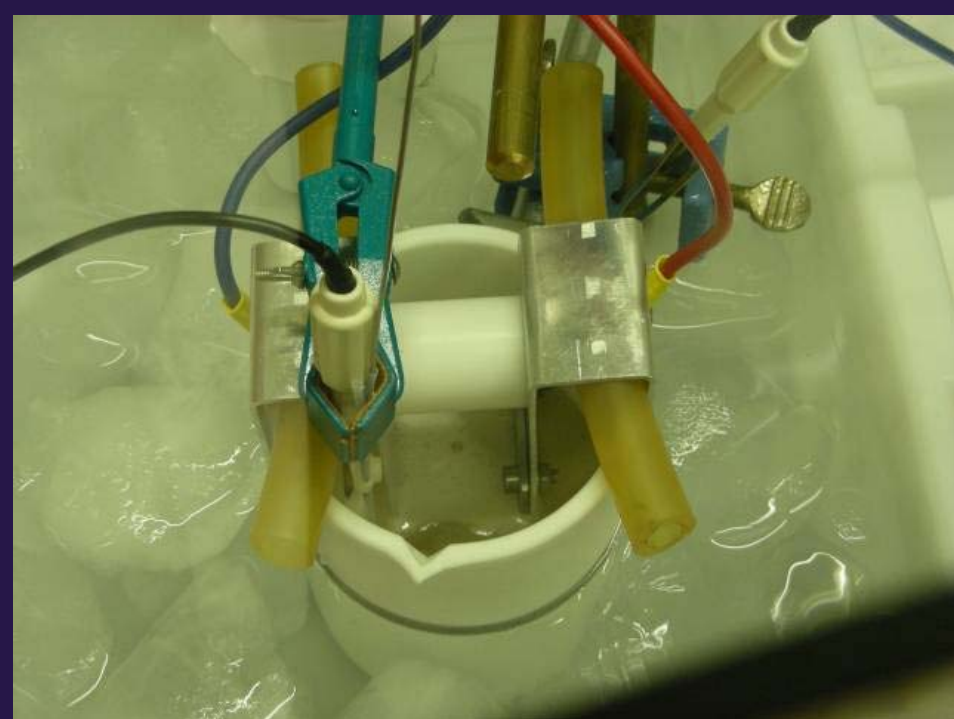
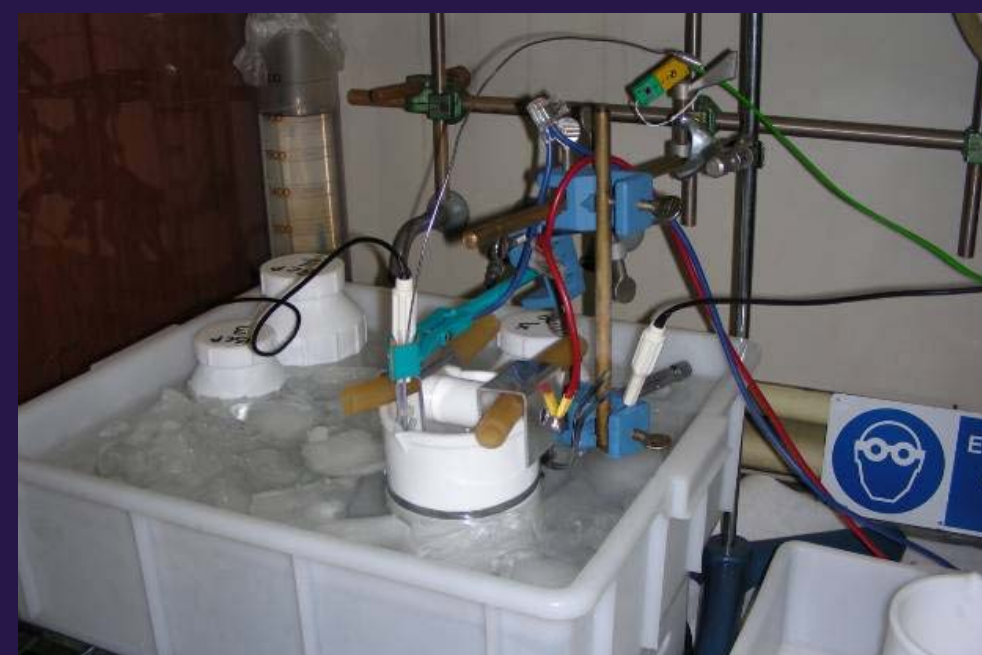
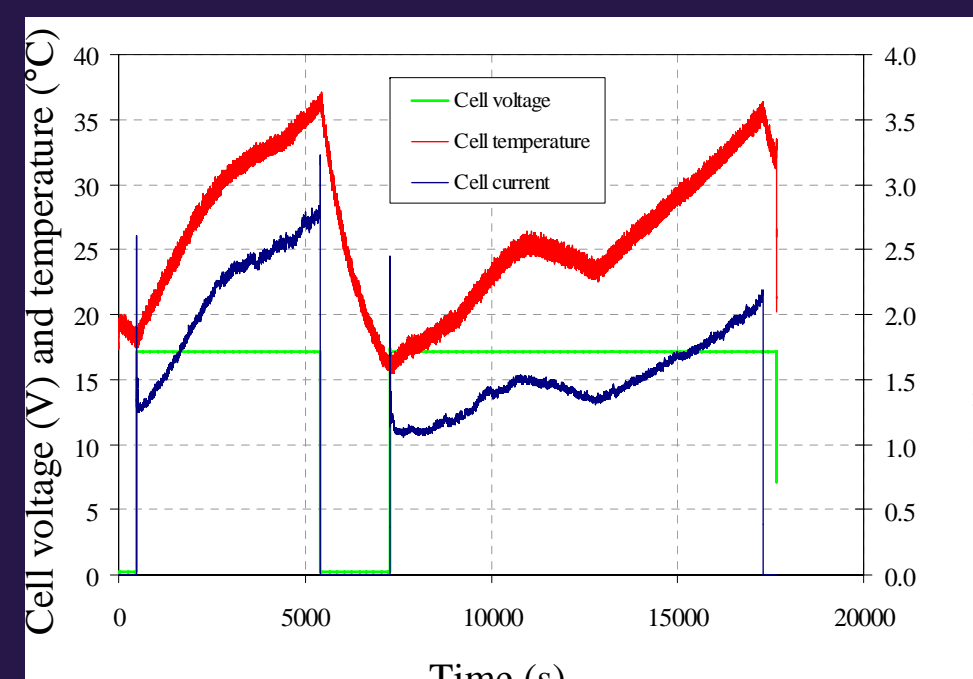
Typical behavior of the voltage, current and temperature during the EP process

ElectroPolishing set up:

- EP solution 1 litre HF: H₂SO₄ 1:9
- a parallel plate electrolytic cell
- two vertical electrodes
- front surface 35 cm²
- electrode distance of 40 mm
- one electrode is pure Al (99.5 %)
- temperature: 20° C - 35° C
- constant voltage process: 17 V

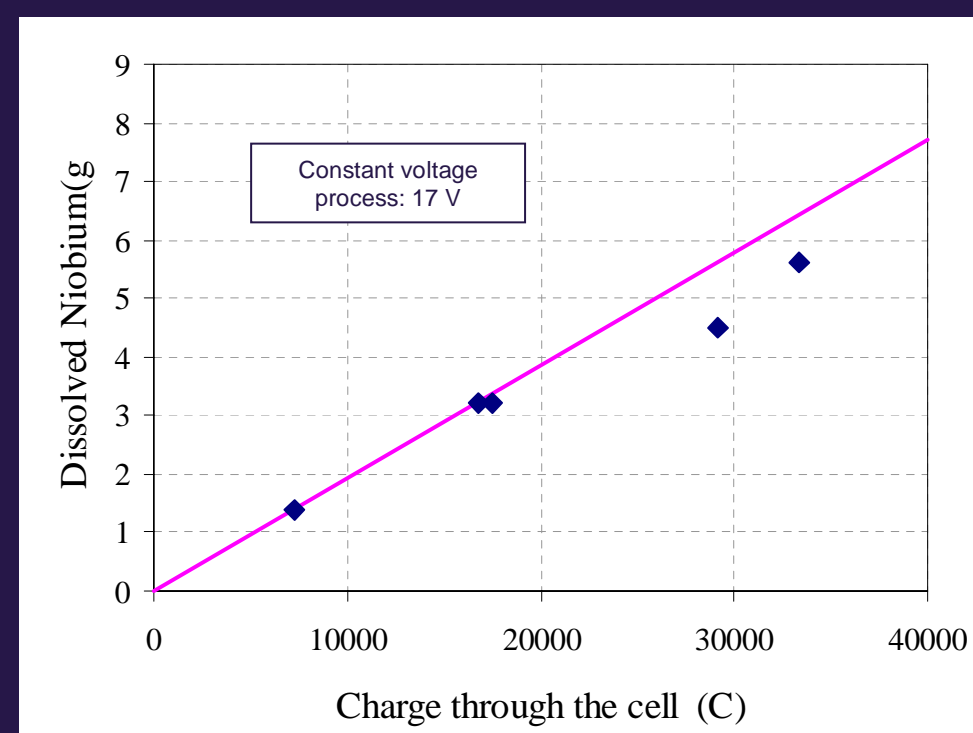
The ratio between the amount of Nb dissolved in the process and the charge passed through the cell gives information about the electrochemical reaction in the EP cell. The angular coefficient of the curve indicates what kind of oxidation reaction is under way in the electrolytic cell. Our data are in accordance with the formation of the Nb₂O₅ (2 electrons for each Oxygen atom, Oxygen/Nb ratio 2/5).

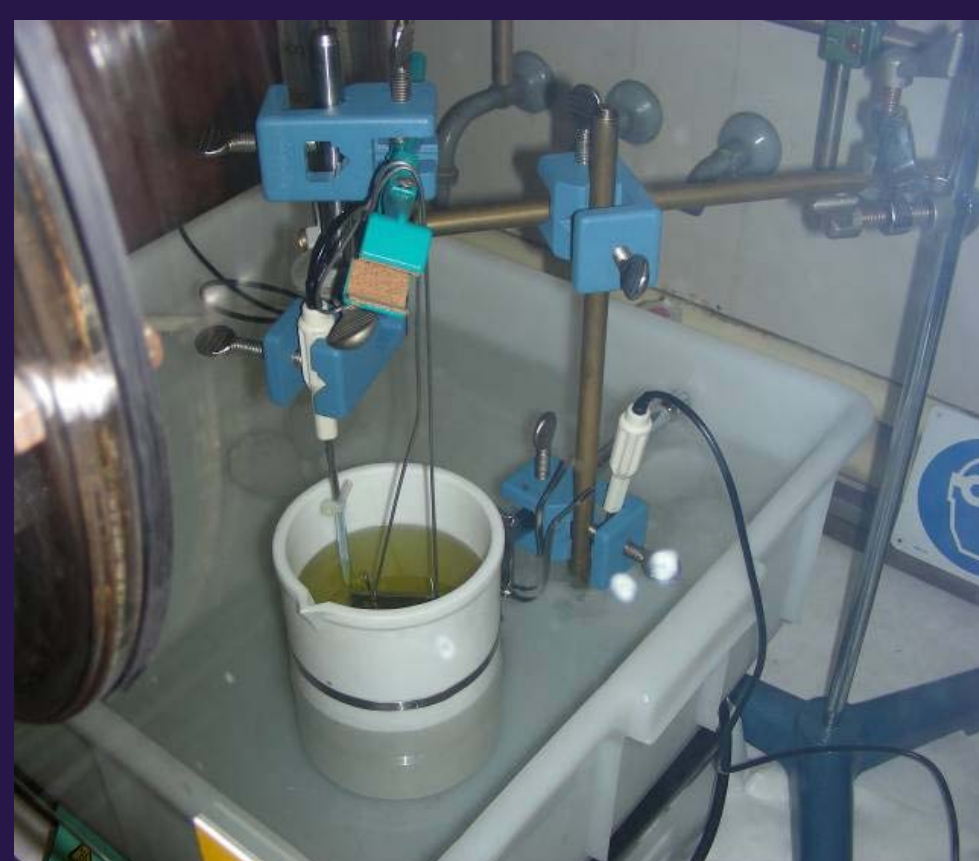
Buffered Chemical Polishing set up:

- the BCP experimental set up use the same ice cooled basin and PTFE beaker as the EP one. Samples are suspended in the BCP solution (1:1:2, HF, HNO₃, H₃PO₄)
- a magnetic stirrer ensures the acid agitation.

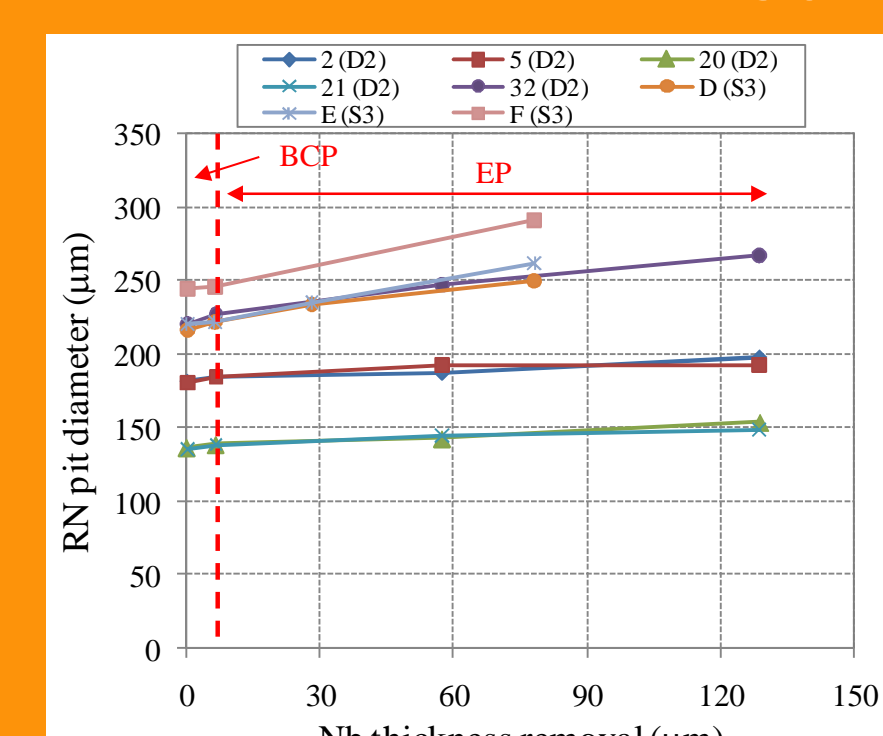
Round Needle (RN) pits

- increase of the pit diameters with the material removal, more enhanced for defects with initial larger diameter
- pit depth decreases but initial holes do not disappear even when the thickness of the removed material is larger, more than one order of magnitude, than their depth

- schematic evolution of RN pits (#20 and #32) and SN pits (pit #10 and pit #30) shapes, after 128.7 µm of Nb removal
- all pits change during the decrease of the surface thickness induced by the treatment
- After the etching process:
 - RN pits have nearly the same depth, despite different initial values
 - RN pits have larger diameter than at the beginning
 - SN pits with depth larger than the thickness removal (pit #30) show a depth reduction lower than the total removed thickness
 - SN pits show a the diameter enlargement greater with respect to the RN pits

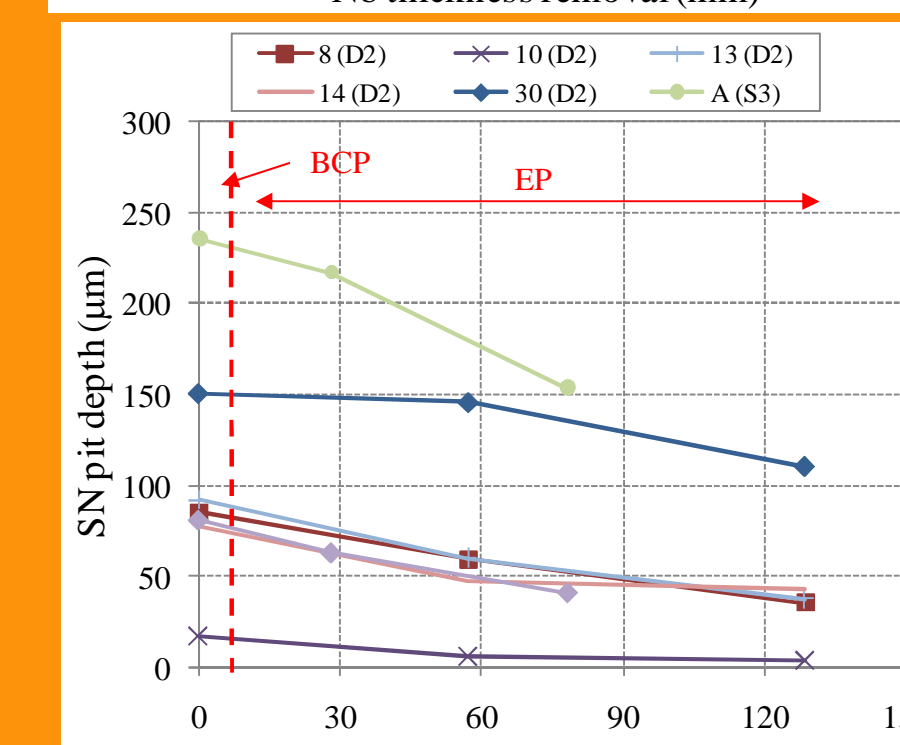
Sharp Needle (SN) pits

- beside a large Nb thickness removal, the two SN pits are not removed
- also for SN pits a "hole", with a depth seven times smaller than the Nb thickness removed, still remains visible on the sample surface (pit #10).
