15th International Conference on RF Superconductivity

# Sources of Quench Producing Defects Low and High Fields

Rong-Li Geng

Jefferson Lab

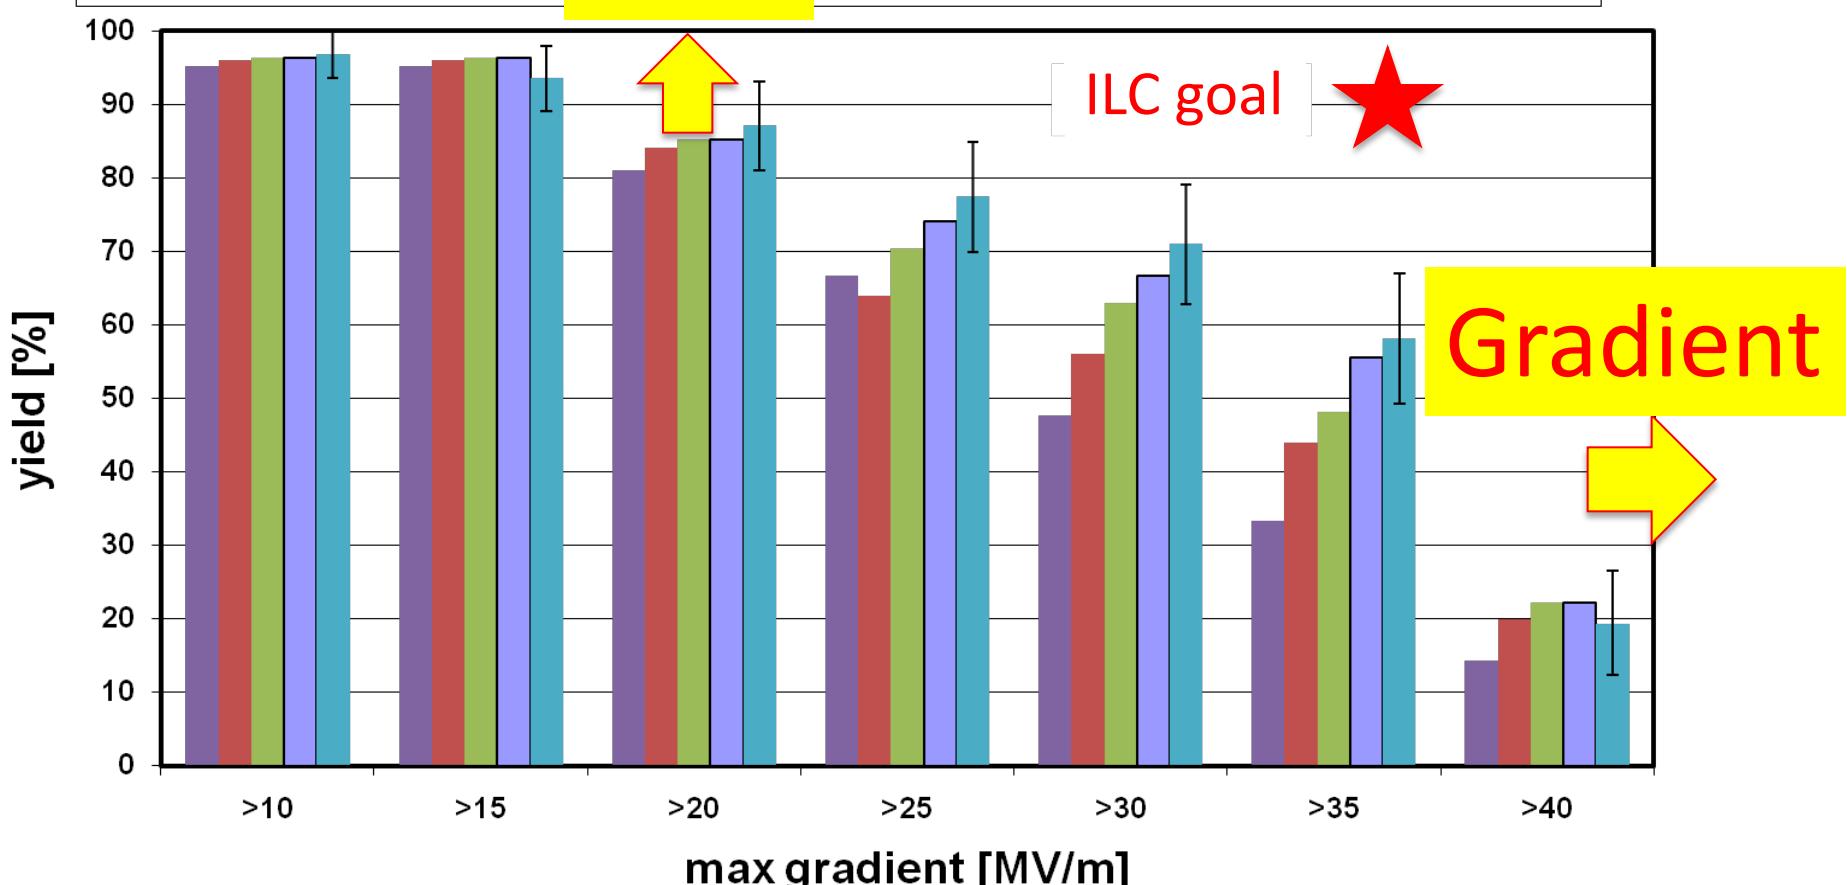
Electropolished 9-cell cavities  
JLab/DESY (combined) 10-second successful test of  
cavities from established vendors

**Yield**

ALCPG 1.Oct.2009 AAP 6.Jan.2010 28.Mar.2010 TDP Rev.5 30.Jun.2010 ALCPG 20.Mar.2011

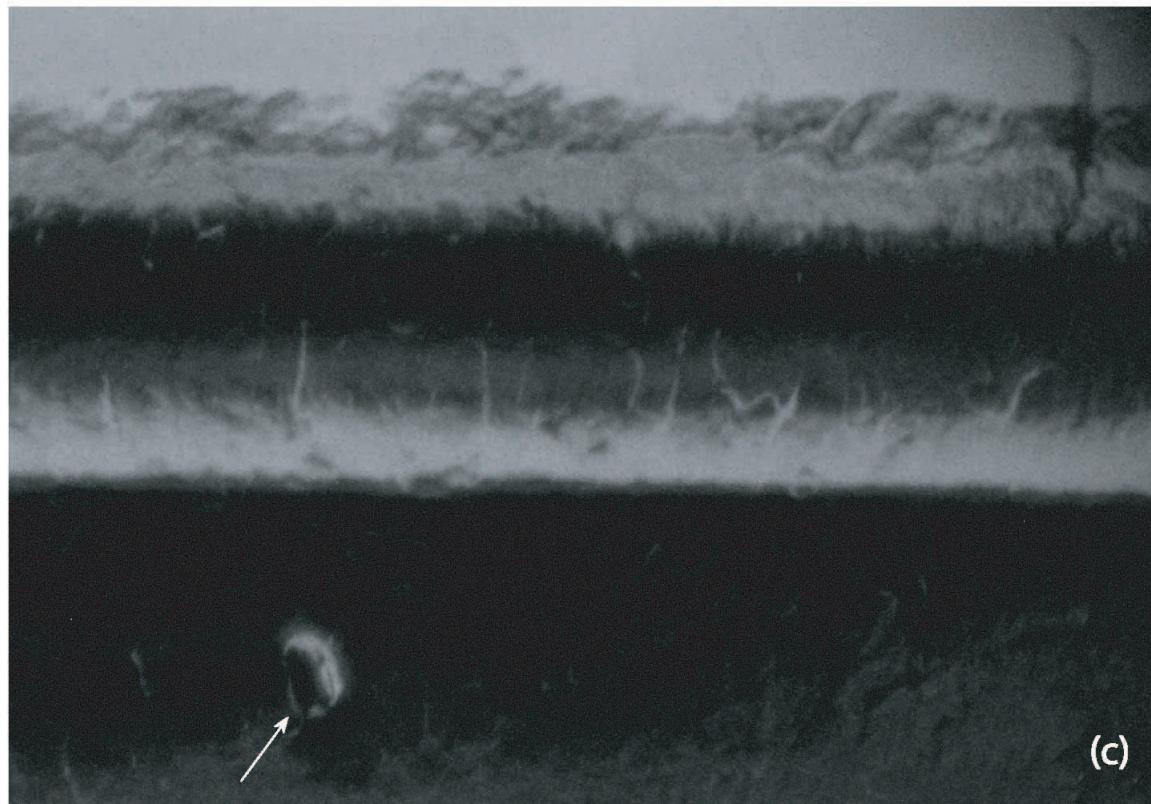
Fine grain EP  
defect causing  
quench 19 MV/m.

Cavity by  
experience vendor

- Type-I
  - Hpk 75-90 mT
  - Defect from fabrication
    - Near or in EBW joint
    - Geometric defects
    - Sum-mm in size
      - Observable with “high-resolution” optical inspection machine
    - Little effect by repeated surface processing
    - Mechanical (local or global) polishing effective

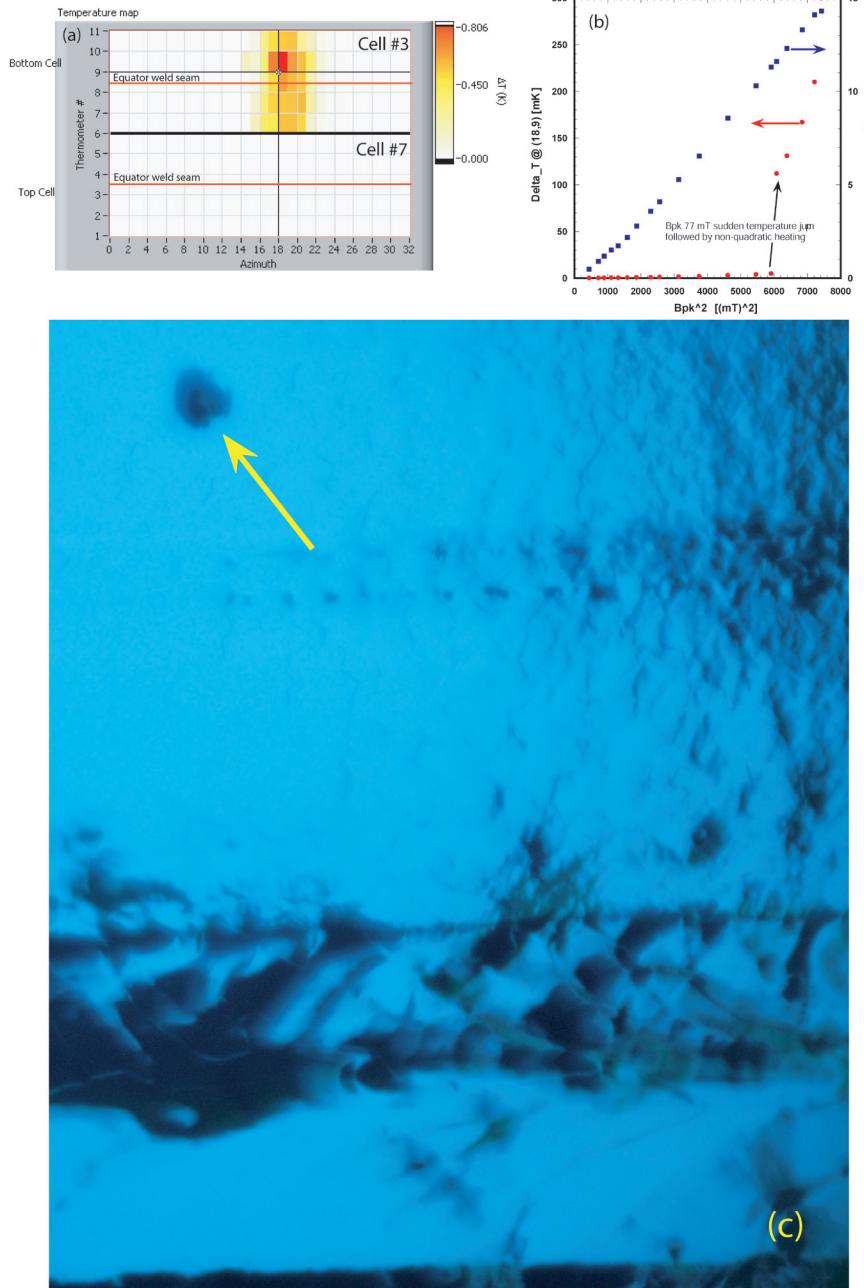
Fine grain EP  
defect causing  
Quench 20 MV/m.

Cavity by then  
new vendor

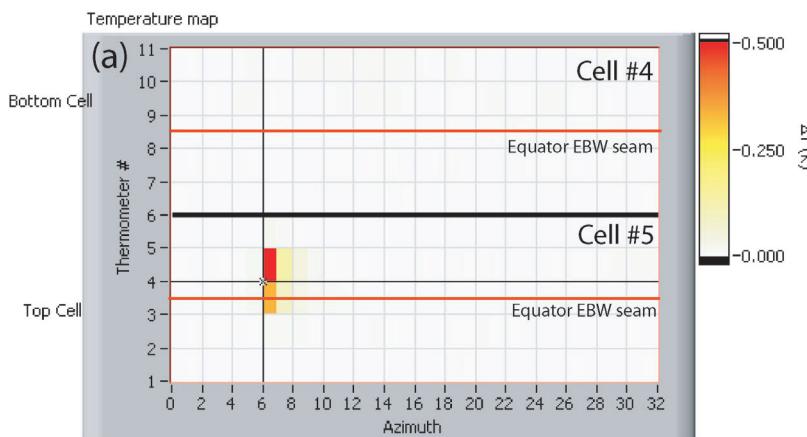
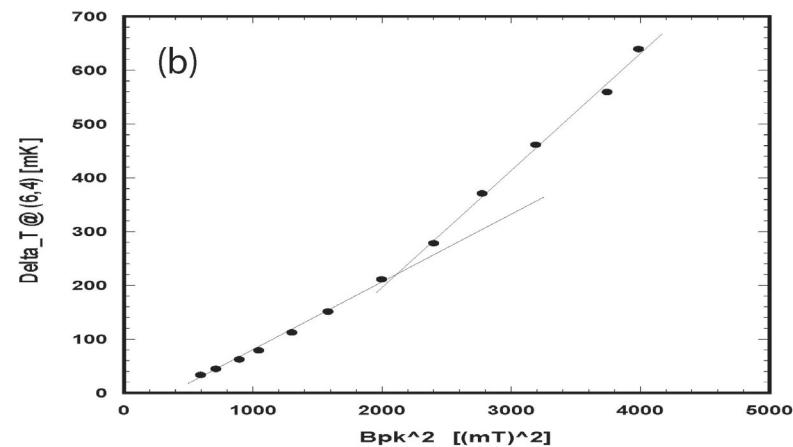
# Fine grain EP defect causing Quench 15 MV/m. Cavity by then new vendor

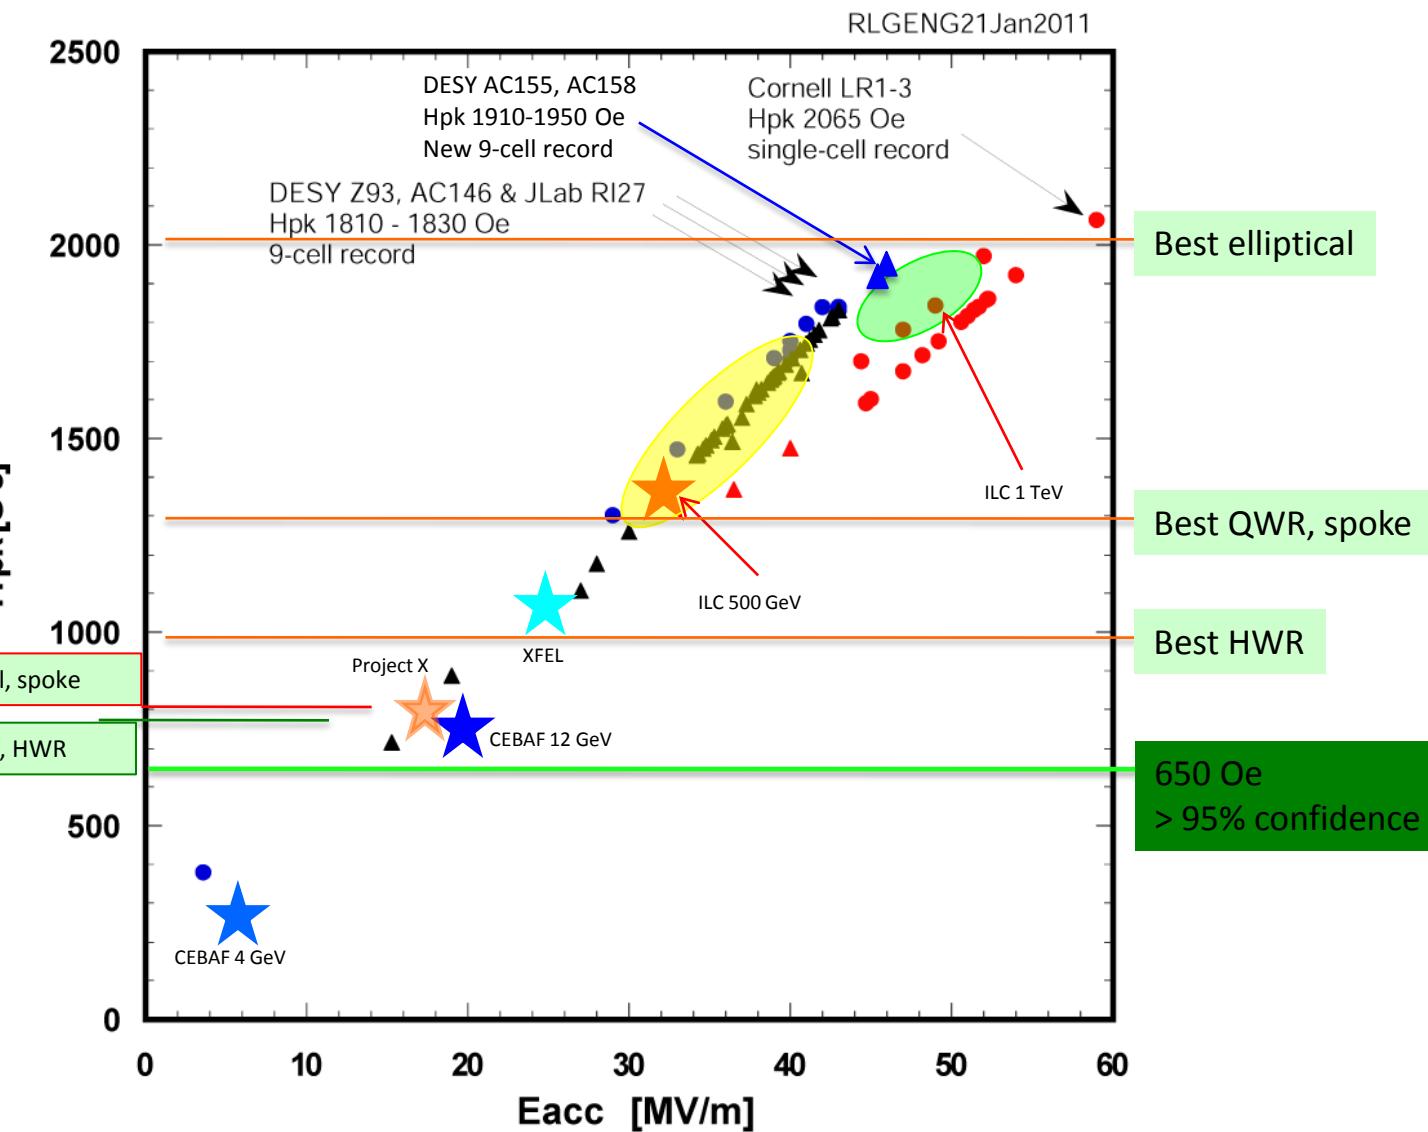
Achieved Peak Surface Magnetic Field in L-band SRF Niobium Cavities  
(Circle: Single-Cell Cavity; Triangle: Multi-Cell Cavity)

- Quench is primarily a magnetic field effect
  - High magnetic field region (arrow) in cavity is critical

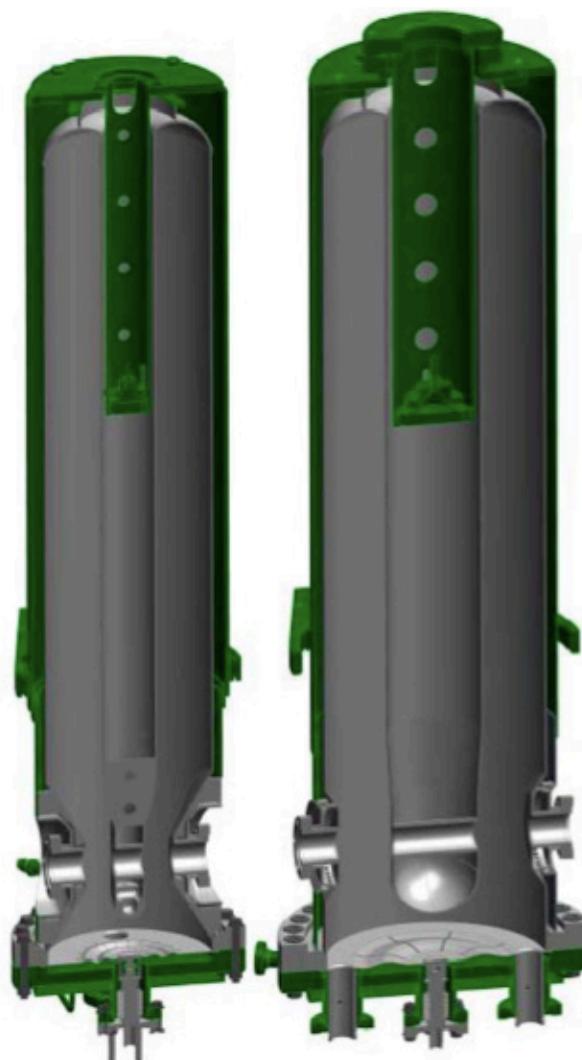
$\beta = 0.041$  $\beta = 0.085$

Facility for Rare Isotope Beams (FRIB)  
Four cavity types, total 350 cavities  
operation temperature 2 Kelvin

$\beta = 0.29$  $\beta = 0.53$
