# Guided Cavity Repair with Laser, E-Beam and Grinding

Genfa Wu

Several methods have been explored in various laboratories to remove the surface features. Those included the laser re-melting, Electron beam re-melting and local mechanical grinding. This paper reports the latest development of those guided repair technologies and their benefits to improve cavity performances.

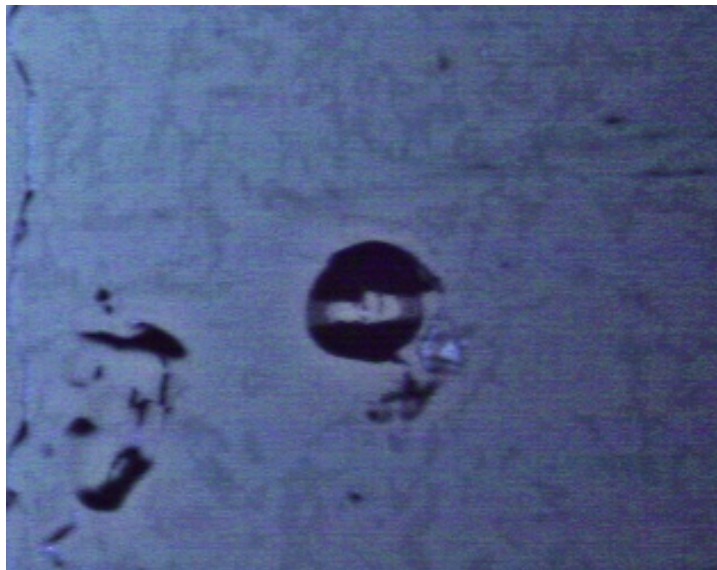
The optical image before re-melting

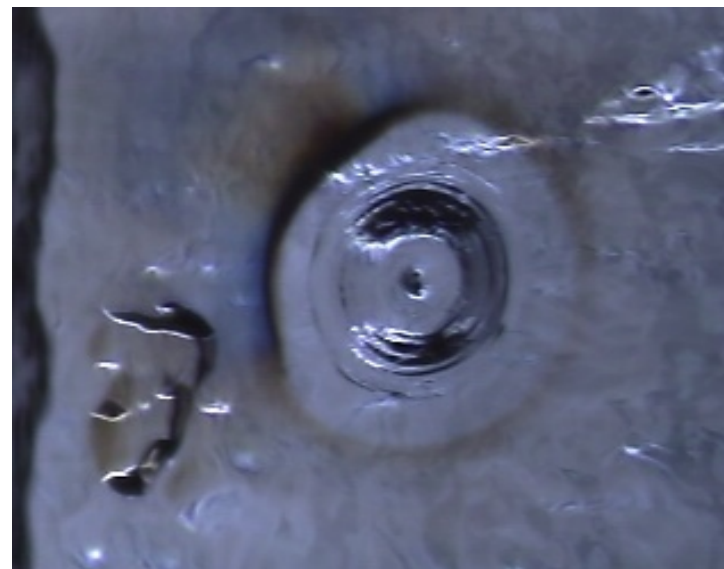
The optical image after re-melting

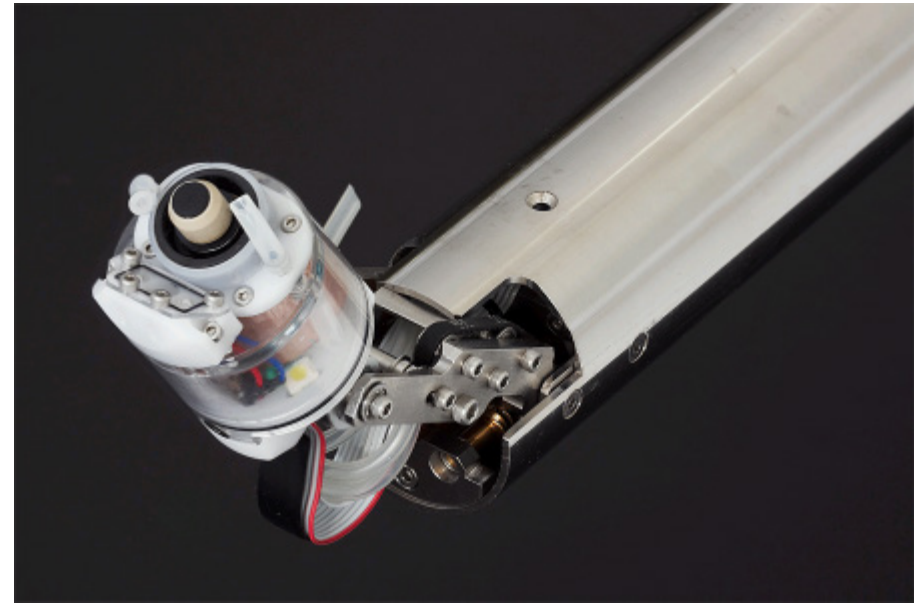
## Grinder #3

To grind at the reverse side of stiffner ring and the slant face etc..

- Iris
- Taper locations
