Commissioning of crab cavity system

Presented by NAKANISHI Kota (KEK)

Factories08@BINP 2008/4/15

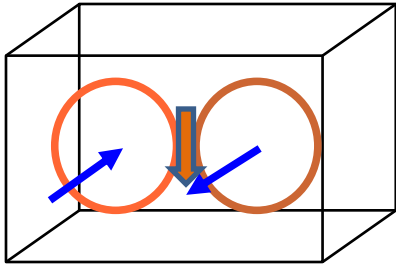
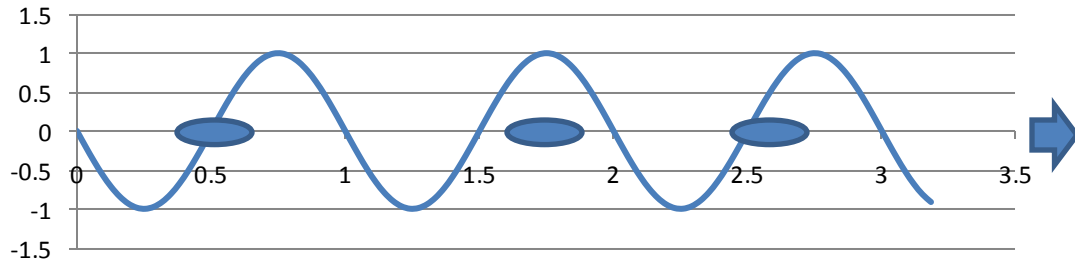
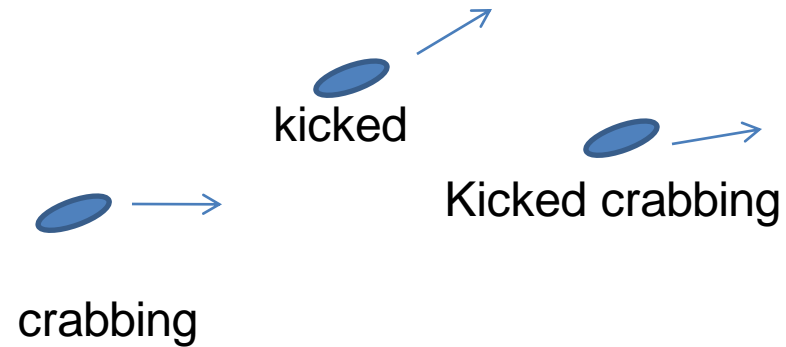
Crabbing mode

- Time varying magnetic field is applied to bunches.
- The phase and voltage should be controlled.

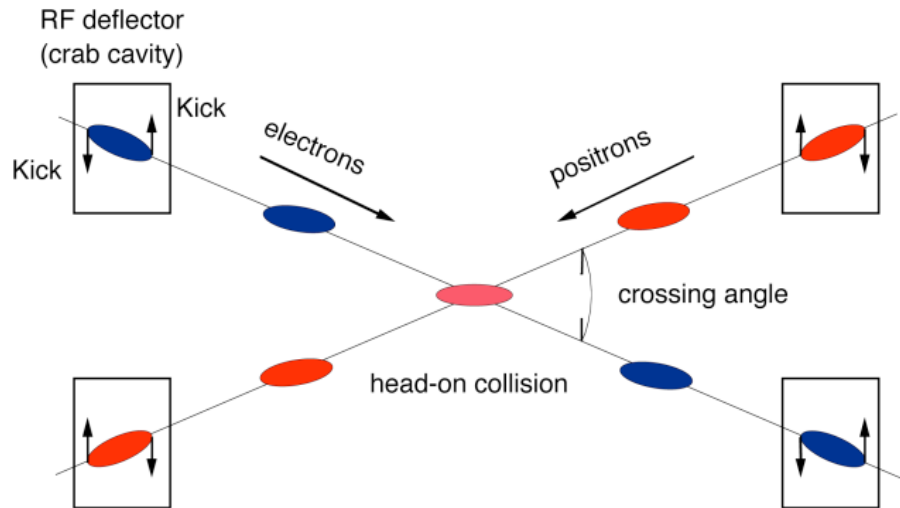
Original scheme (4 cavities)

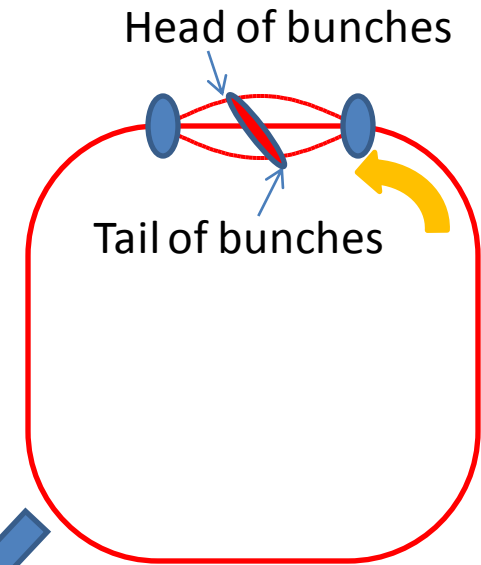
2 cavities for each rings

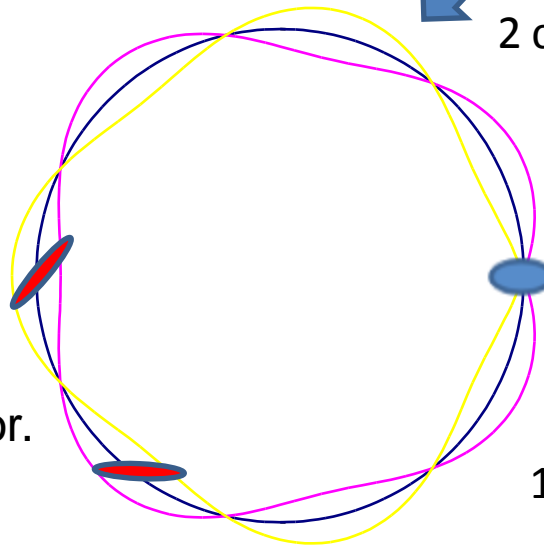
1 cavity for each rings

To adopt this scheme is very effective to reduce the cost.

- (1) The number of cavities can be reduce.
- (2) The installation site can be chosen freely. They was installed near by He refrigerator.

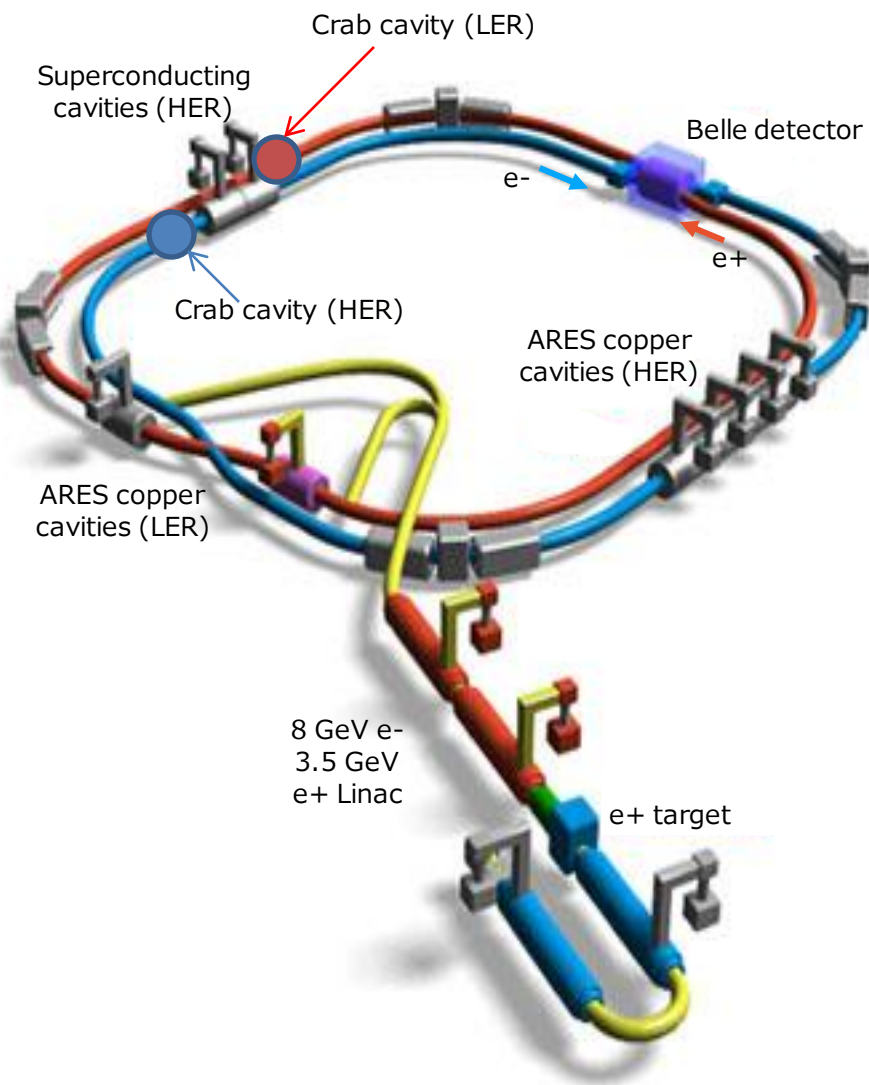
Crab cavities were installed near by superconducting acceleration cavities.

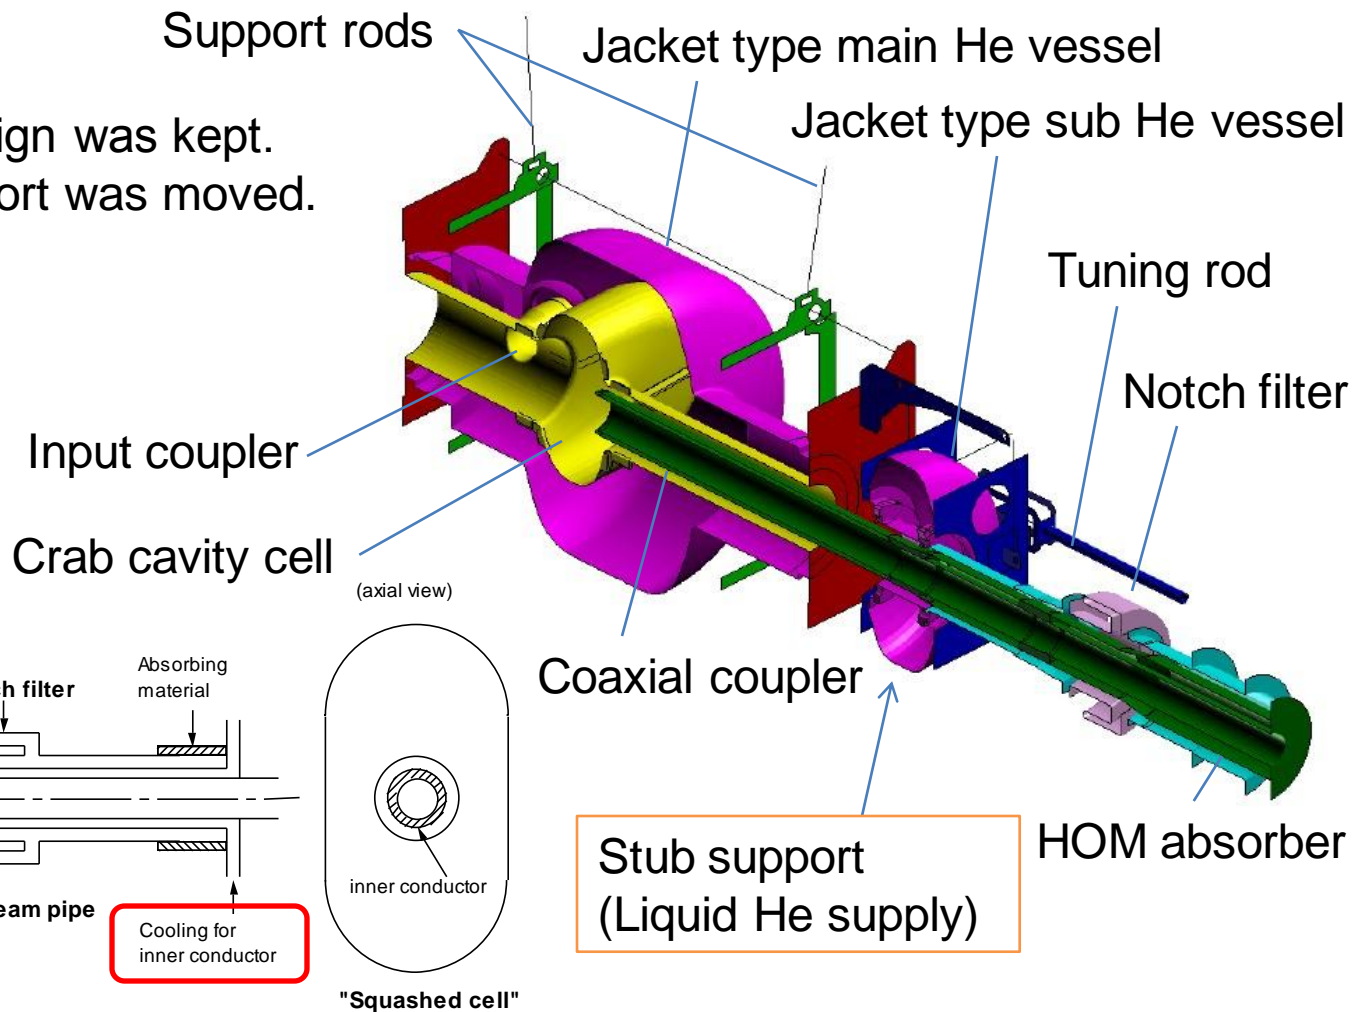
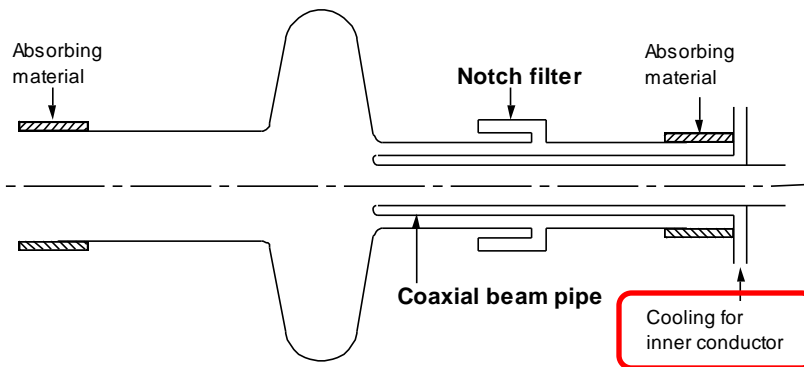
Squashed Crab cavity for B-factories

Basically Dr.Akai's design was kept.
Just liquid He supply port was moved.

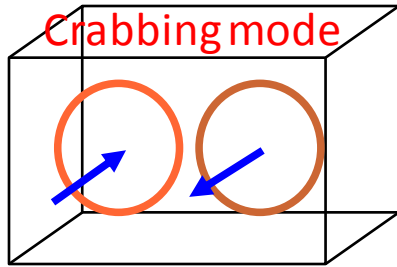
509MHz

Dipole mode cut off frequency of small beam pipe (coaxial coupler) is about 610MHz.

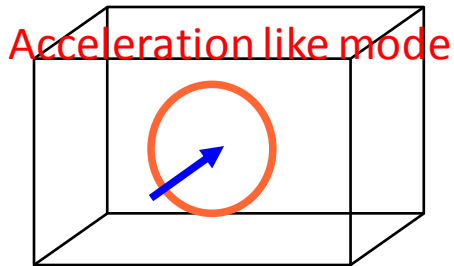
~415MHz

These mode should be
dumped by coaxial coupler.

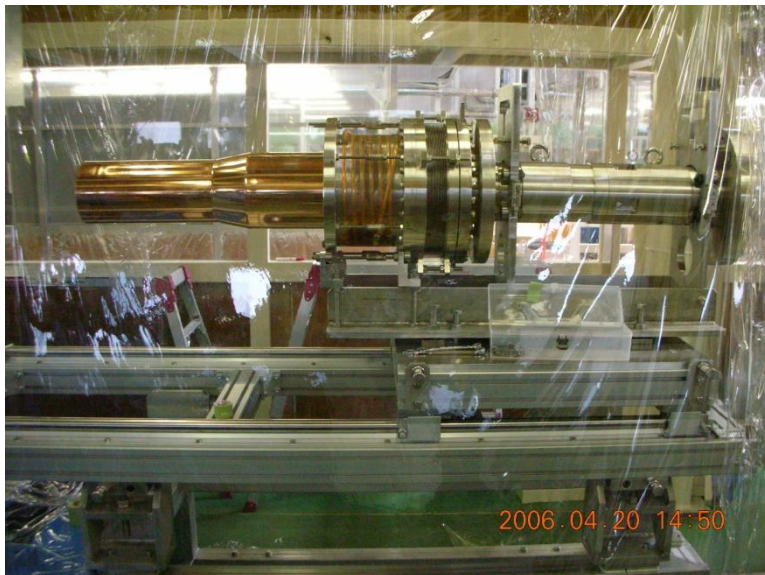
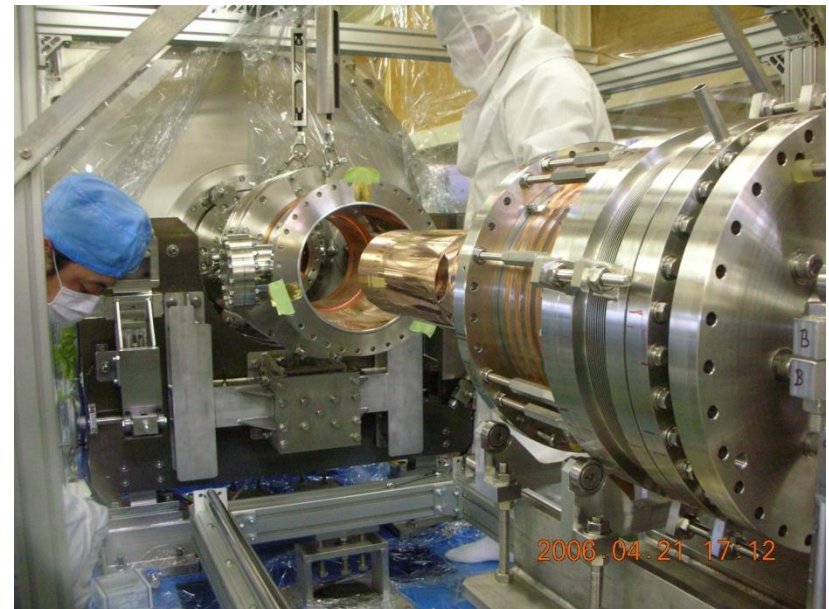
- Assembling the coaxial coupler was very difficult. We spent about 2 months to connect the mechanical joints.
- To connect them, an accurate installation tool should be made.

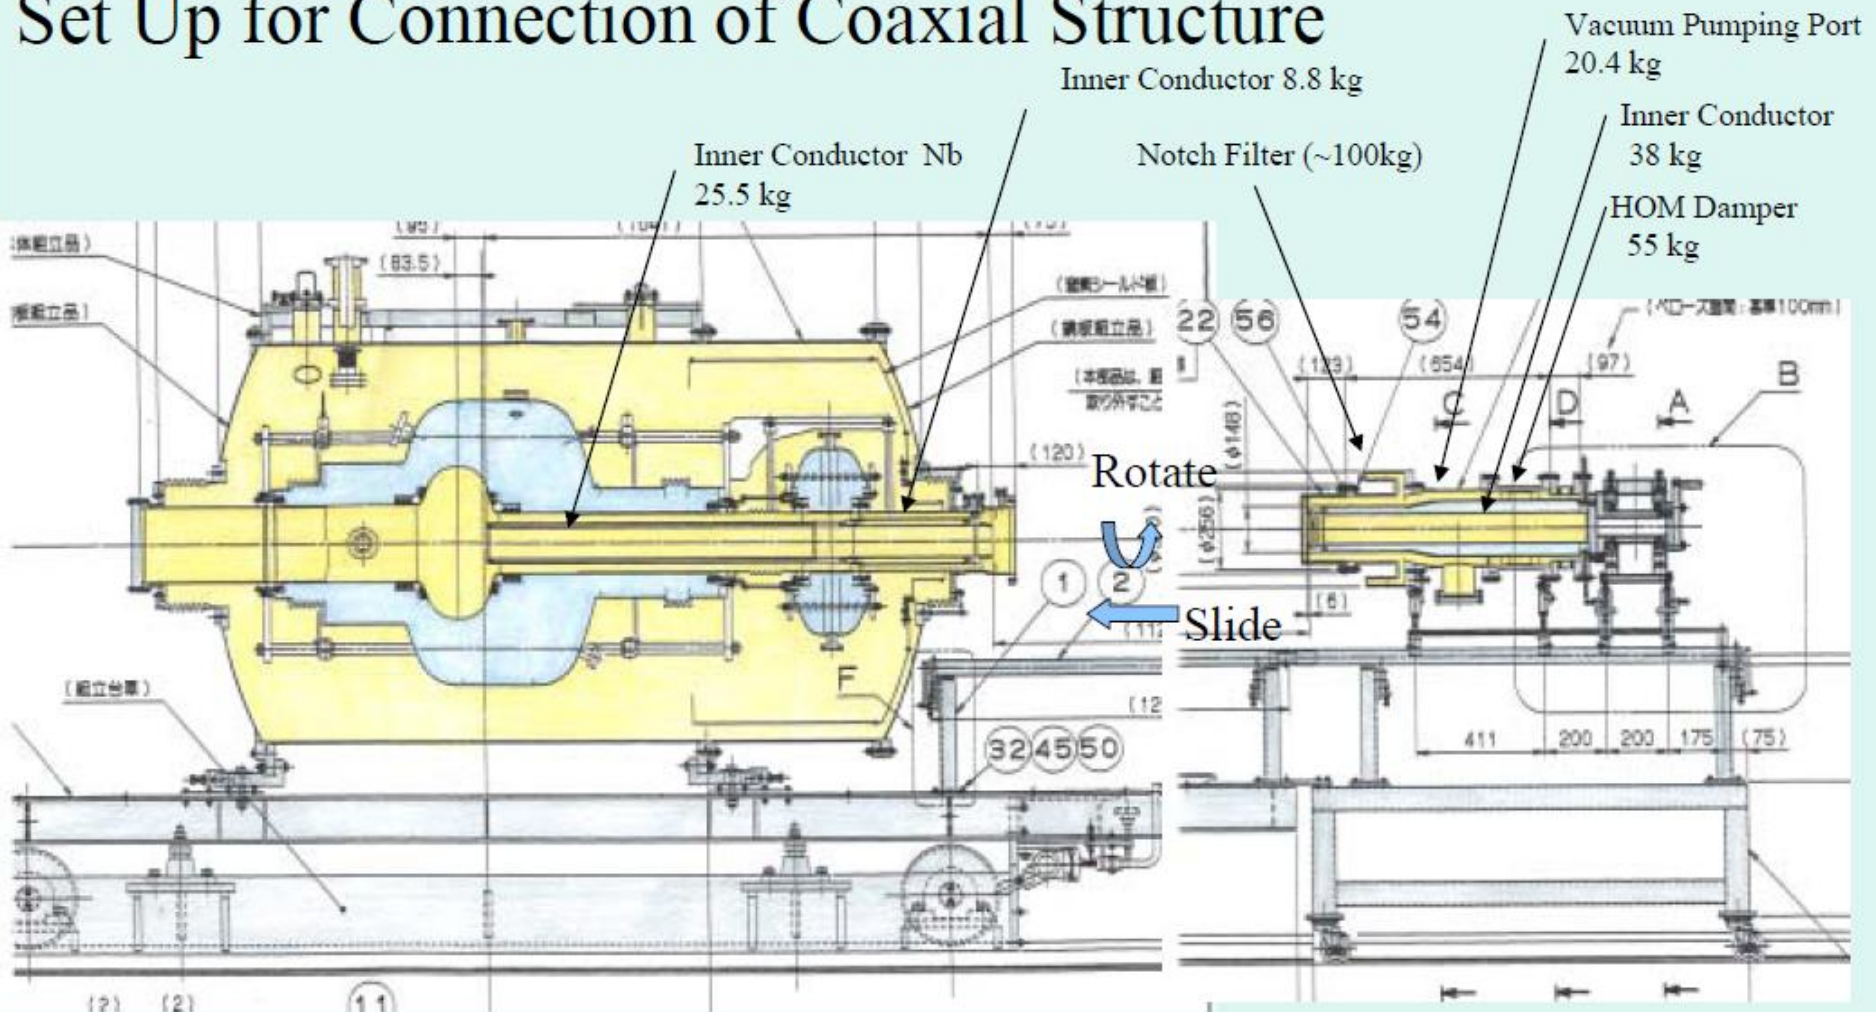
Set Up for Connection of Coaxial Structure

Could not connect !

The Coaxial Structure is Heavy.

Need Precise Alignment

Not Strong Support Structure
No Precise Adjustment Knob

Need Modification

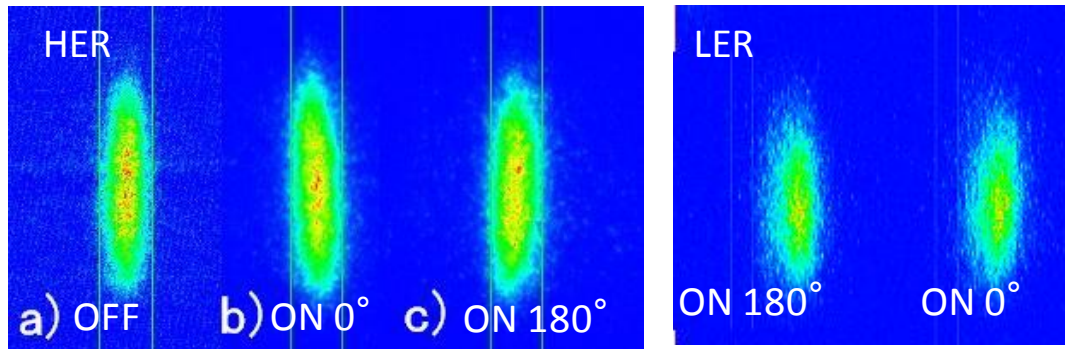
Bunches has tilted

- The crab motion was observed directly using a streak camera.

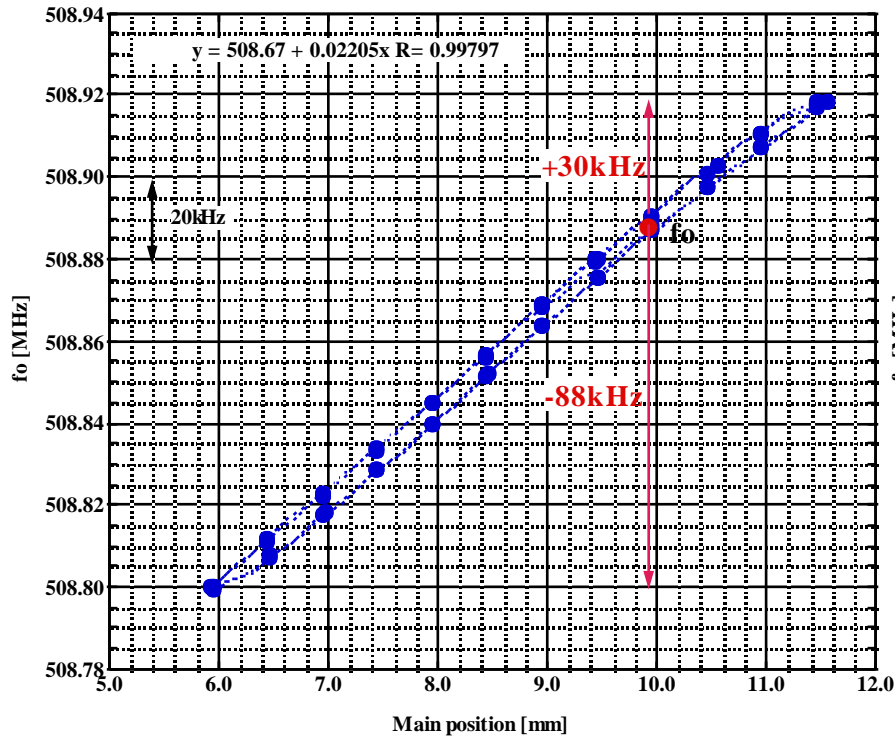
HER

Main tuner (motor)

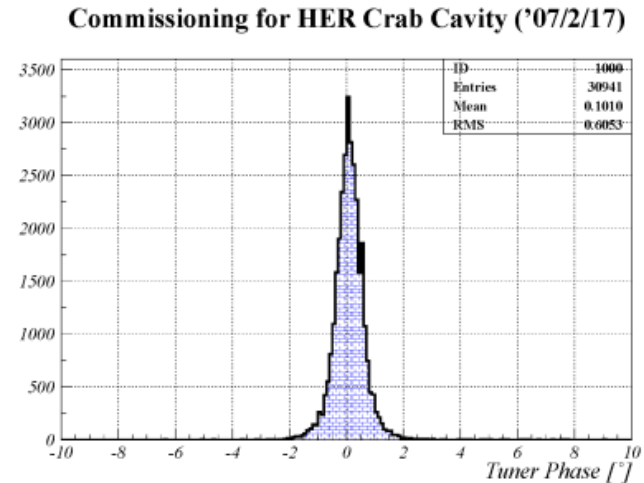
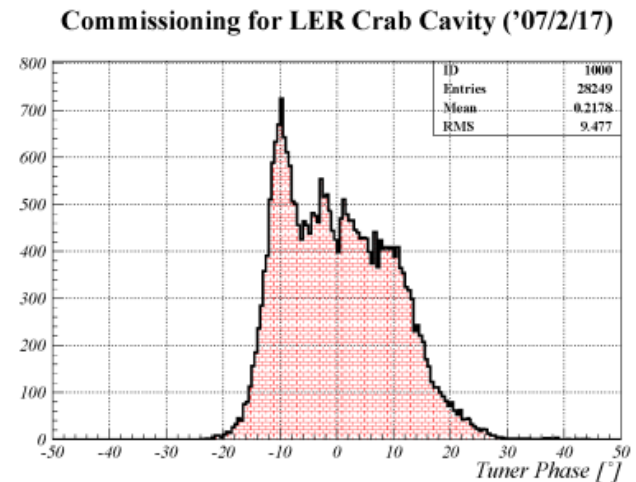
Distribution of tuner phase

- The tuner phase for LER is unstable due to the bad fine tuner response.

RMS=0.6°

RMS=9.5°

Phase stability (histogram of phase detector signal)

The tuner phase instability was suppressed by low level RF control system.

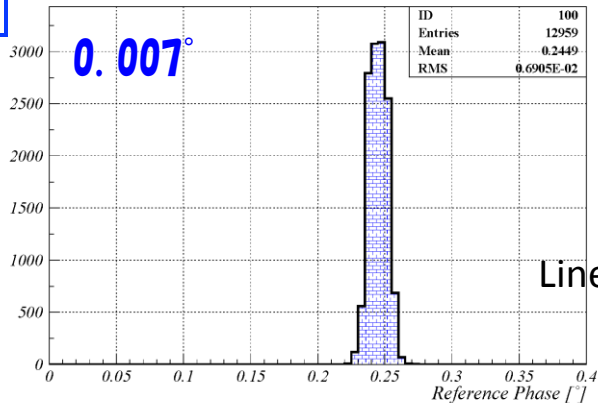
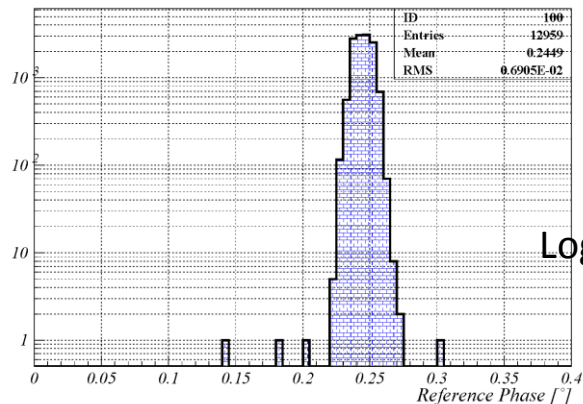
Commissioning for HER Crab Cavity ('07/2/20)

Distribution of cavity phase (cavity feedback loops on)

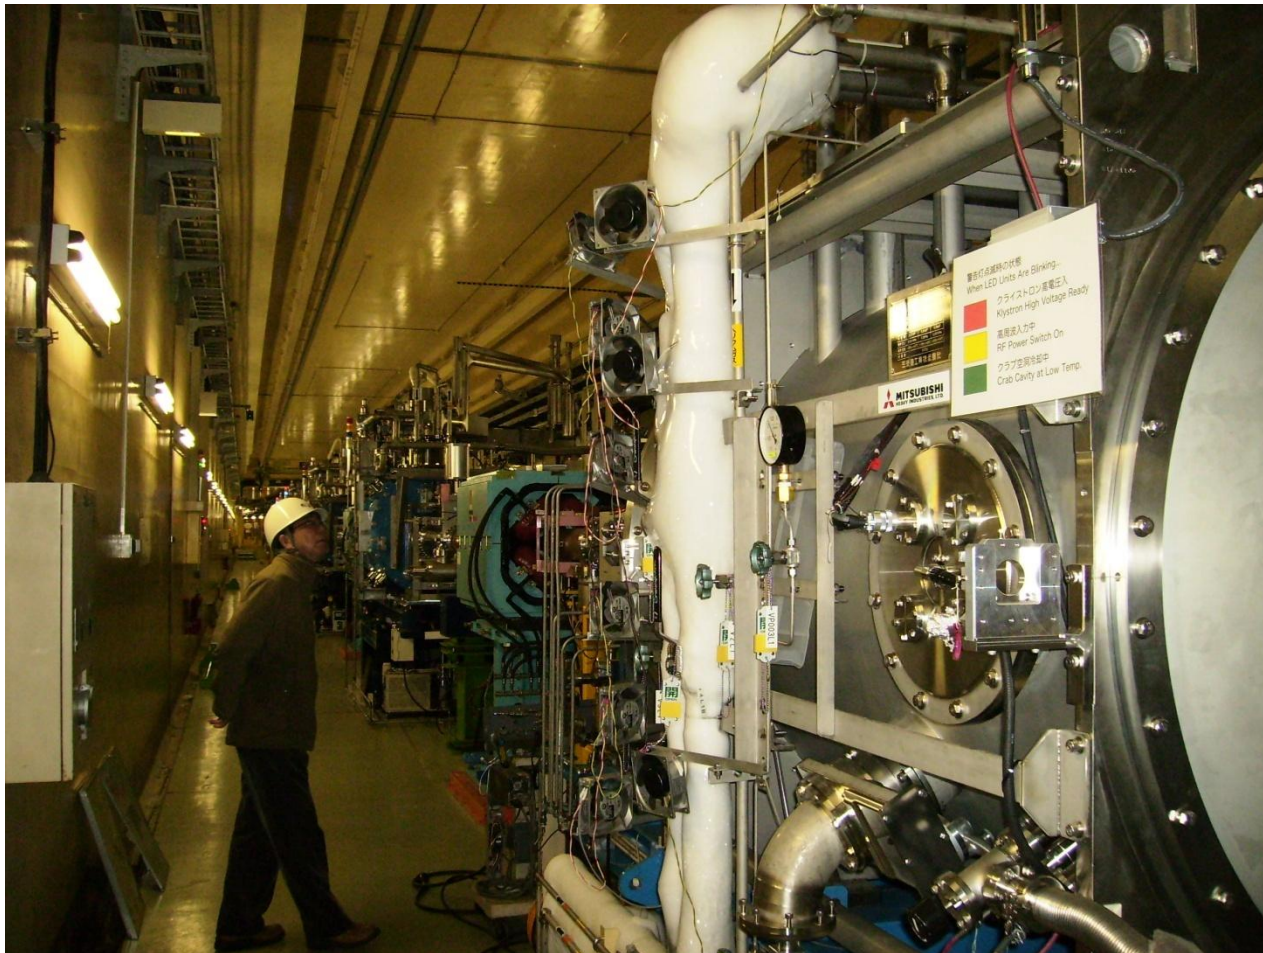
Ice balls

- (1) Boiled He gas return to refrigerator through isolation pipe. To cool down the coaxial coupler, Liquid He was taken from He vessel. That gas return to suction of compressor through the normal (not isolated) pipe, because the amount of He flow was expected very small.
- (2) Some coaxial coupler quench was observed. Temperature of gas outlet rose at that time. After that gas flow was increased.
- (3) Ice ball grew.

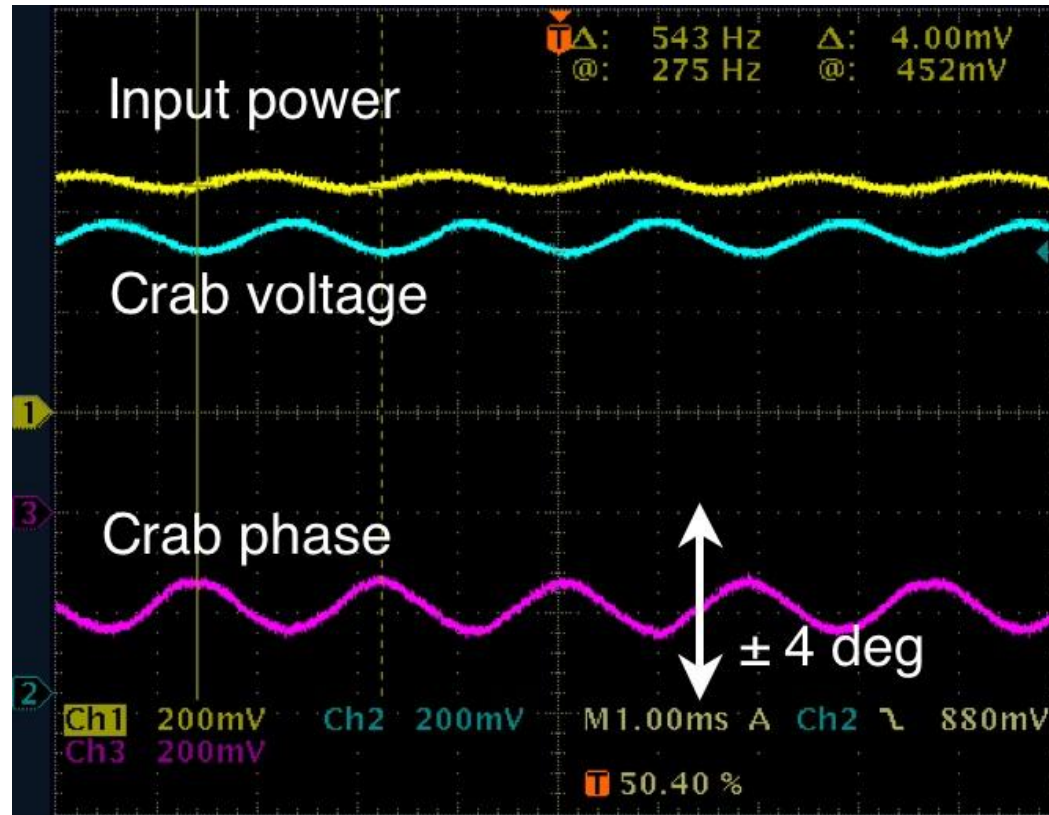
Instability in high current operation

In the high-current crab-crossing operation, we encountered a large-amplitude oscillation of beams and the crabbing field caused by the beam loading on crab cavities together with the beam-beam force at the IP. We found that the oscillation can be avoided by shifting the crabbing phase, shifting the tuning offset angle, and adjusting the loop gain appropriately.

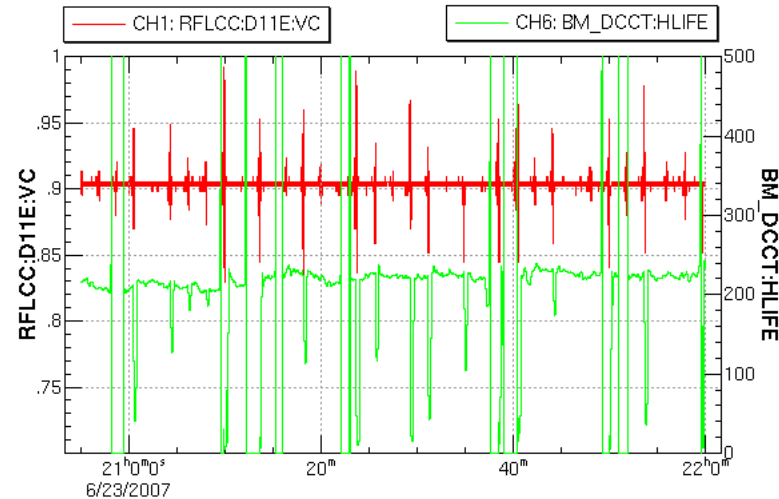
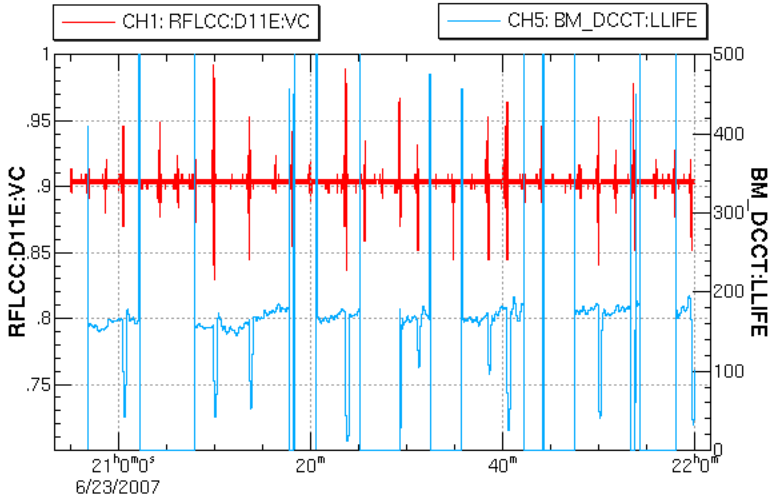
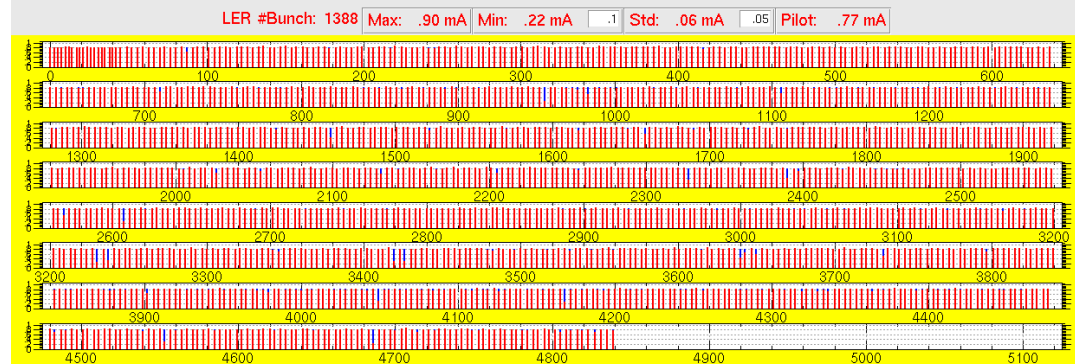
- 両リングの寿命が急落することがあり、
LER 電圧変動と同期している。

Some times, beam life was suddenly dropt.
LER Vcrab was also unstable at that time.

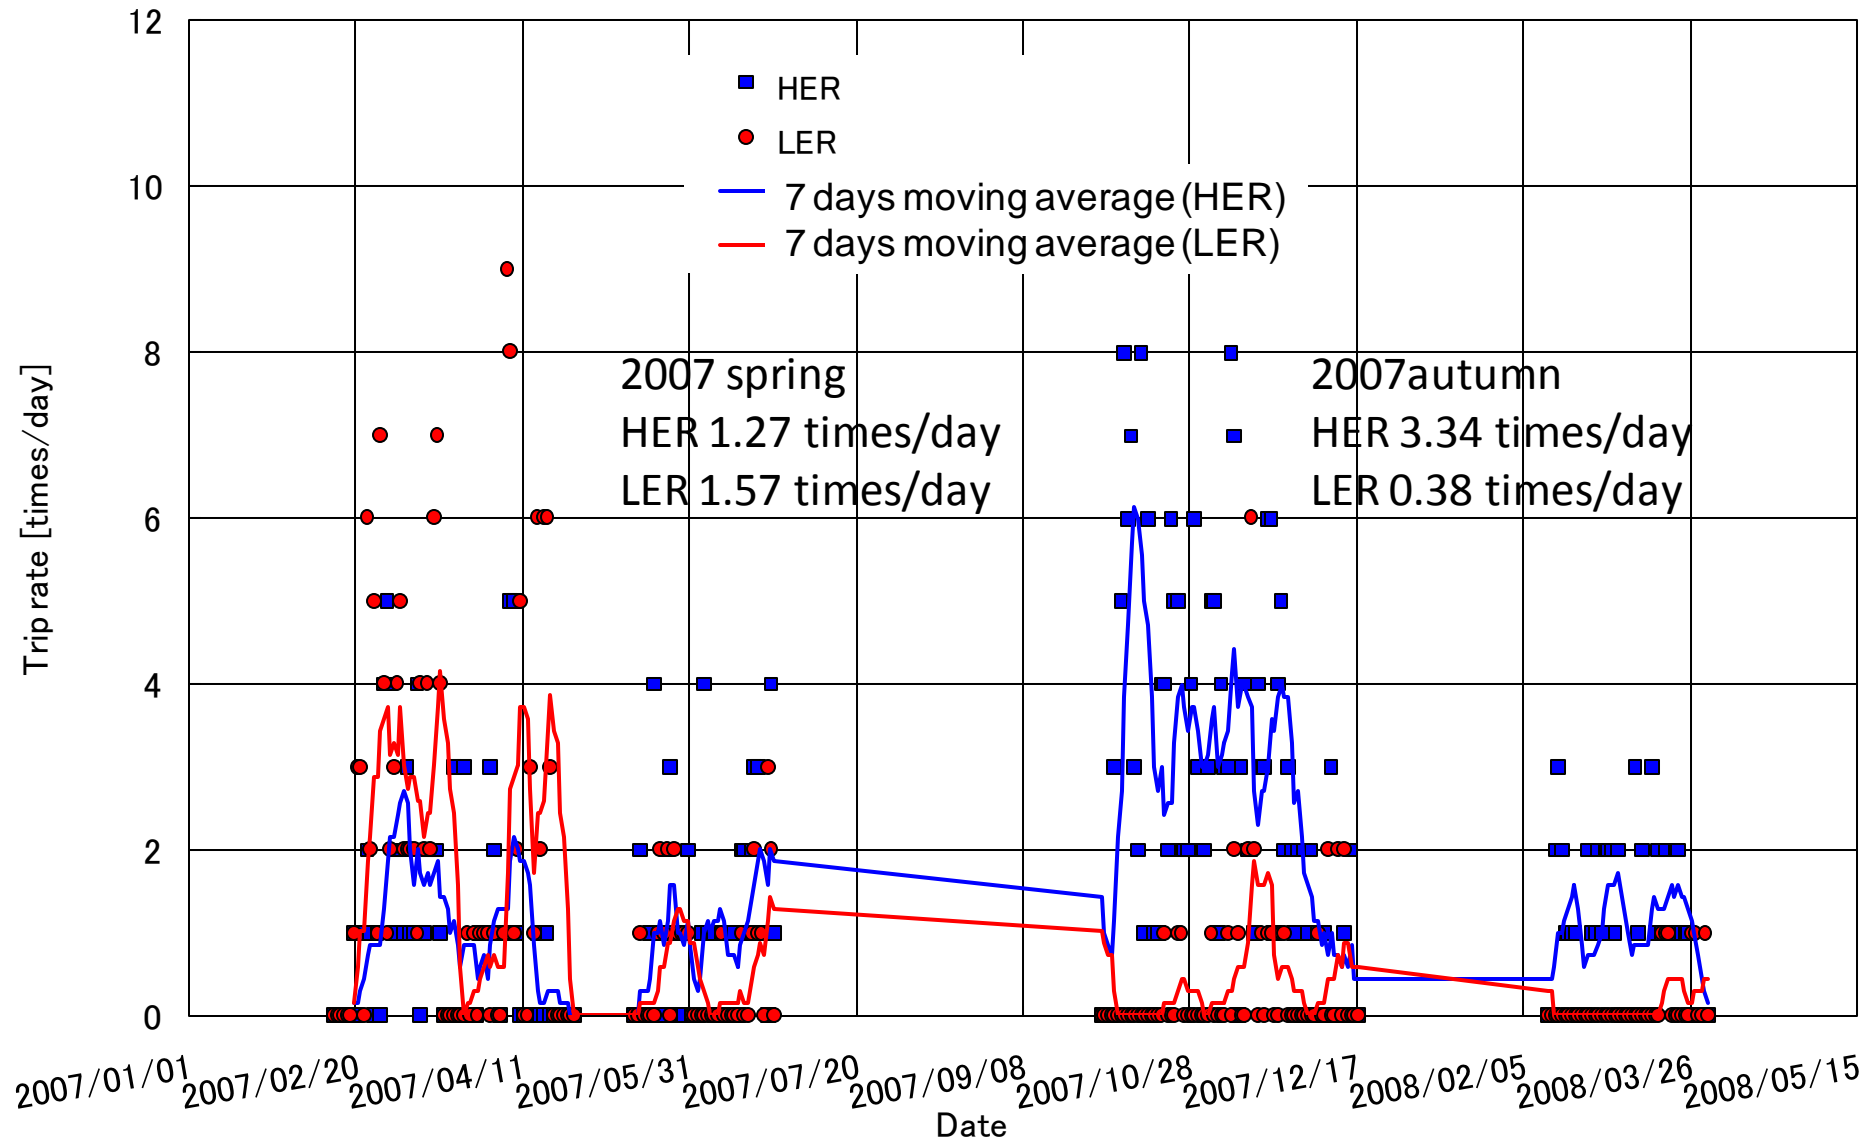
Trip rate

Kick voltage [MV]

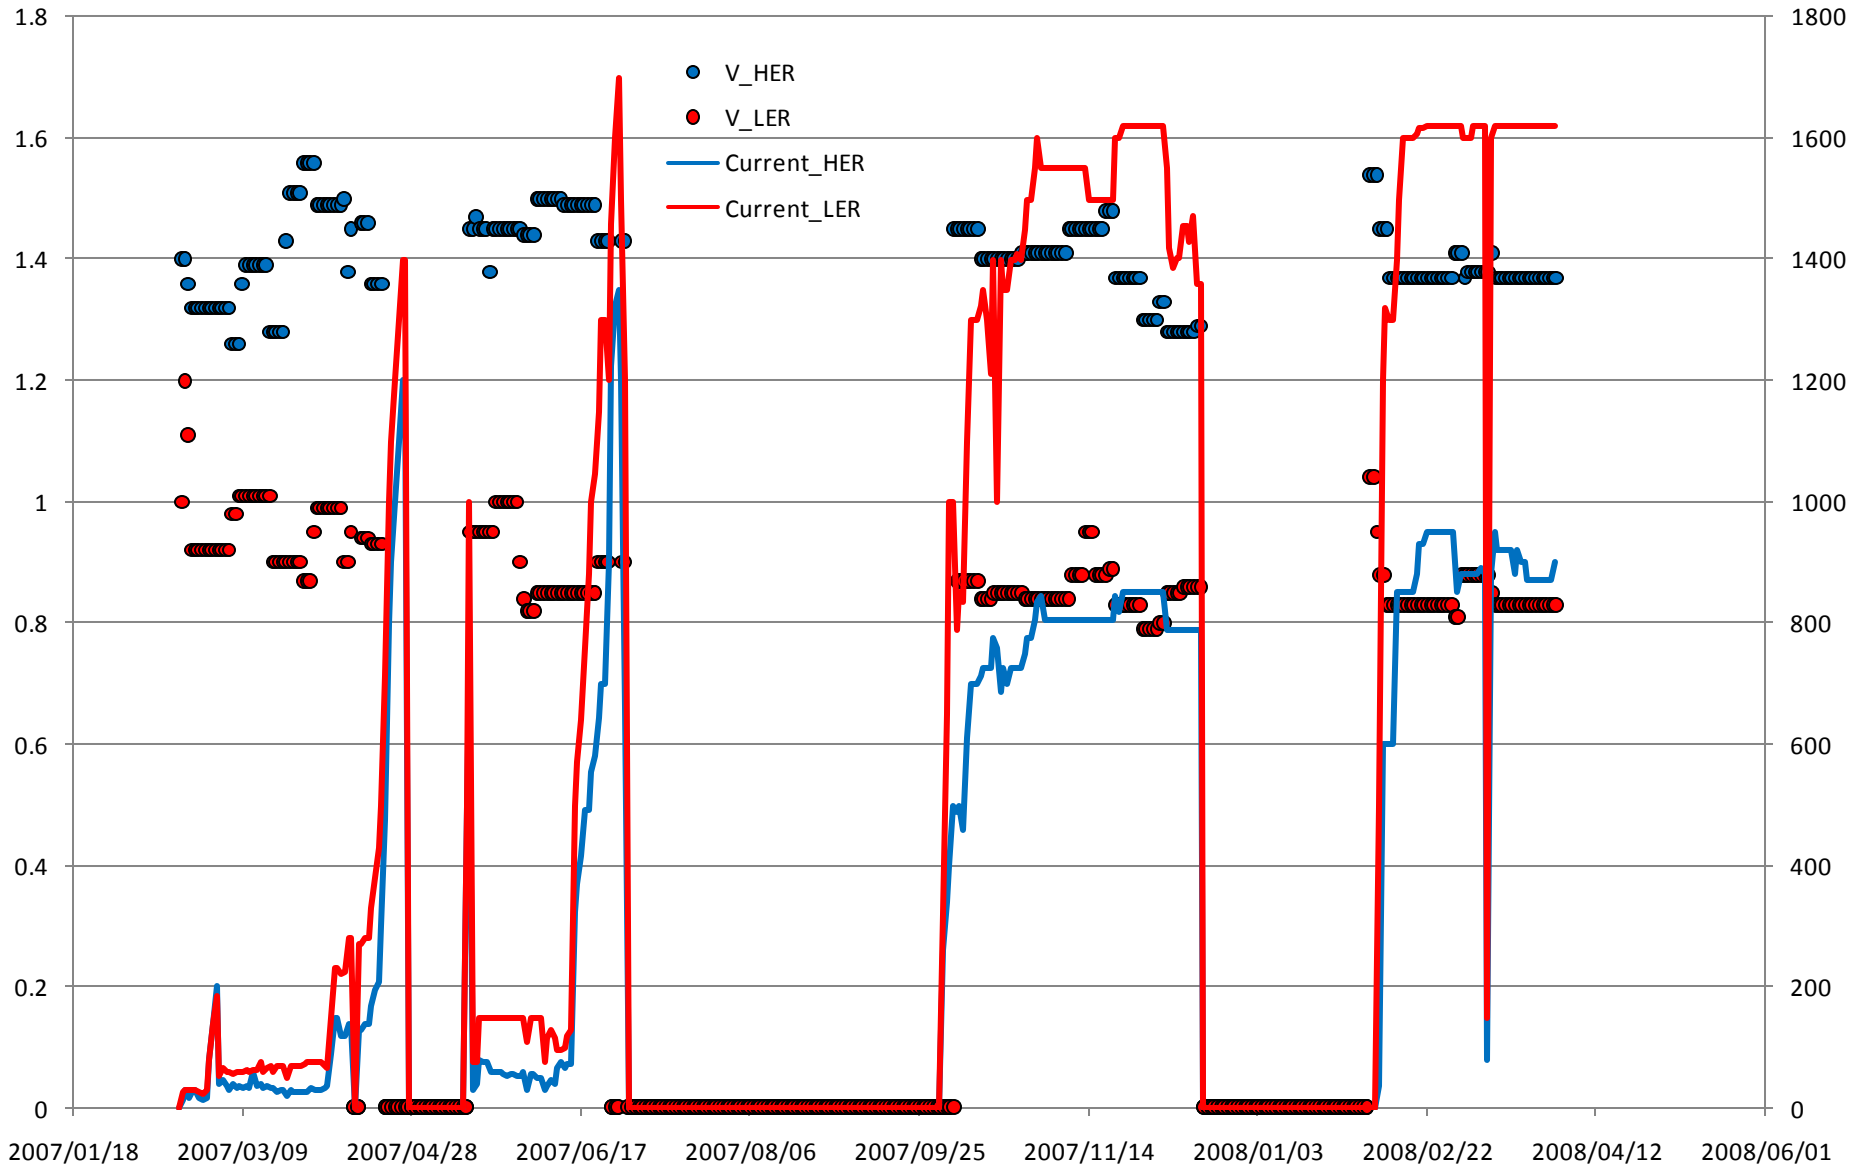
Beam current [mA]

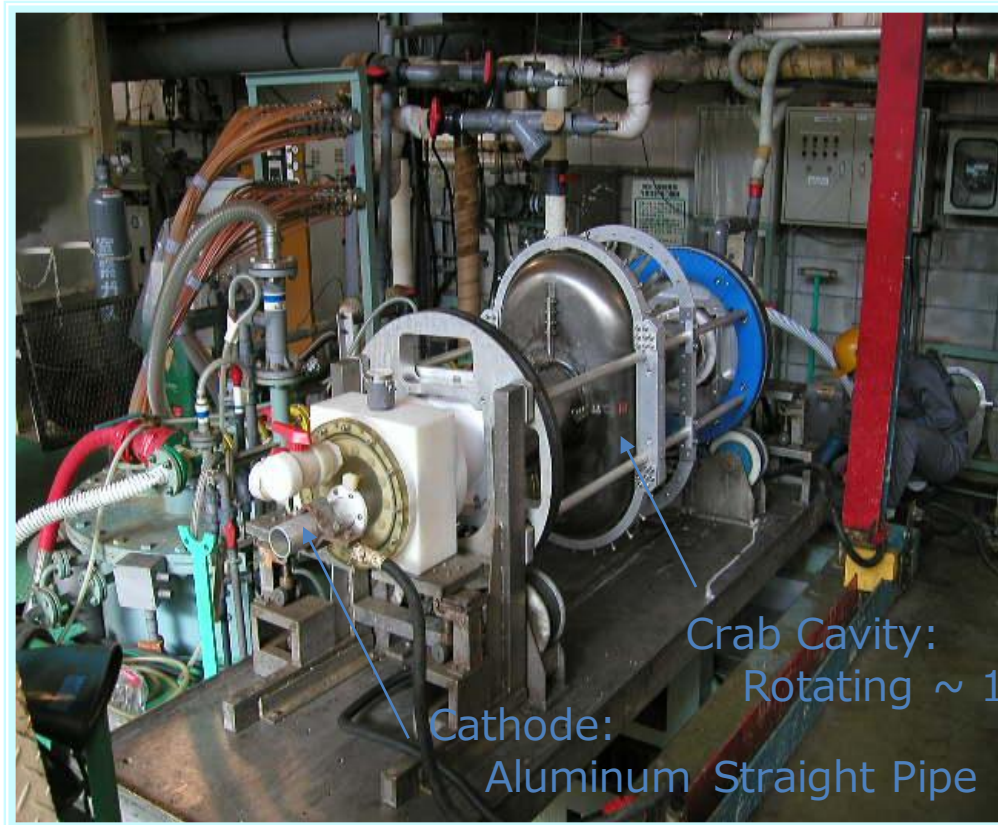
Electro Polishing at Nomura Plating Ltd.

EP 1 $\sim 100 \mu\text{m}$
EP 2 $\sim 5 \mu\text{m}$

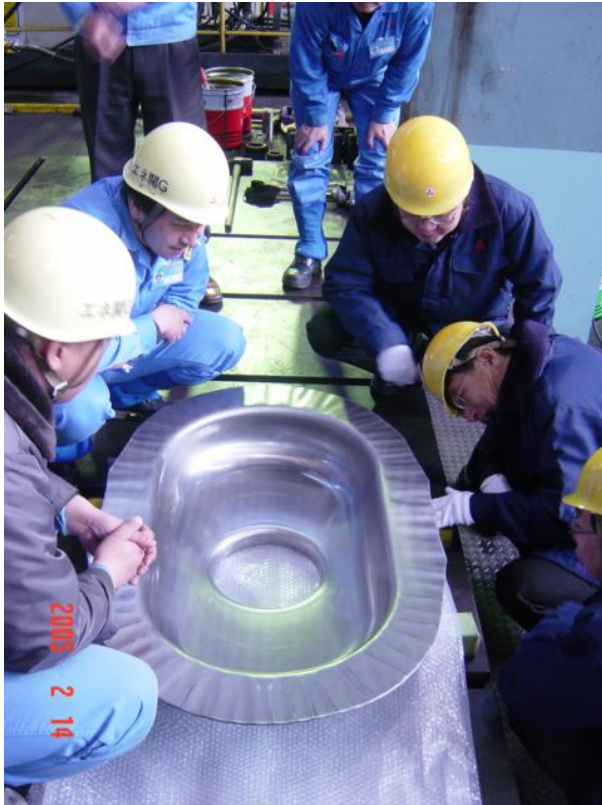
Forming of 4 Half-Cells for Crab Cavity for LER and HER

Feb. 14, 2005 at Mitsubishi Heavy Industries, LTD. Kobe

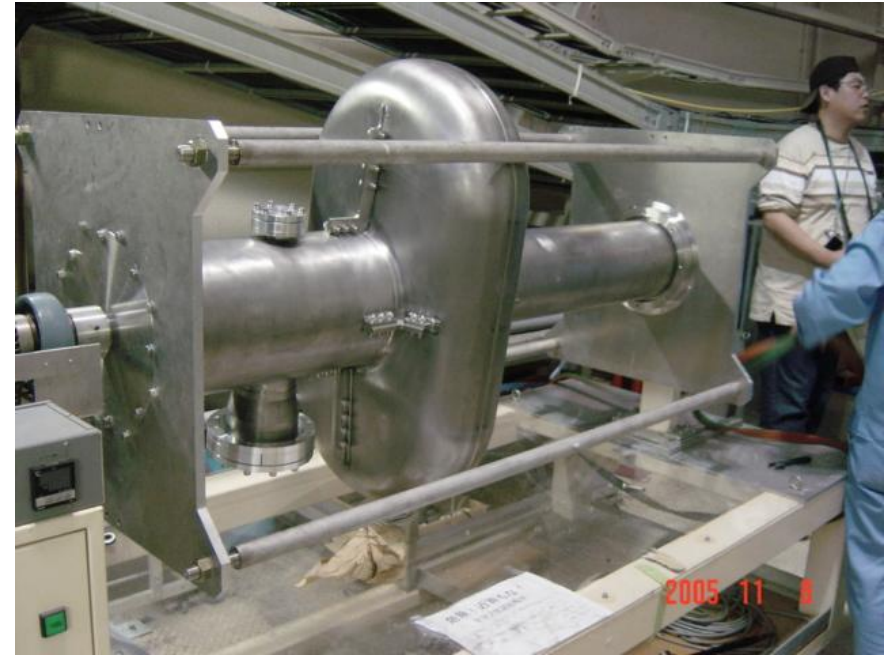
Barrel Polishing

Polishing Time 312 Hr

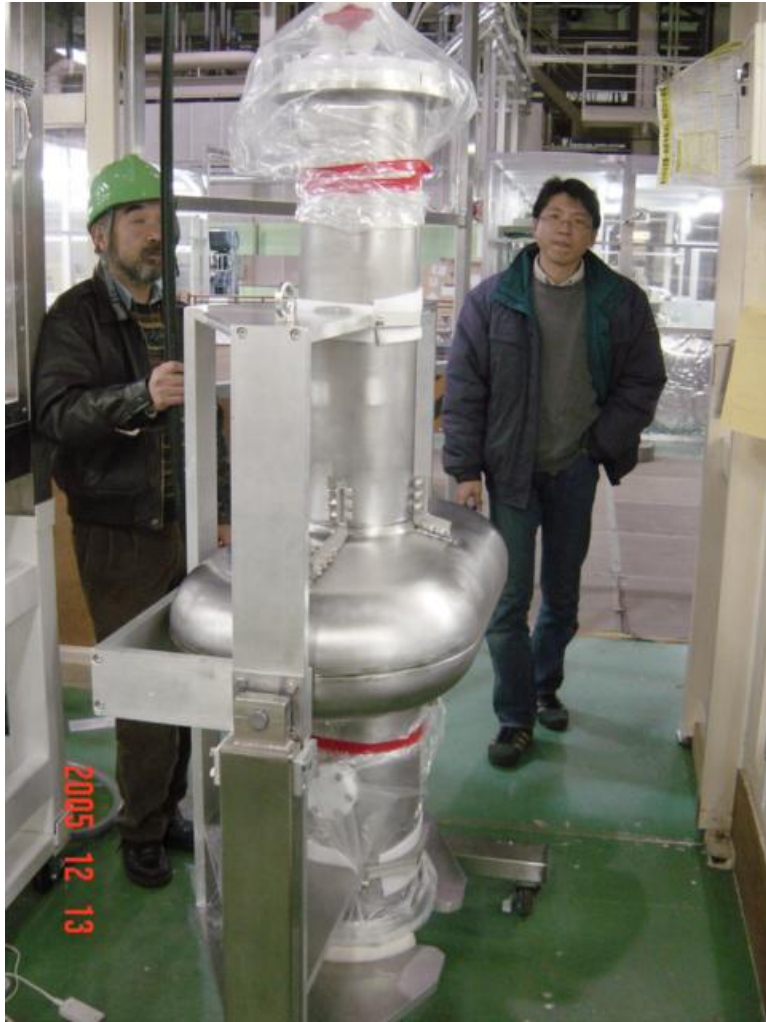
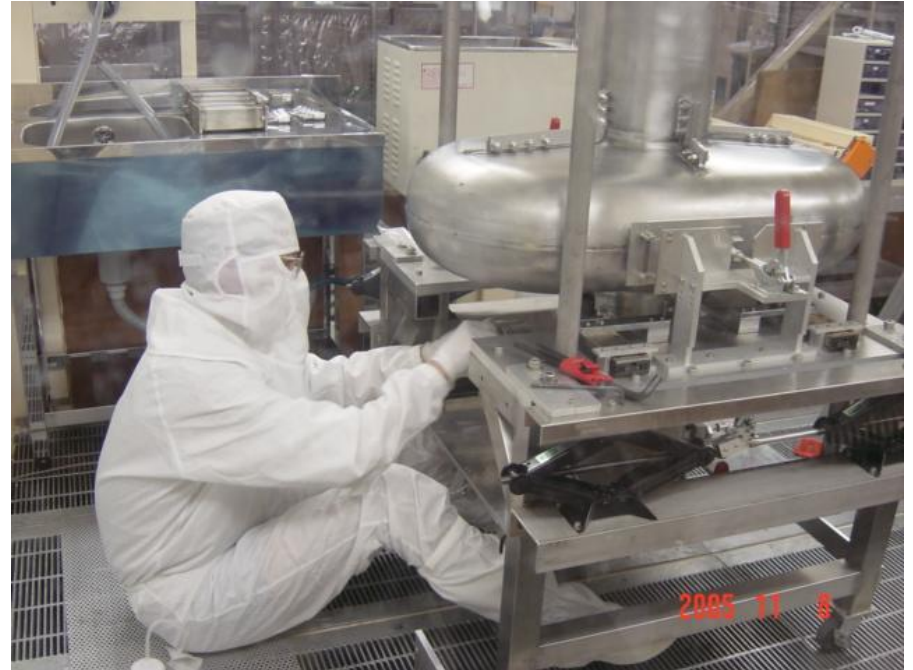
High Pressure Rinsing and Assembling for RF Cold Test

Set Flanges of Beam Pipes and Ports
in Class 100 Clean

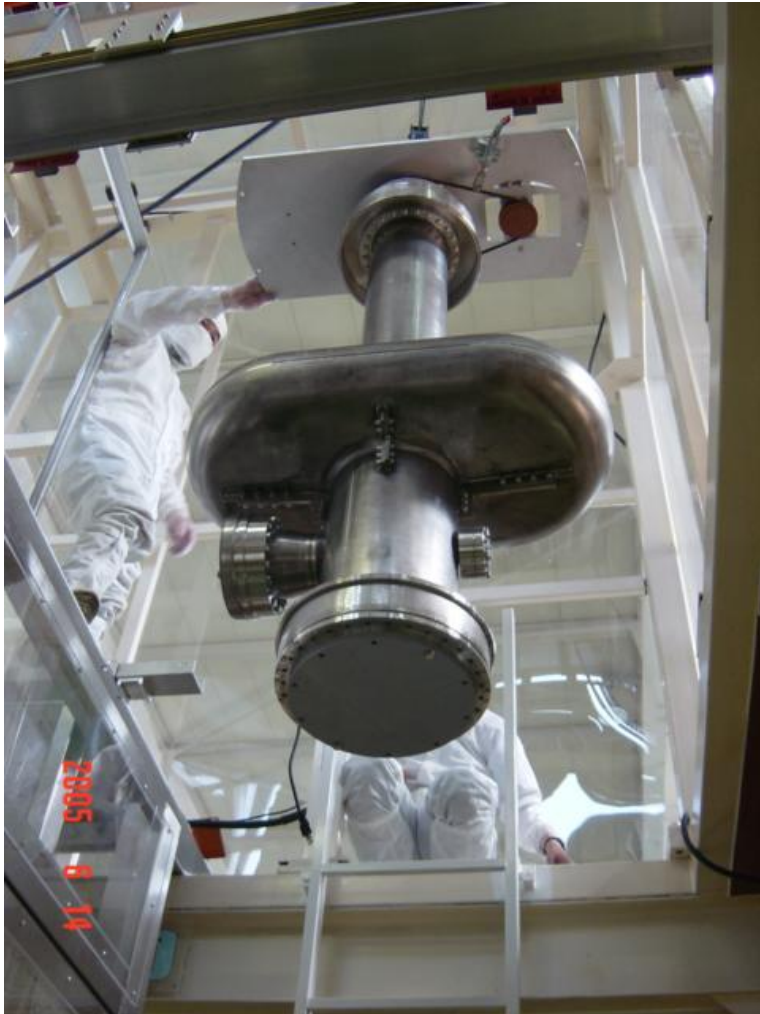
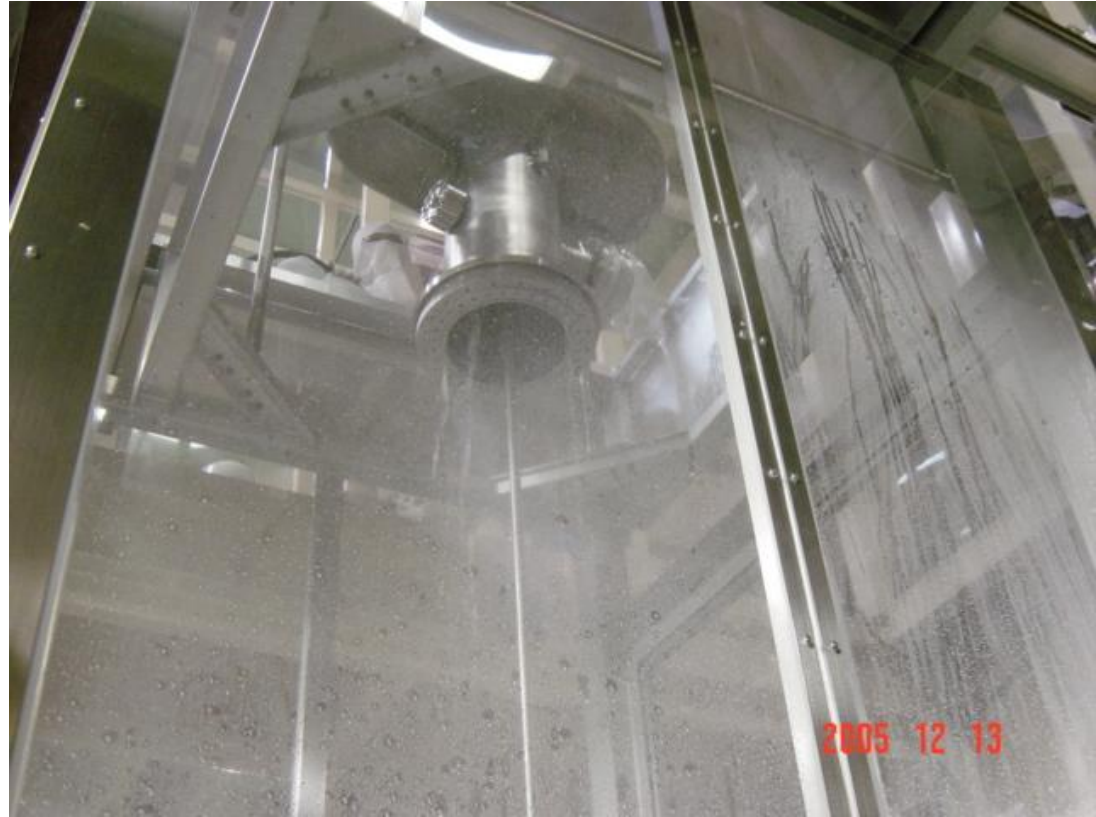
High pressure rinsing

High Pressure Water Rinsing
by 80 bar Ultra-Pure water

Rotation & Up-Down Motion
